Jajarkot Earthquake: Impacts and Future Directions for Earthquake Resilient Reconstruction

Gokarna Bahadur Motra, PhD

11 Nov. 2023 (2080/08/08)

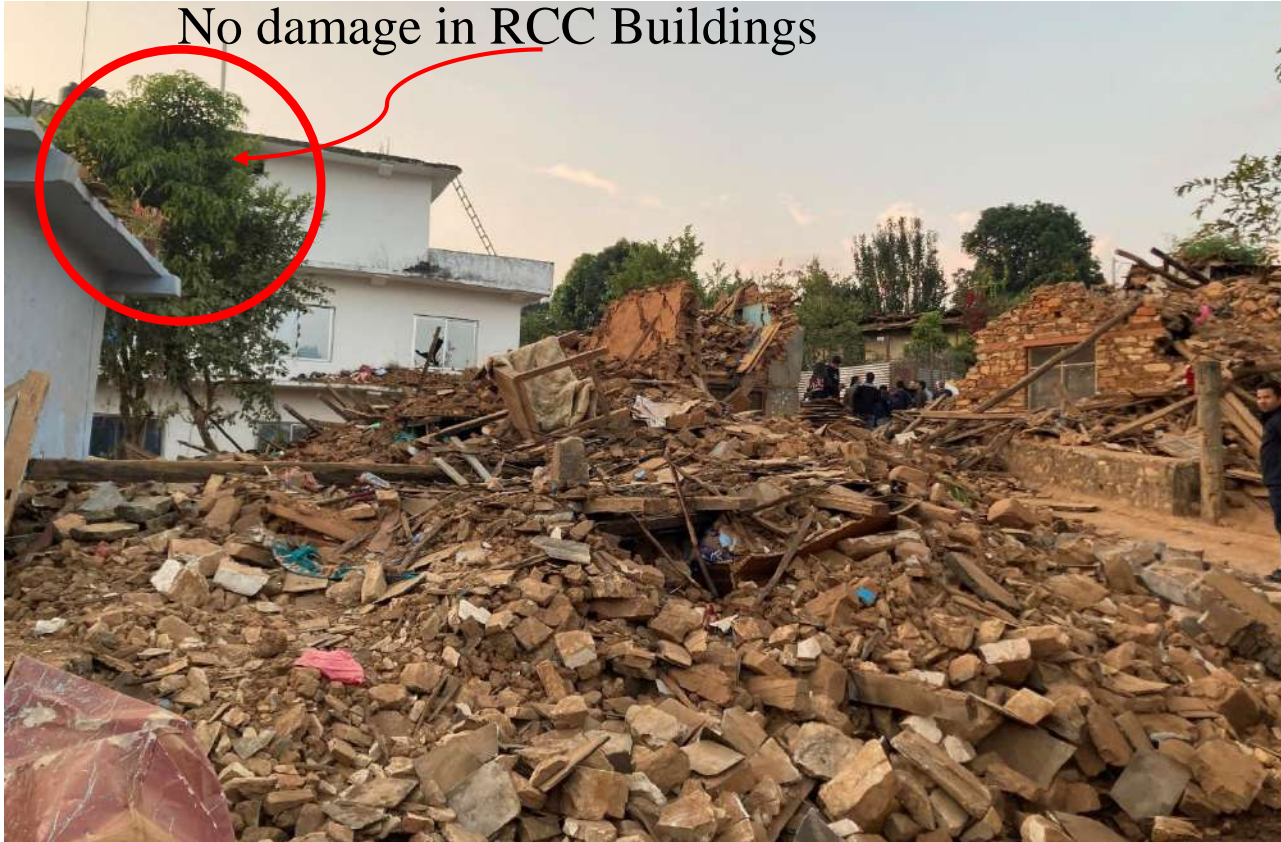
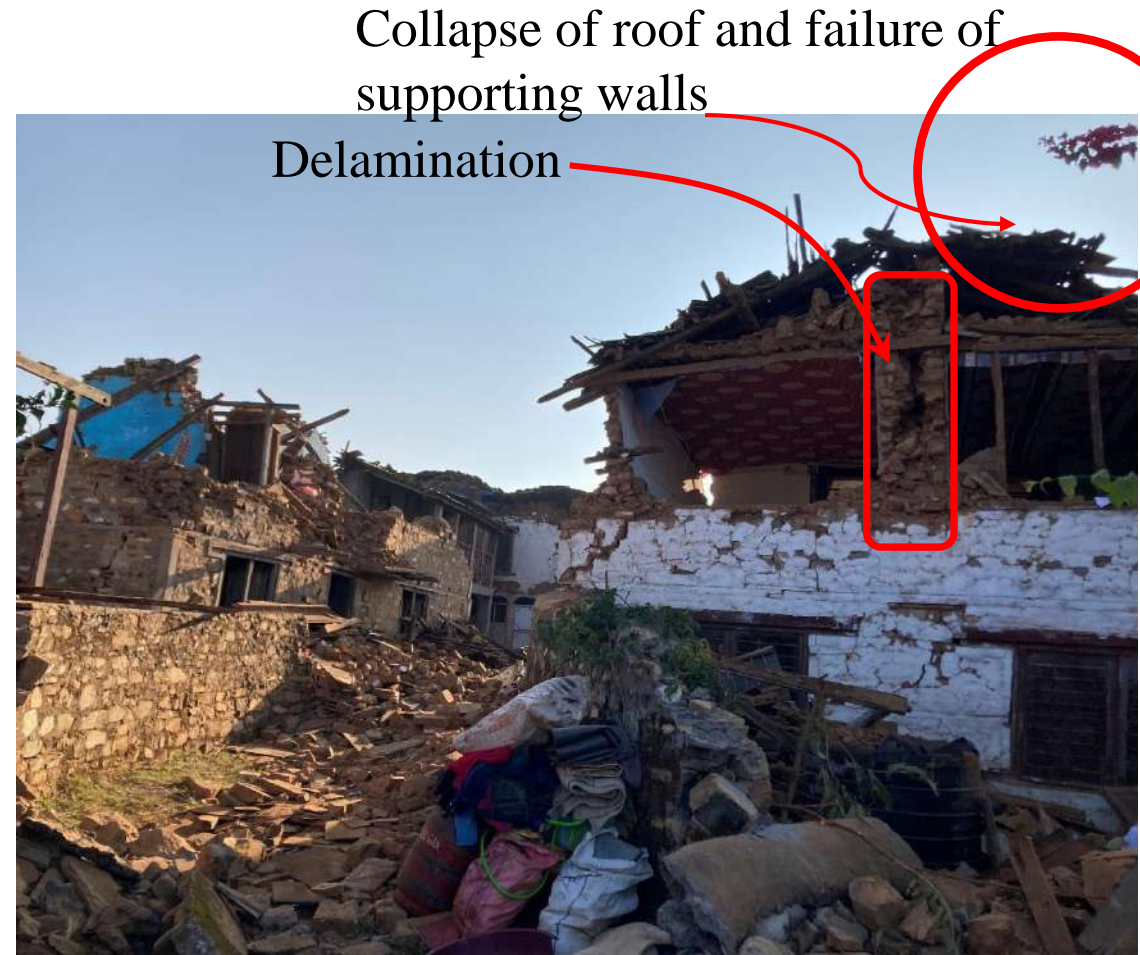
Collapse of Stone Masonry Building in Mud Mortar at Khalanga, Jajarkot

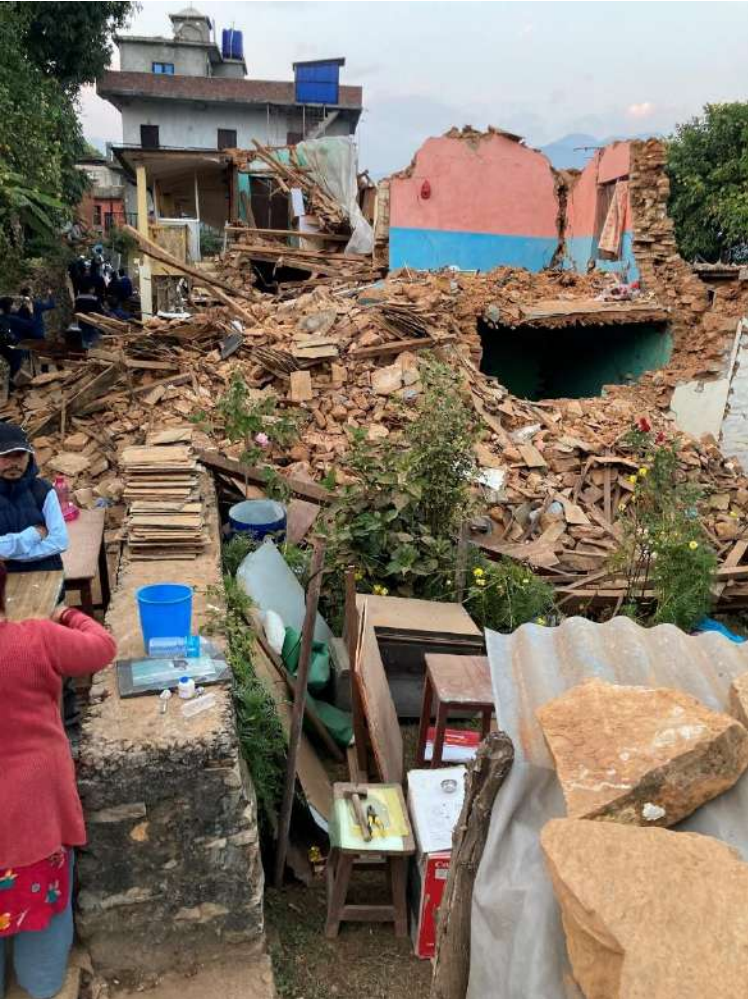
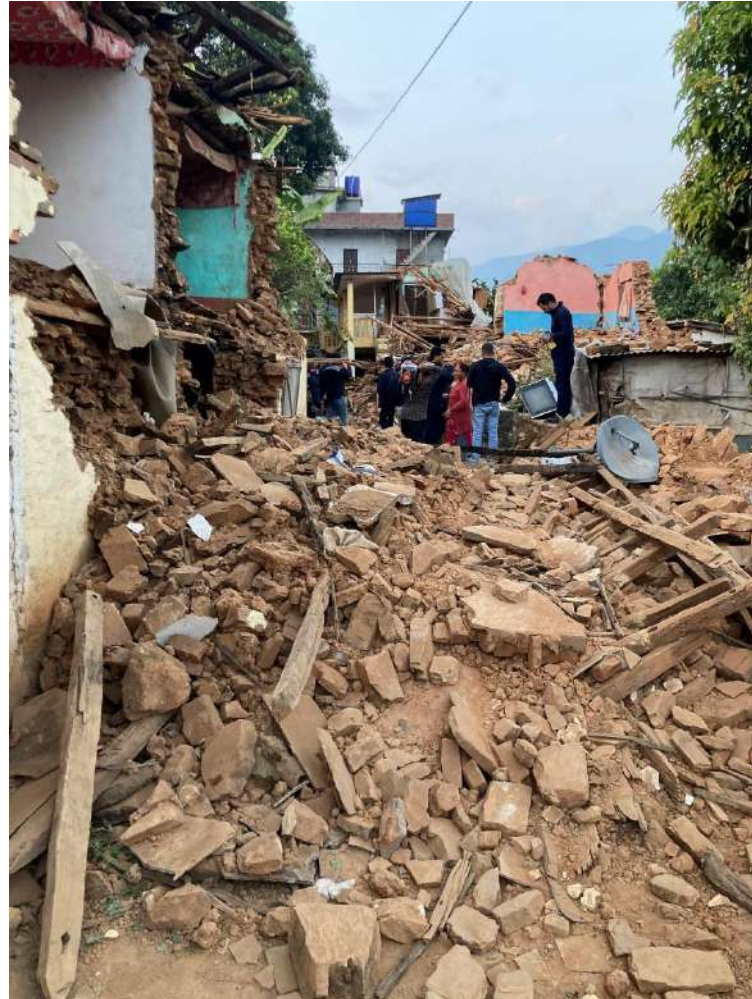
- Old unreinforced masonry buildings suffered extensive damage due to low strength of masonry via material deterioration over the years
- Debate among professionals: can it be made earthquake resistant or not?
- Collapse of the roof and failure of supporting walls
- Weak diaphragms and their poor connection with the masonry wall caused collapse of floor as well as failure of supporting walls

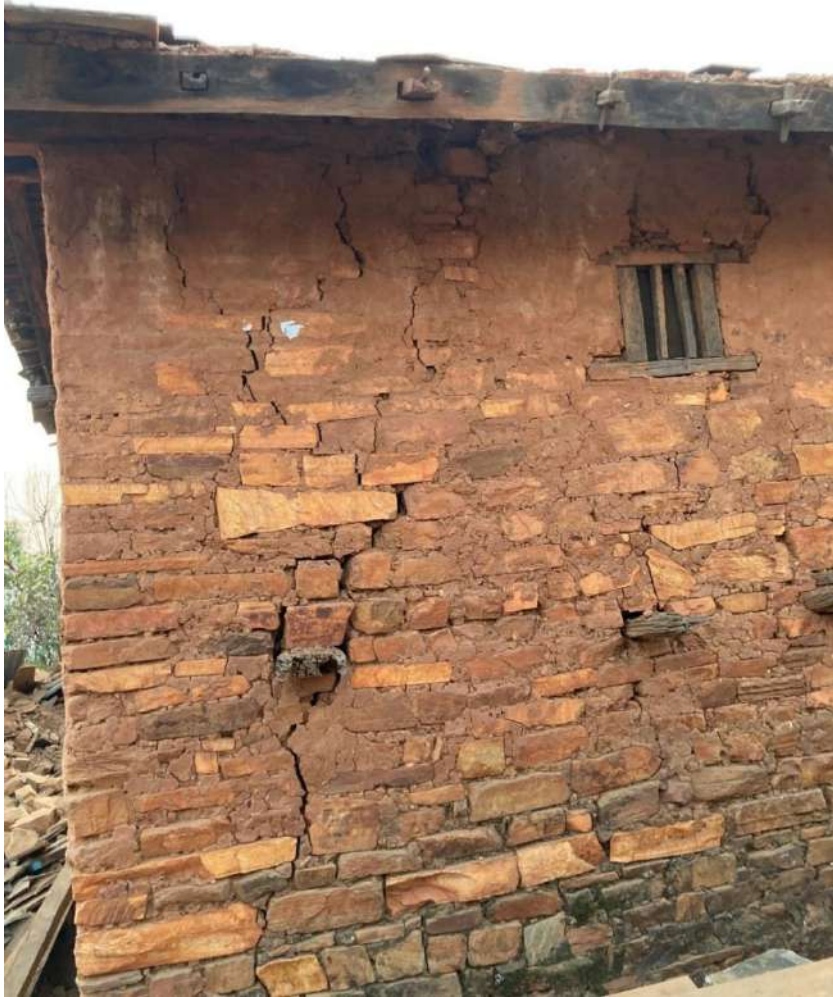
Formation of cracks at the corners of the URM buildings
Most of the URM structures lost significant strength due to formation of vertical cracks at the corners of the building, reducing the out-of-plane stability of the walls drastically

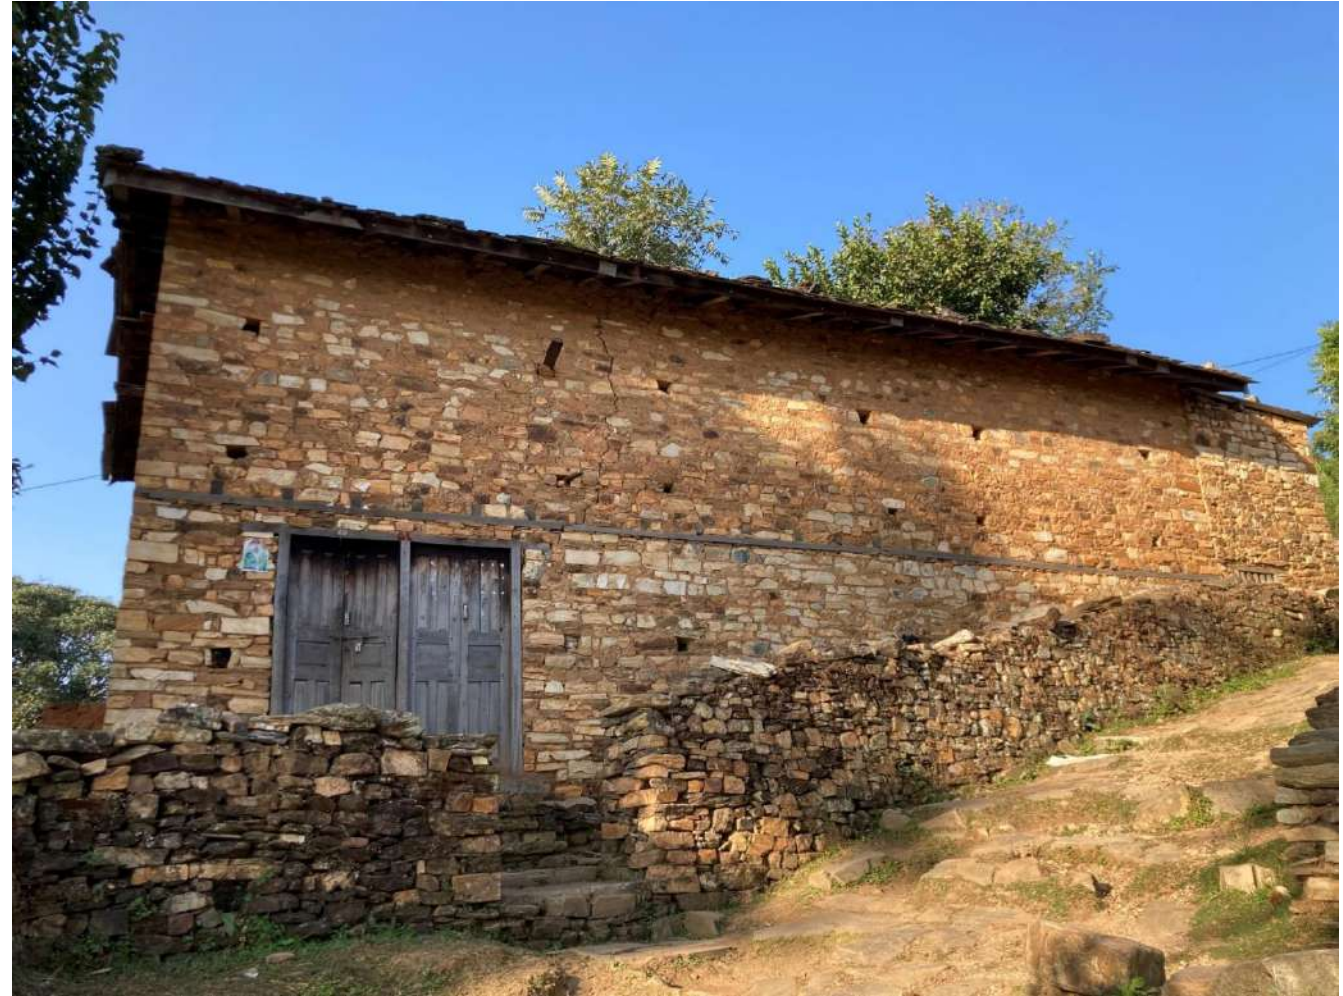
Stone masonry buildings with timber bands survived

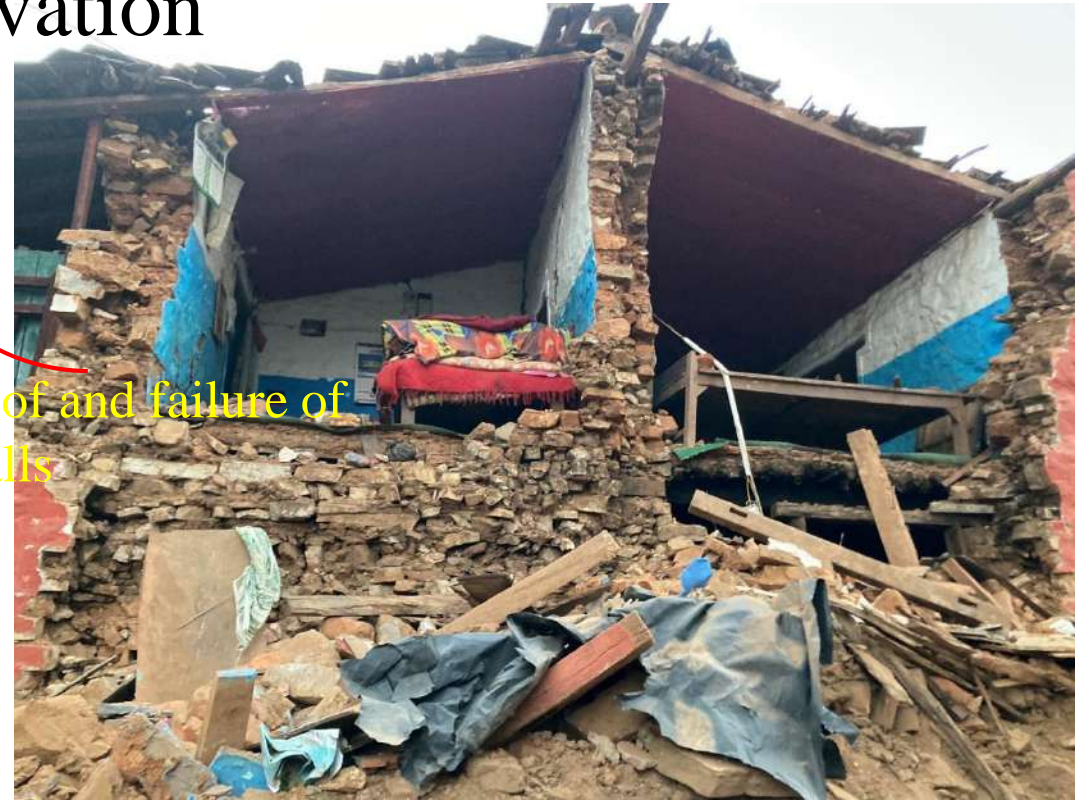
Collapse of roof and failure of supporting walls

- Heavy roof collapse and out of plane failure of supporting walls
- Typical out-of-plane failure of URM walls

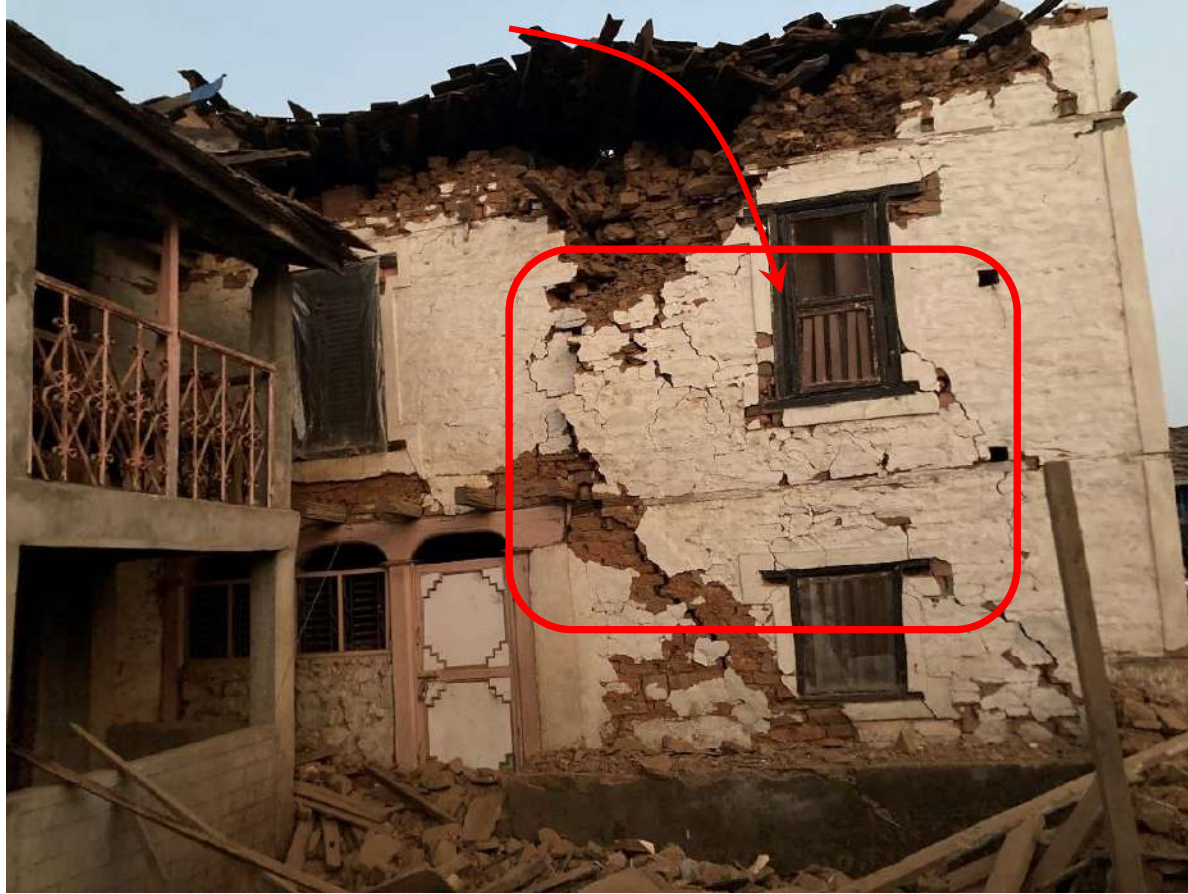
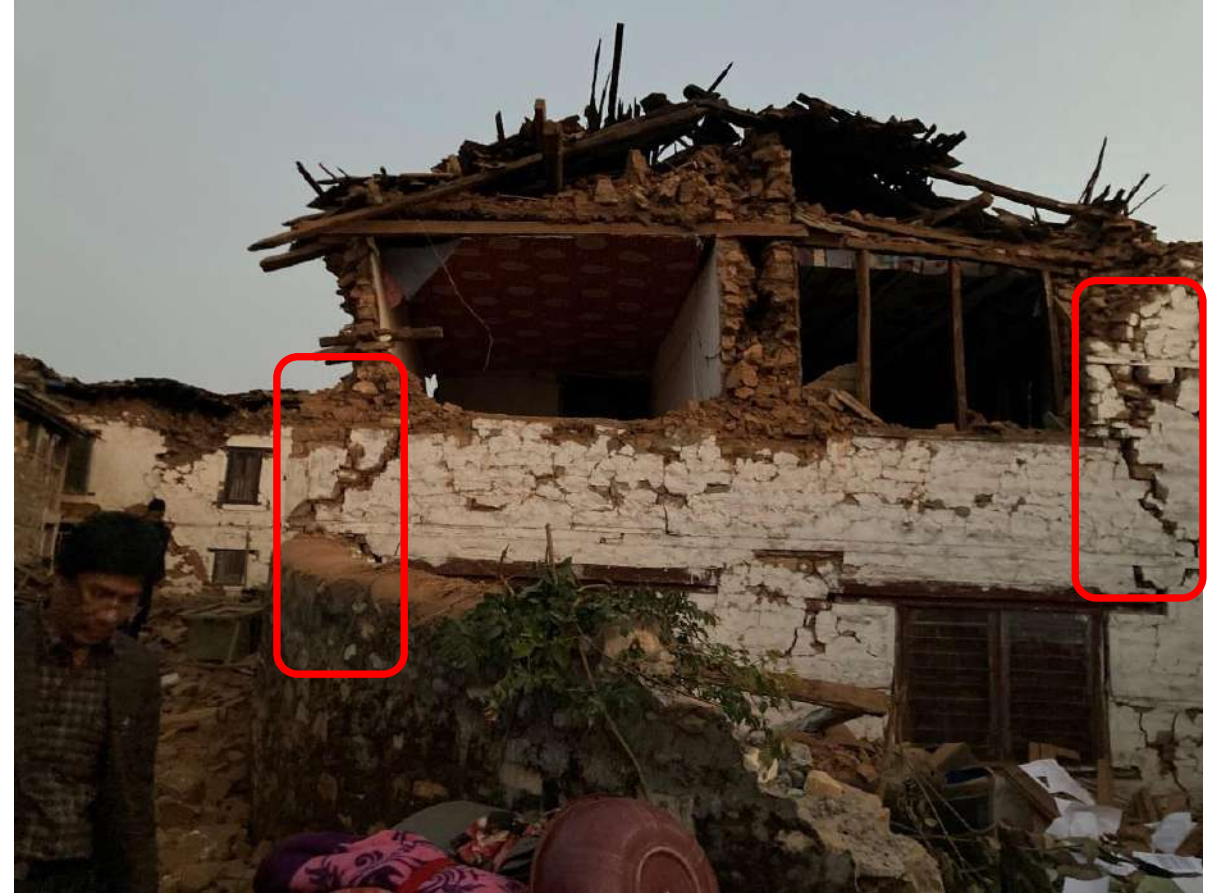
Diagonal shear cracks

- Heavy roof collapse and failure of supporting walls in out-of-plane
- Diagonal shear crack in shear walls

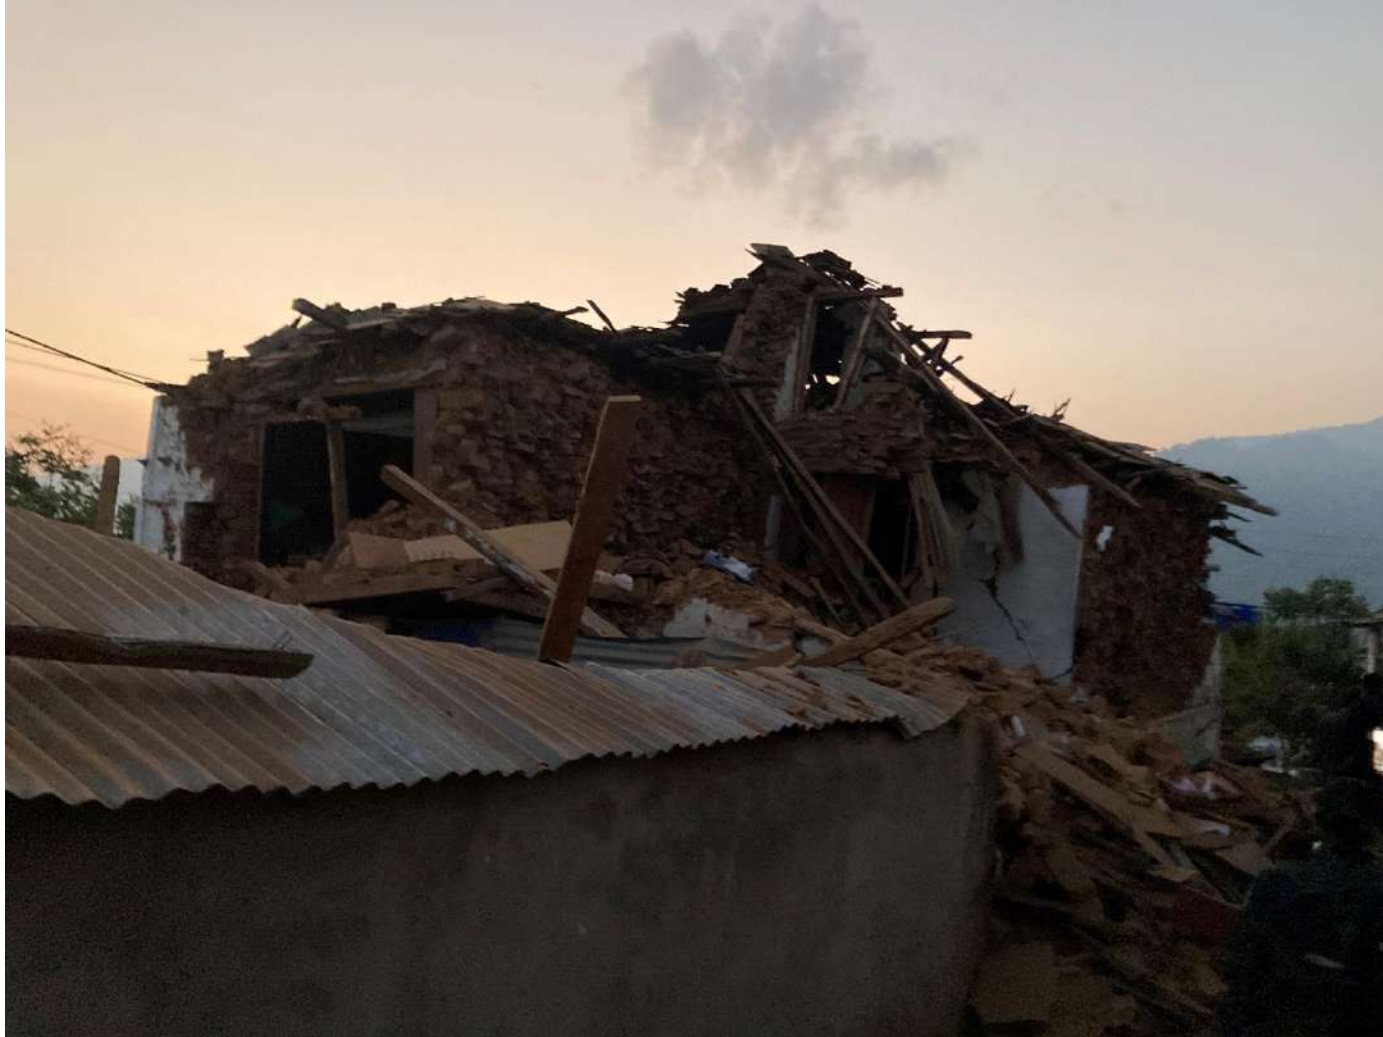
Complete collapse

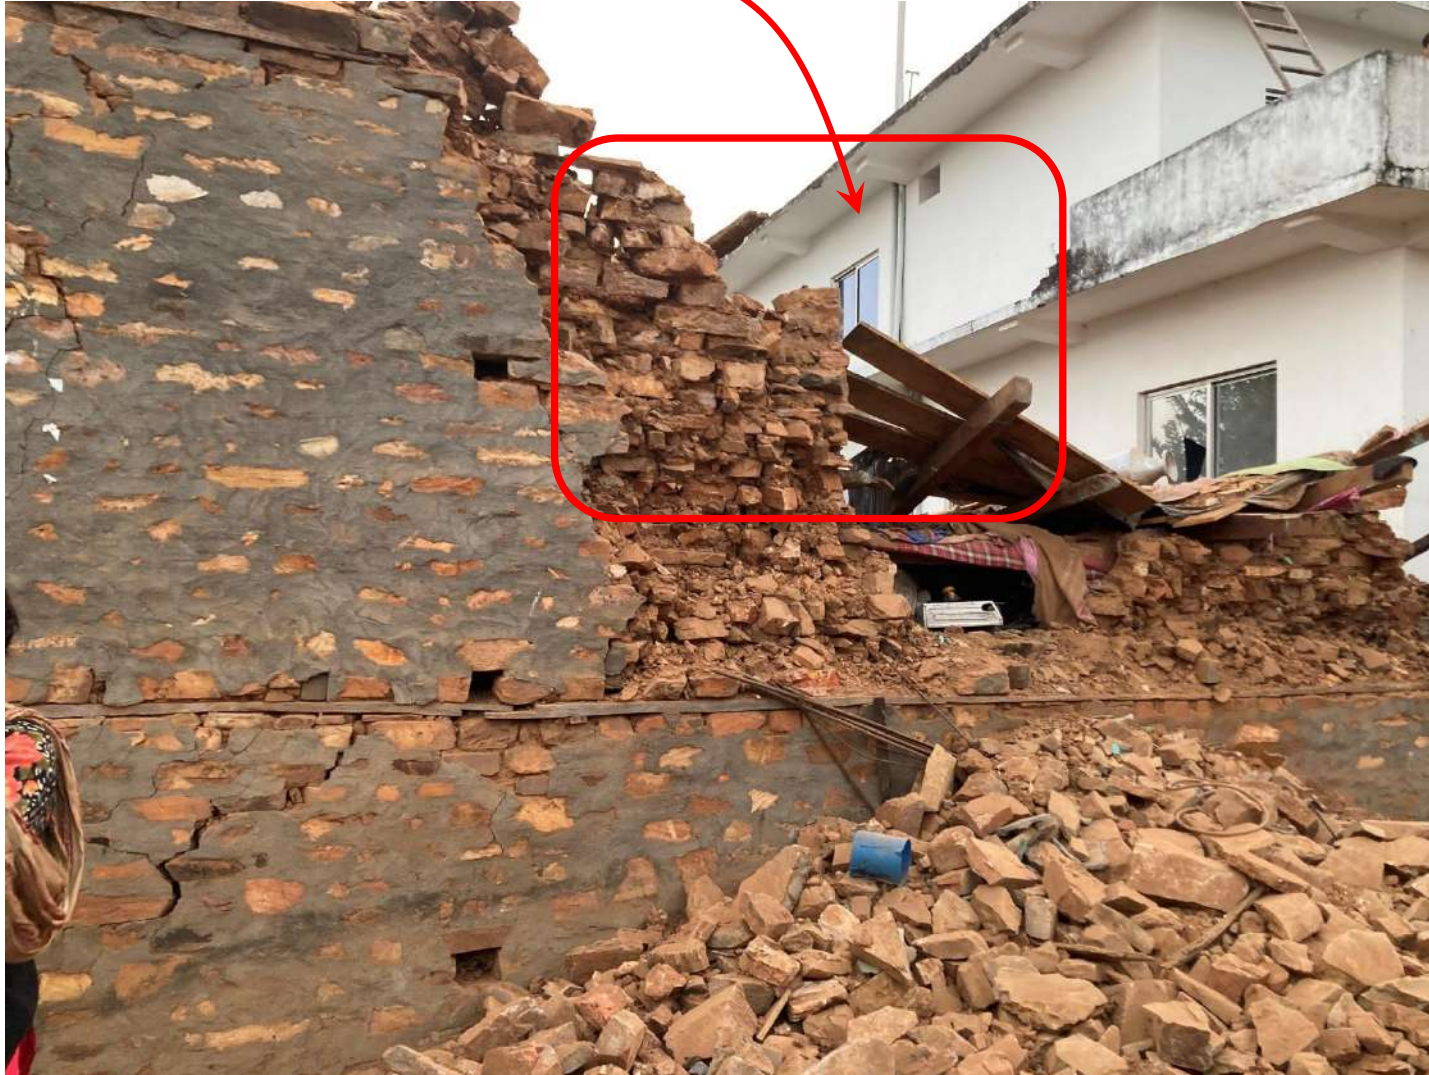
Lack of bonding stones

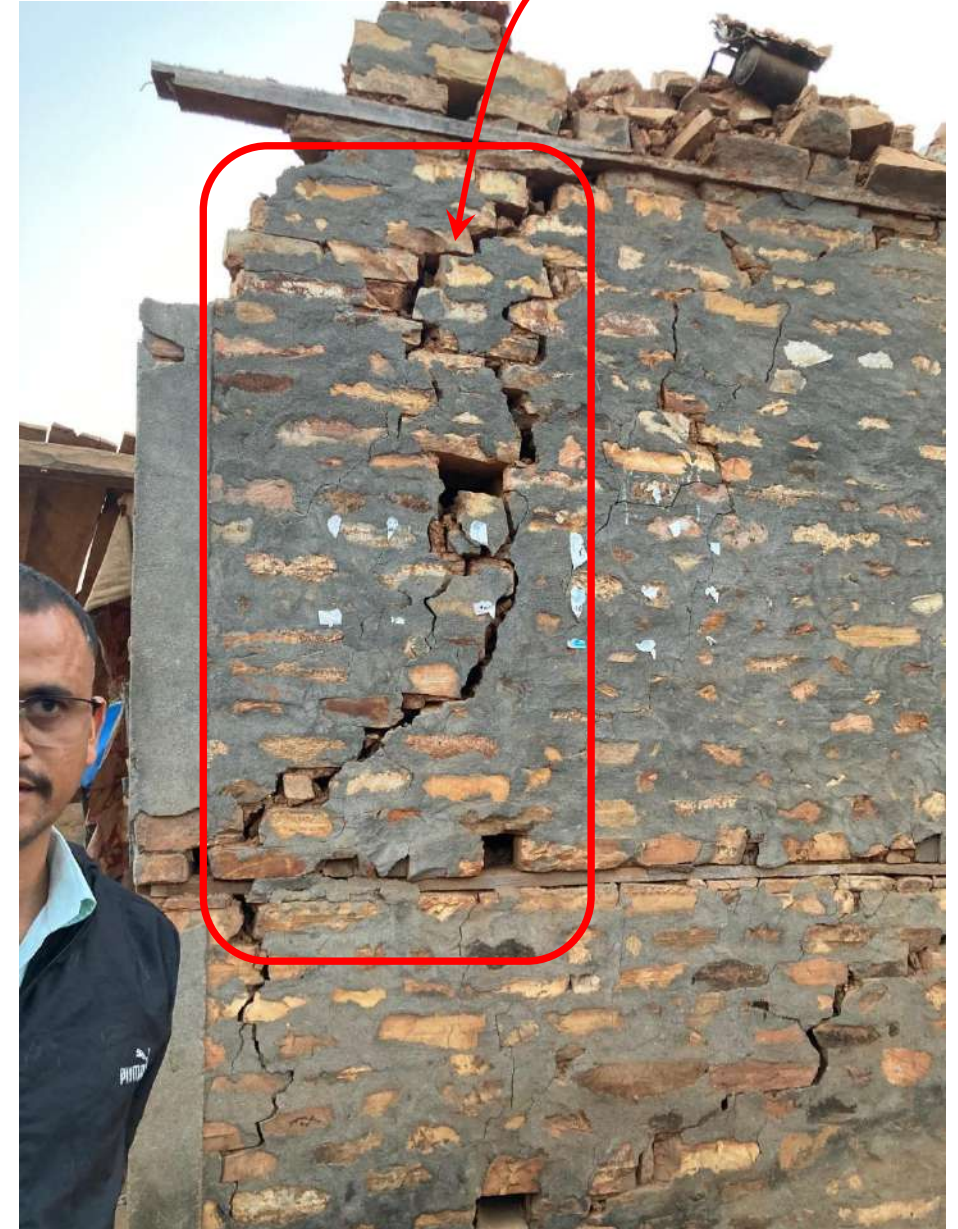
Wall failure at corner

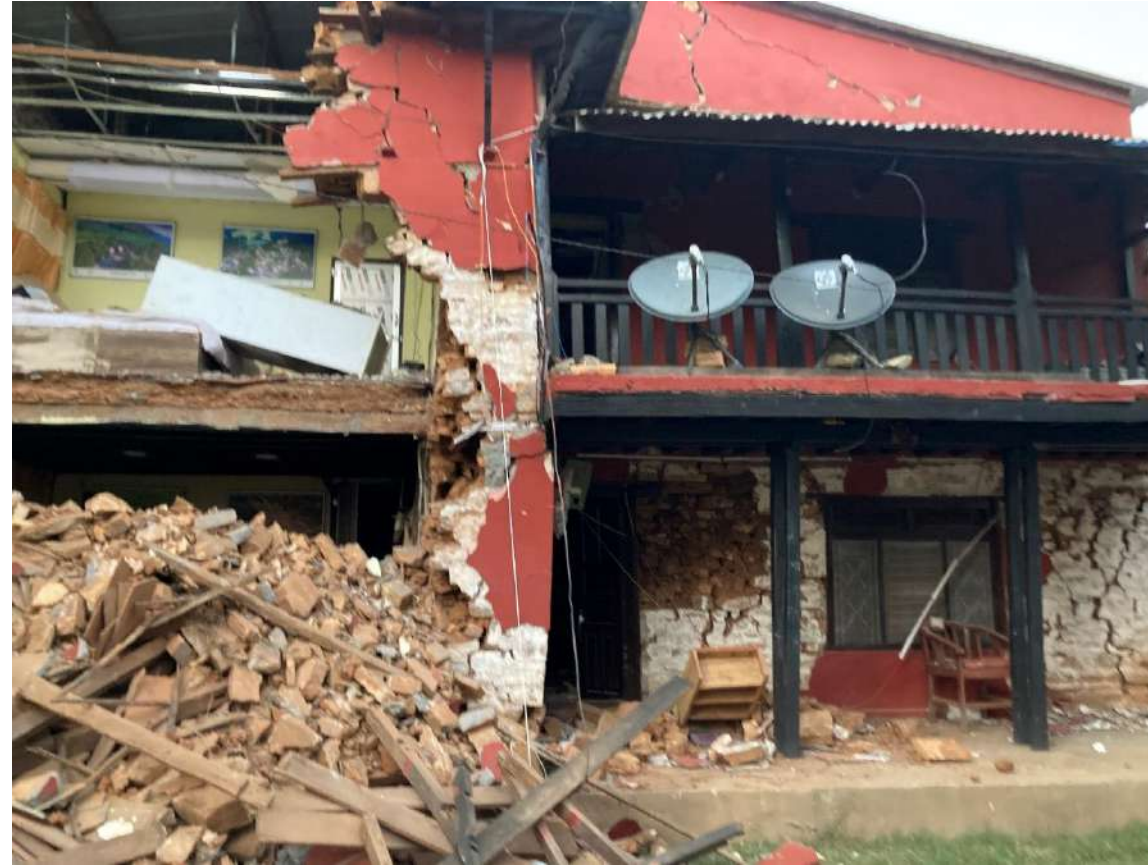
Wall pier diagonal cracking

- Flexible floor- holding one direction walls only
- Formation of vertical cracks at the corners of the building reduce the out-of-plane stability of the walls drastically that leads to strength loss significantly.

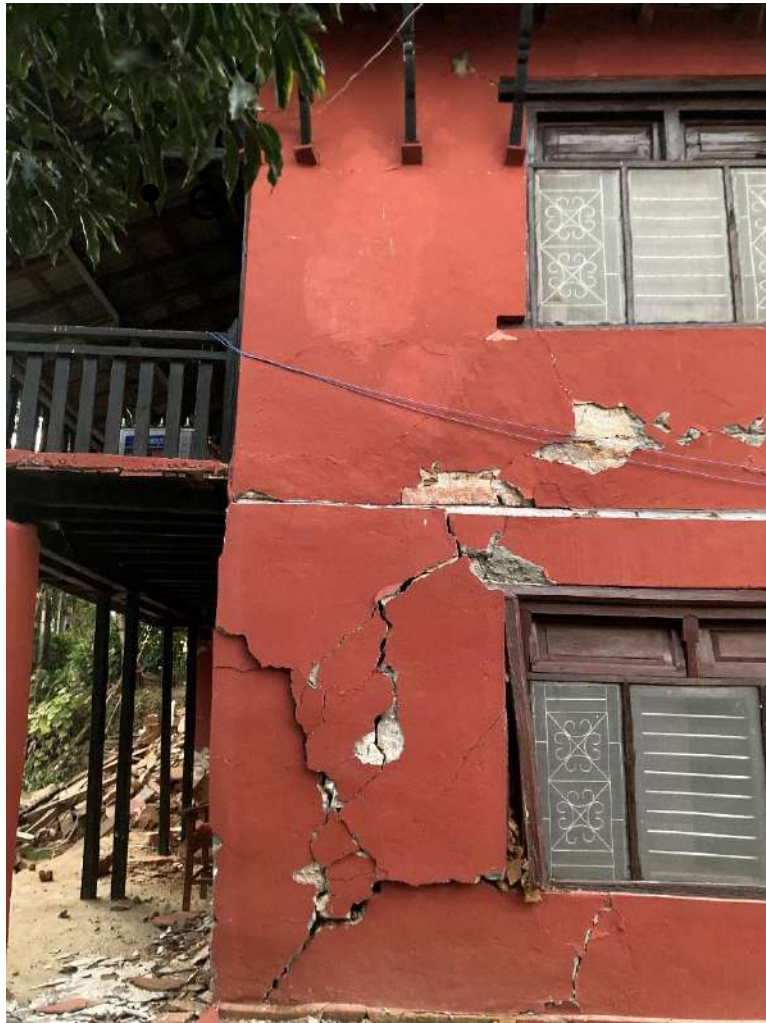
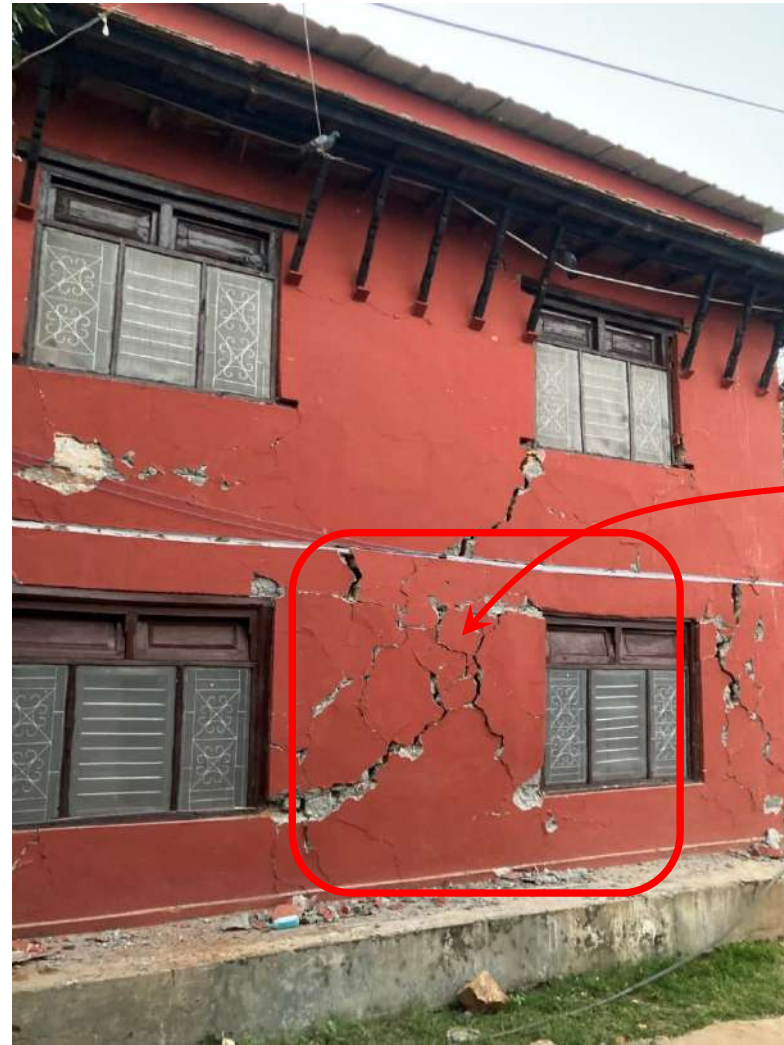
Wall pier diagonal cracking

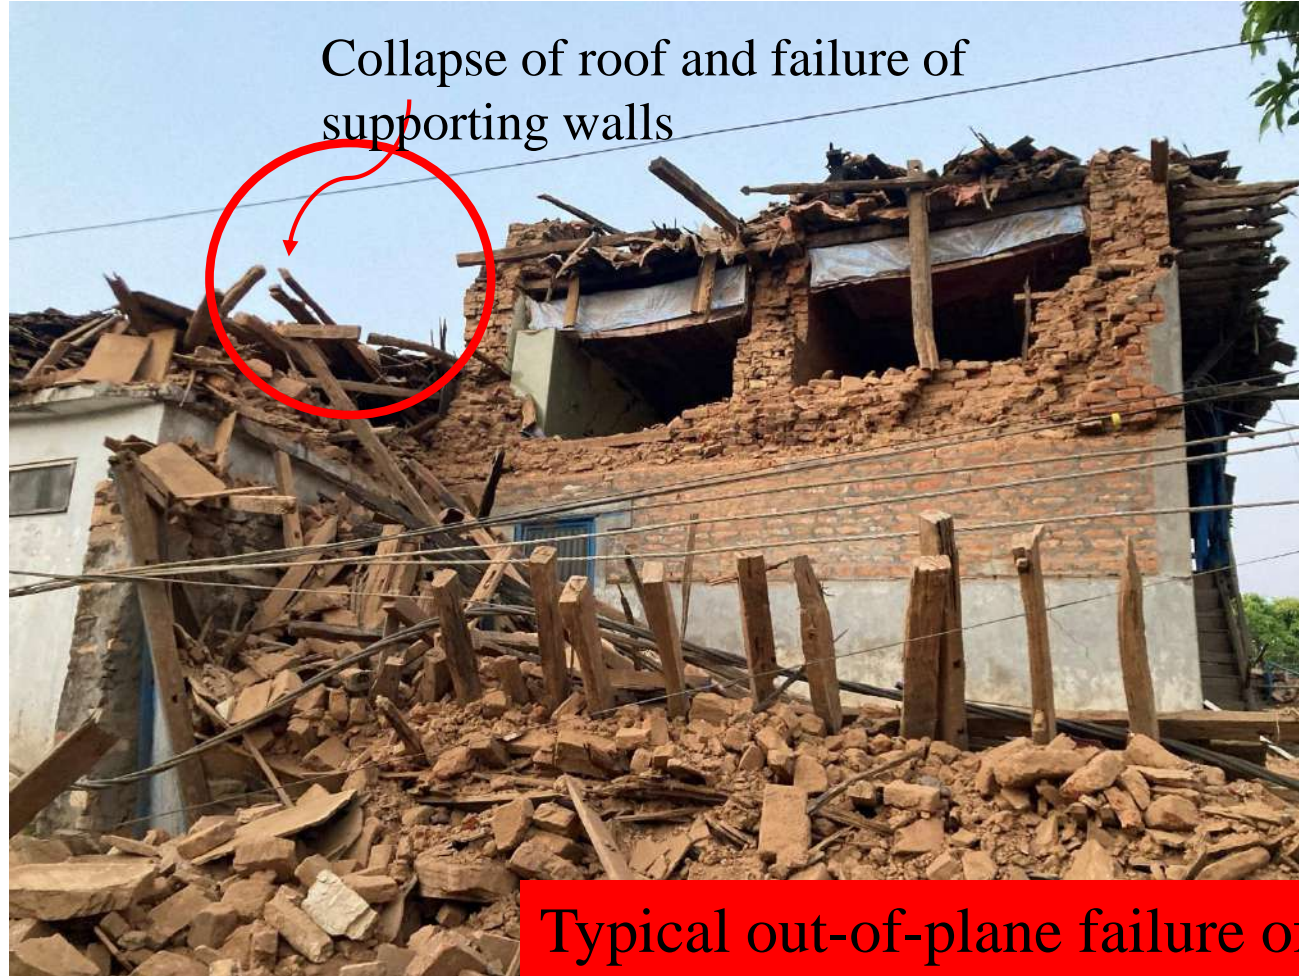
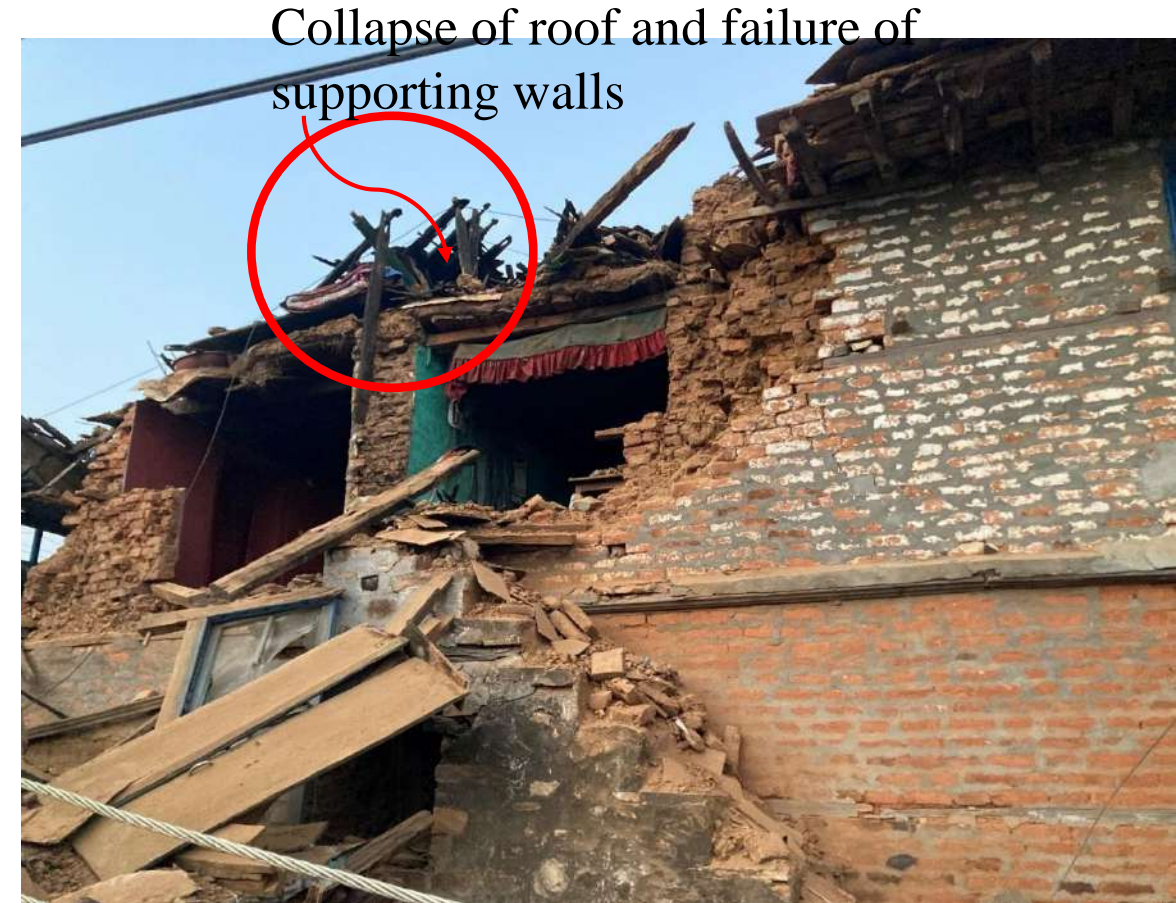
- In old masonry buildings, out-of-plane collapse of load bearing walls was widely observed in Jajarkot.
- Poor connection with the diaphragm and cross walls led to such collapse.

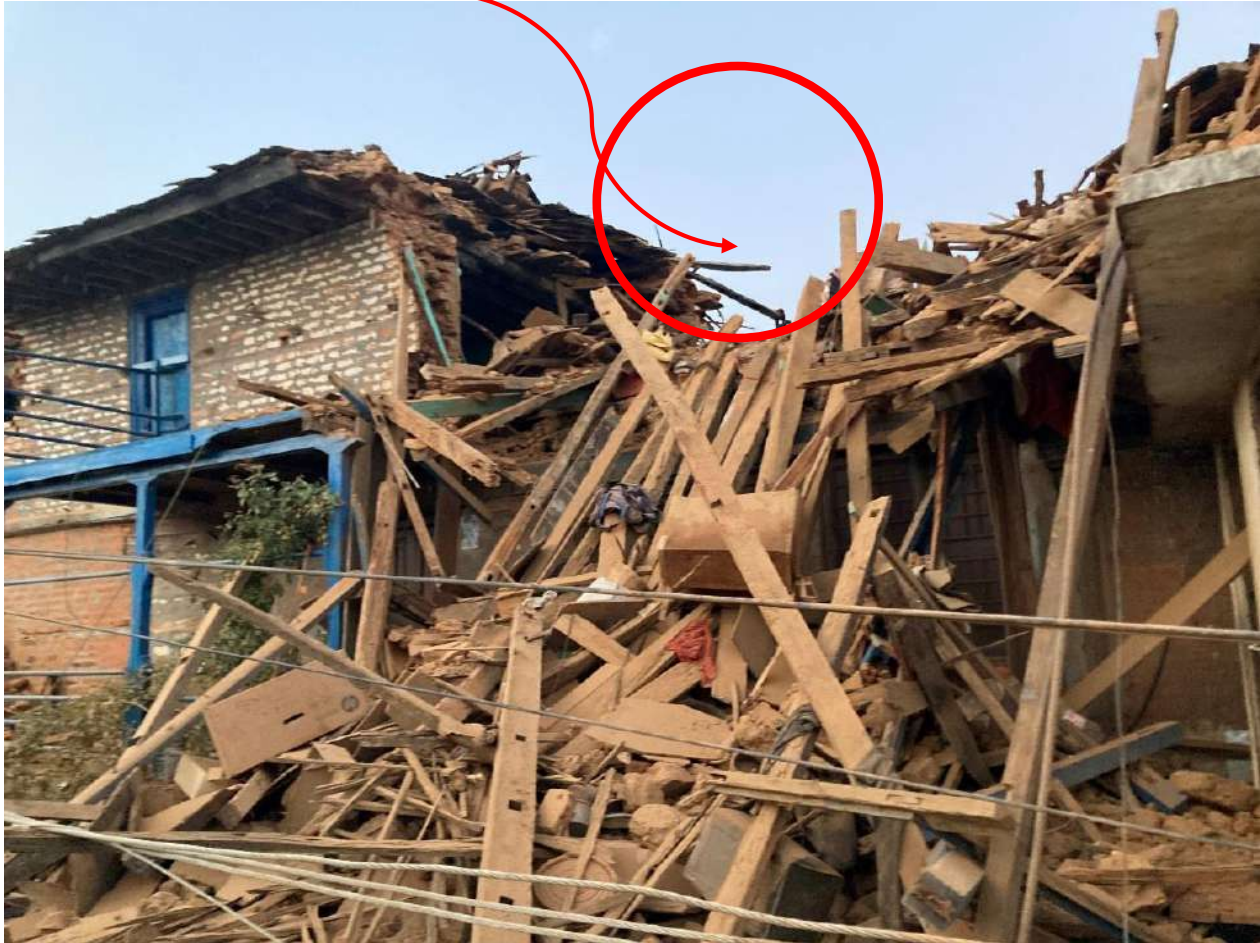
Collapse of roof and failure of supporting walls

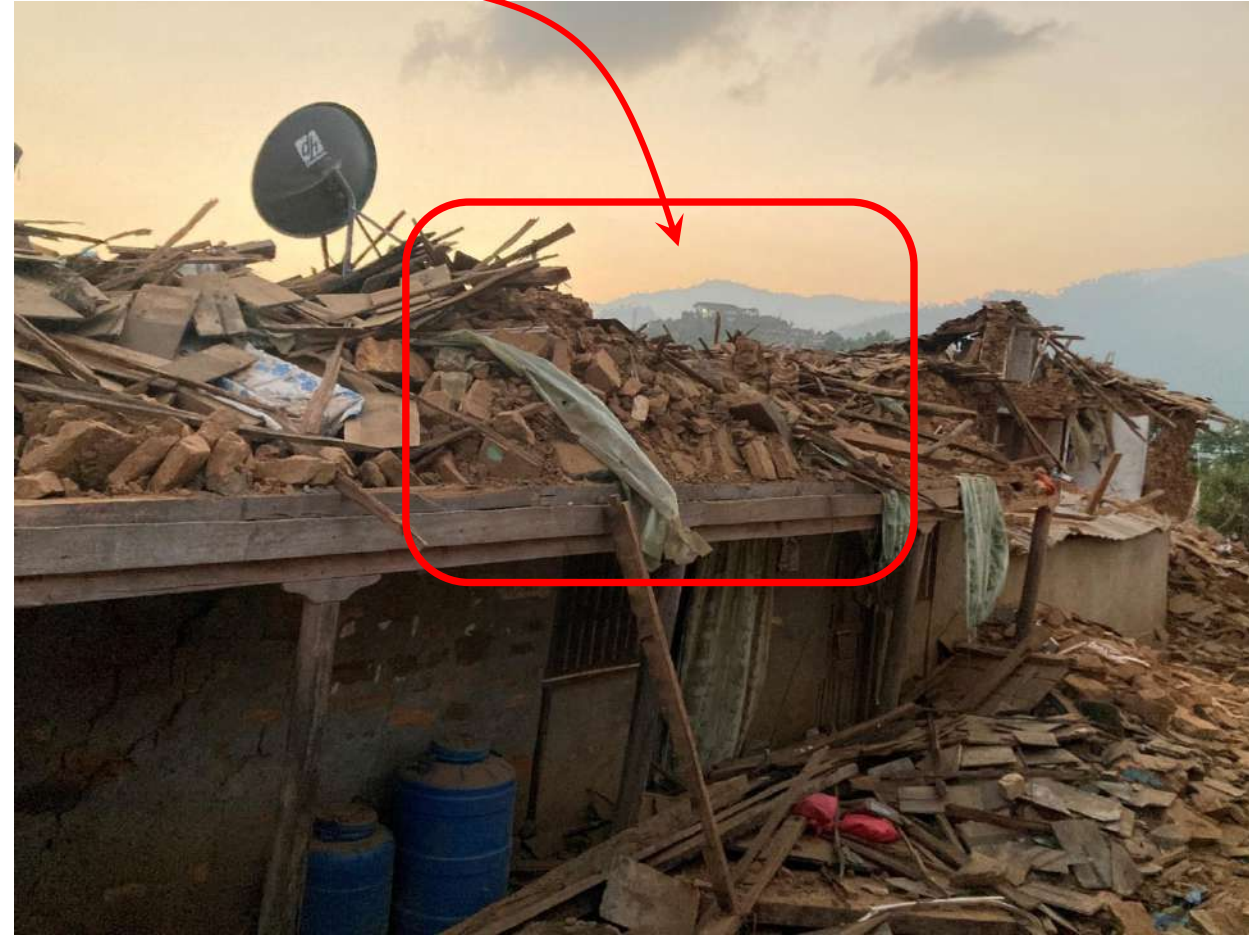
Complete collapse

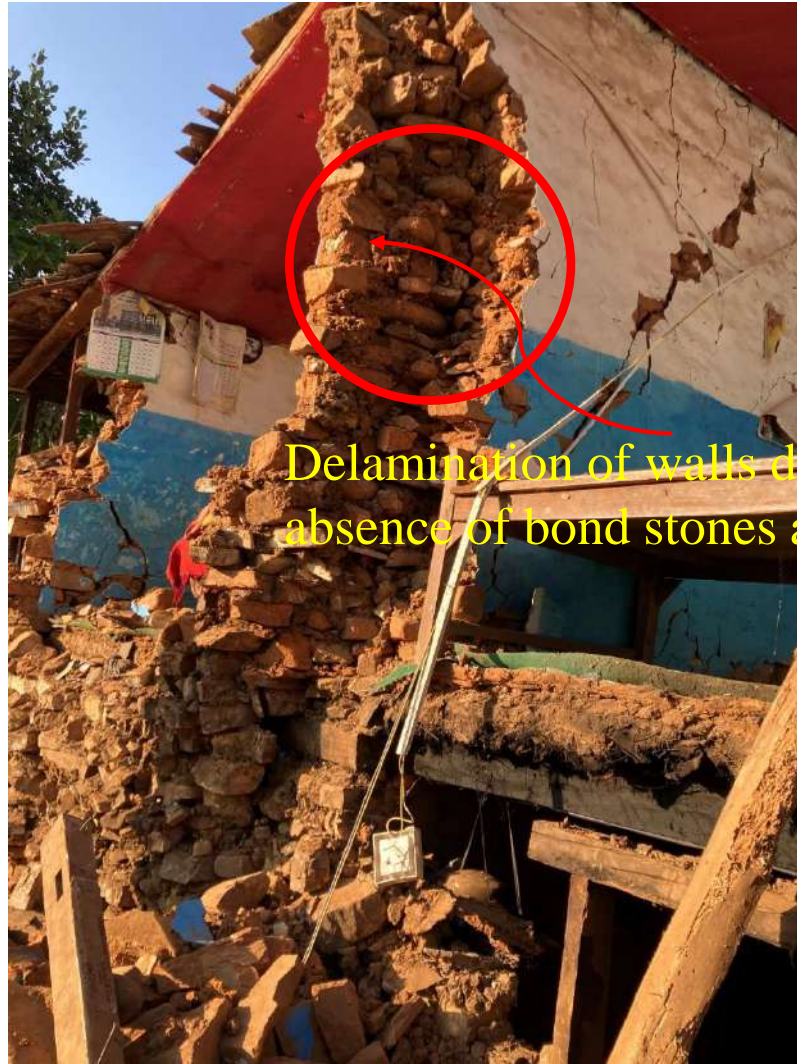
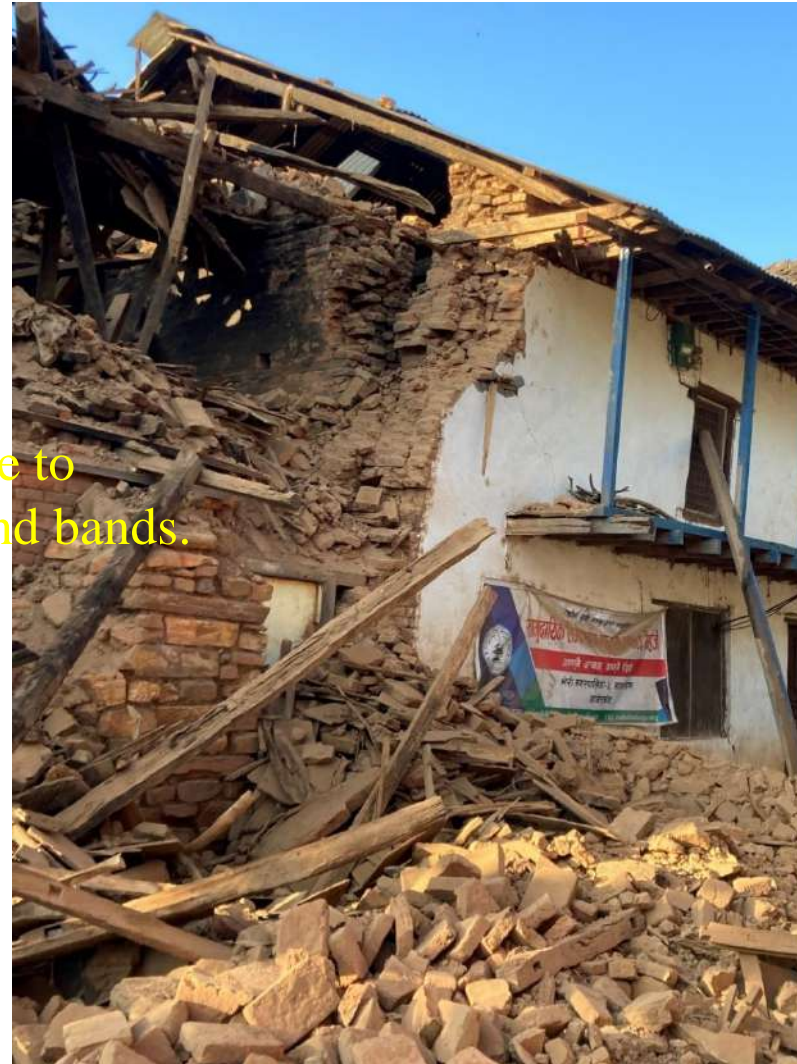
Corner separation, collapse of roof and failure of supporting walls
