Jajarkot Earthquake: Impacts and Future Directions for Earthquake Resilient Reconstruction

Gokarna Bahadur Motra, PhD

11 Nov. 2023 (2080/08/08)

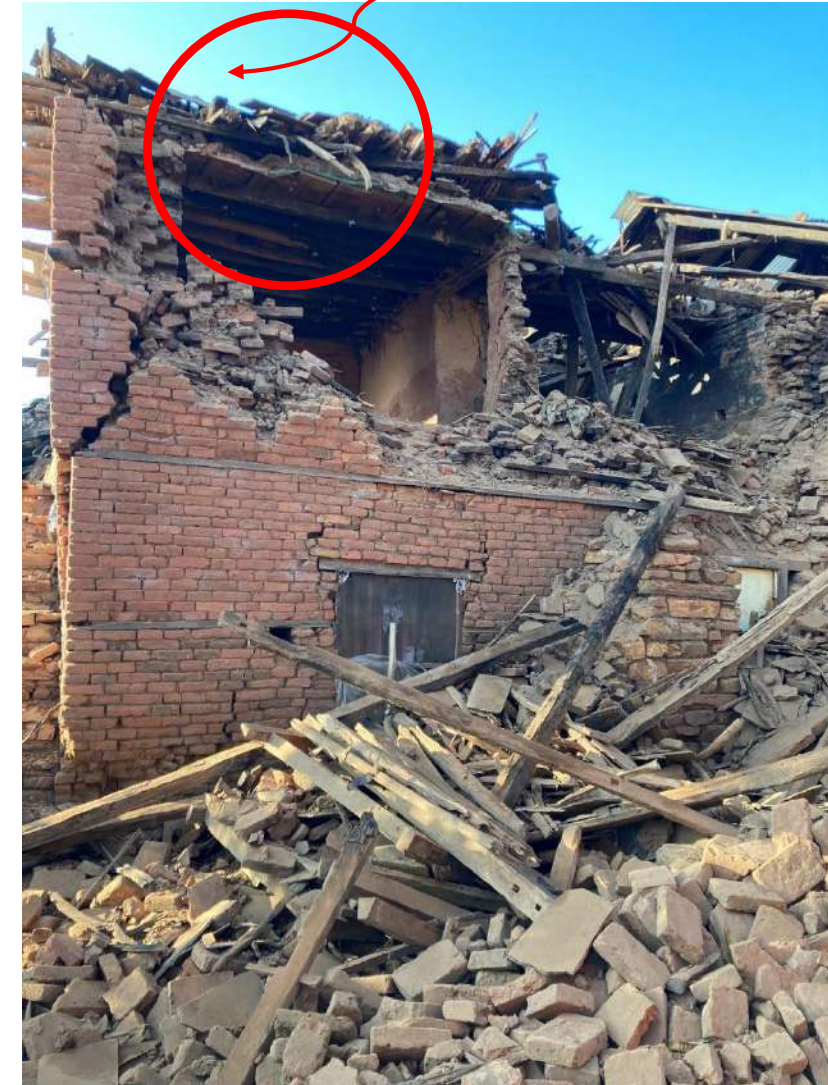
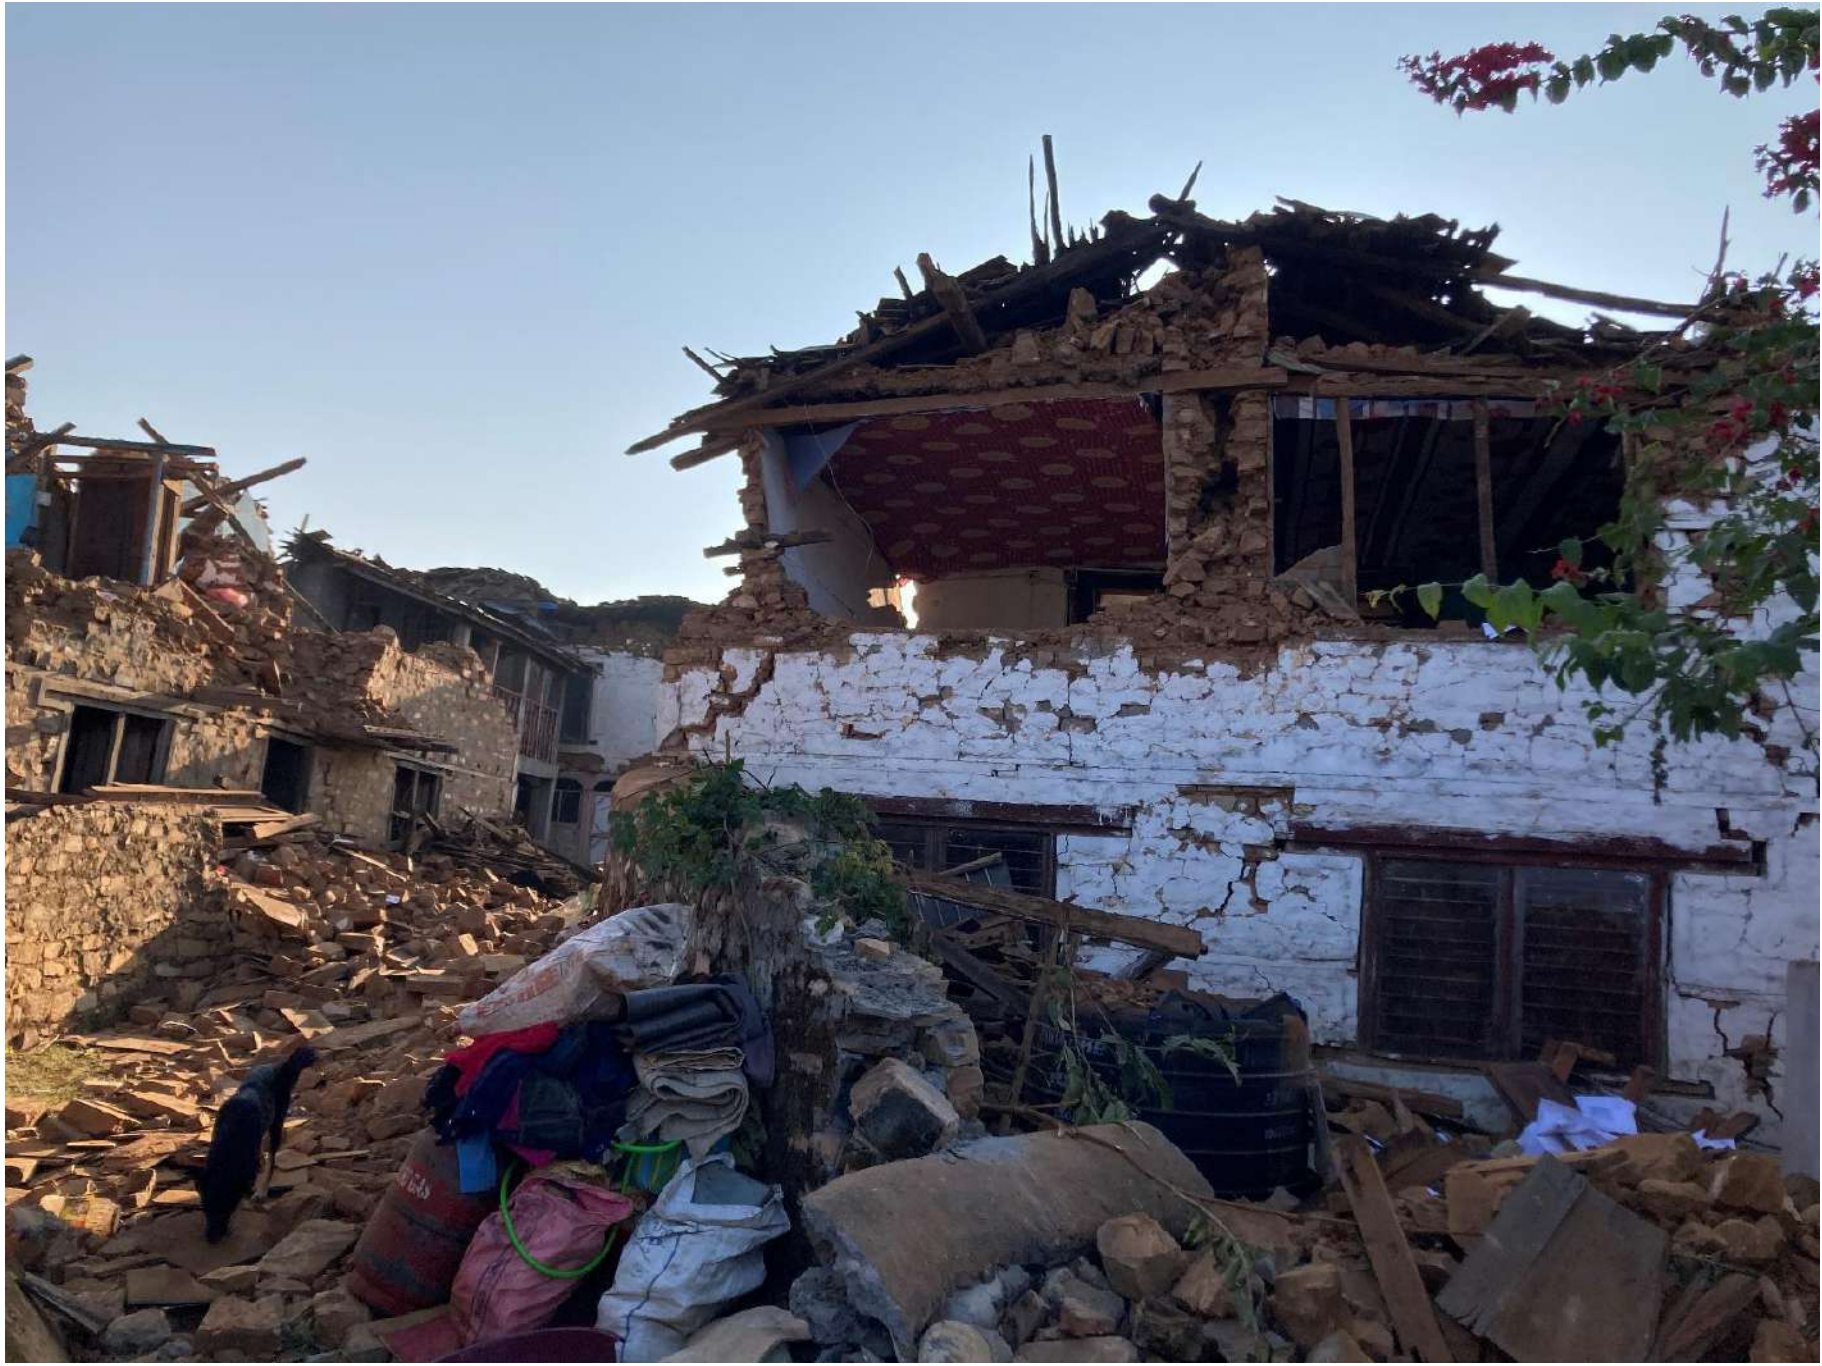
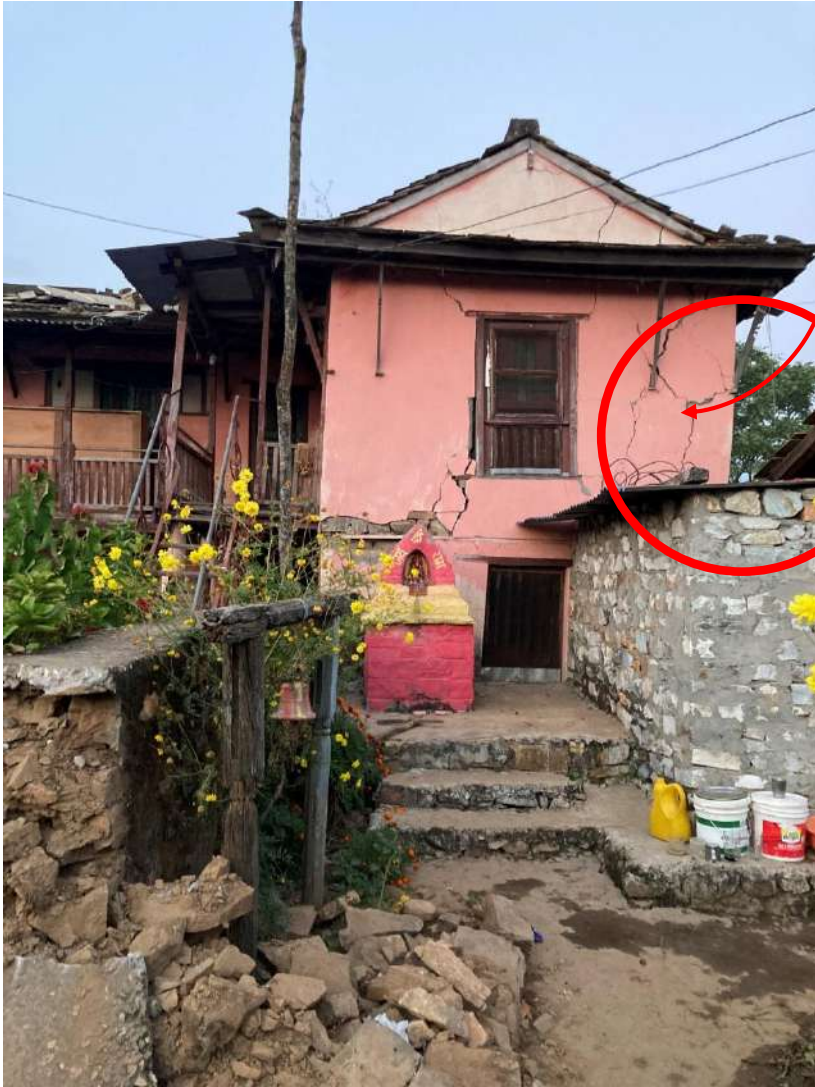
Formation of cracks at the corners

Formation of vertical cracks at the corners of the building reduce the out-of-plane stability of the walls drastically leading to loss of strength of URM walls significantly.

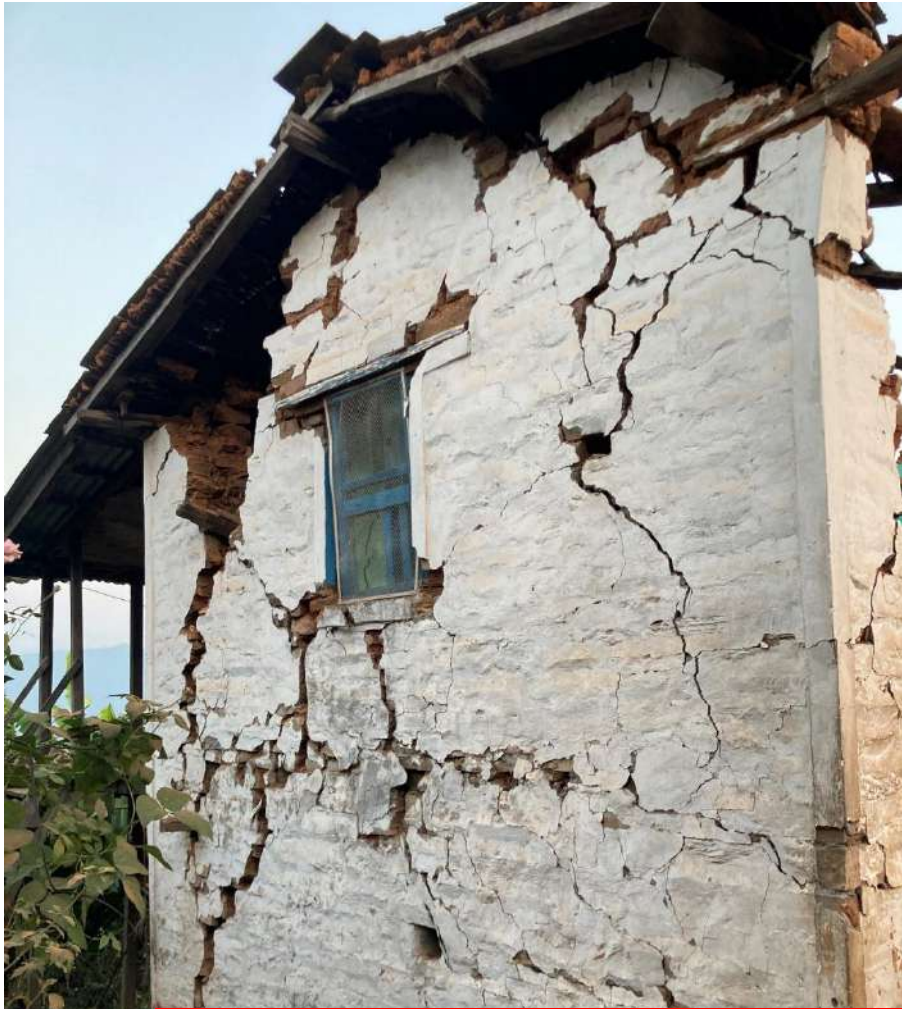
Absence of gable band and heavy roof lead to the formation of cracks at the corners and diagonal cracks in the URM walls leading to collapse

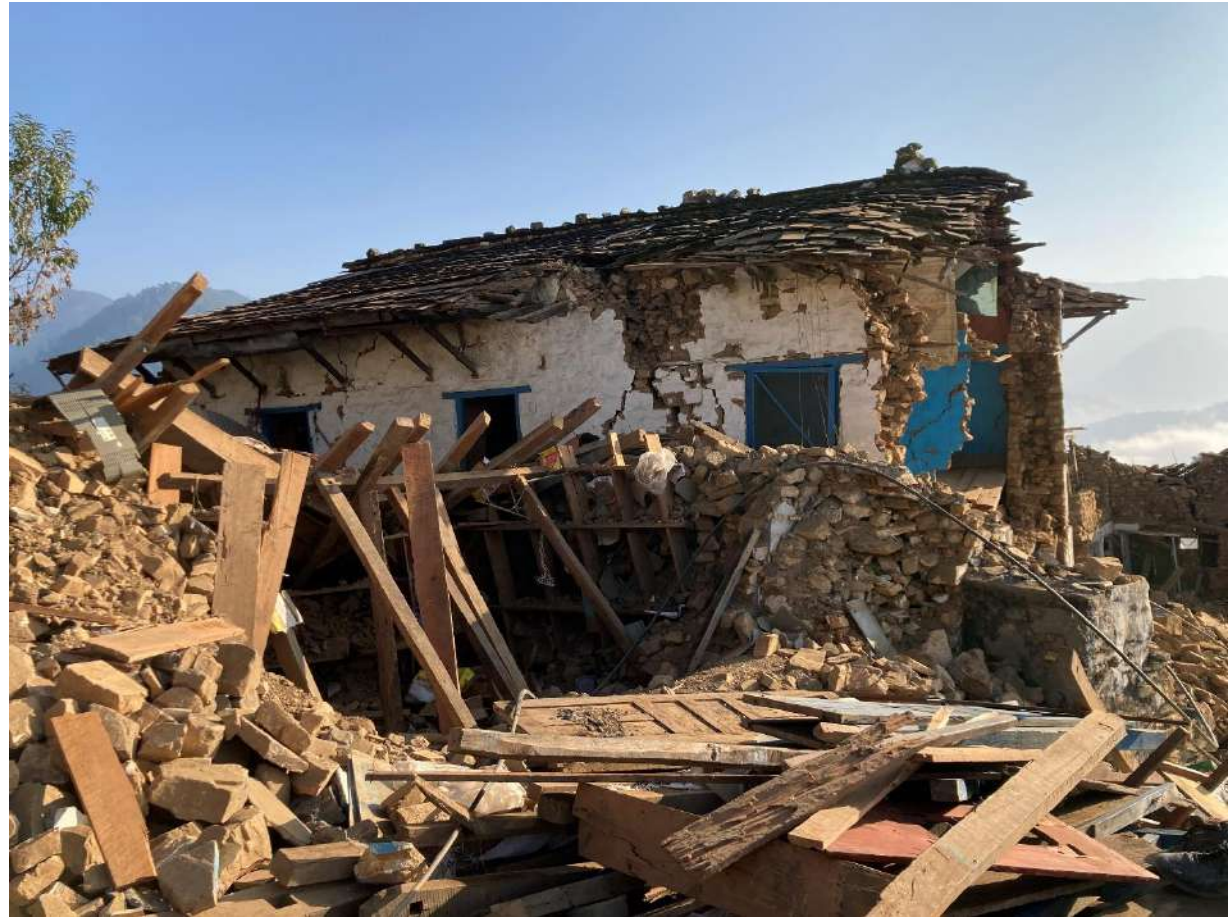
Weak diaphragms and their poor connection with the masonry wall caused collapse of floor as well as failure of supporting walls

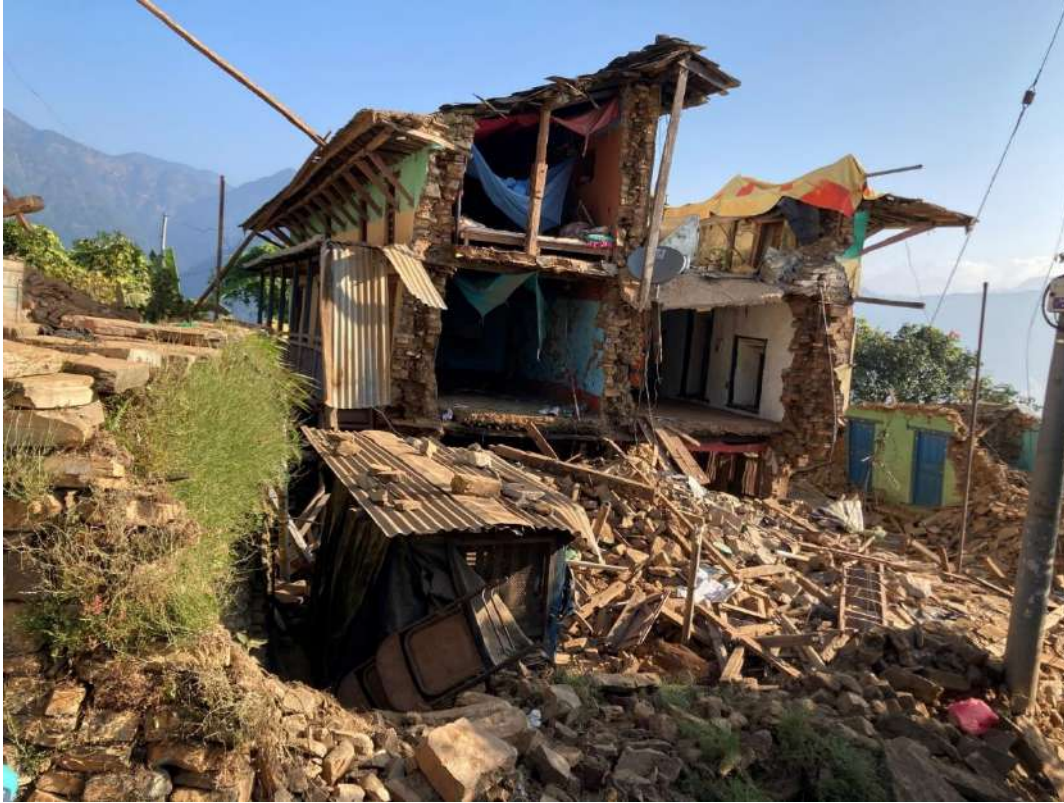
Failure of supporting wall

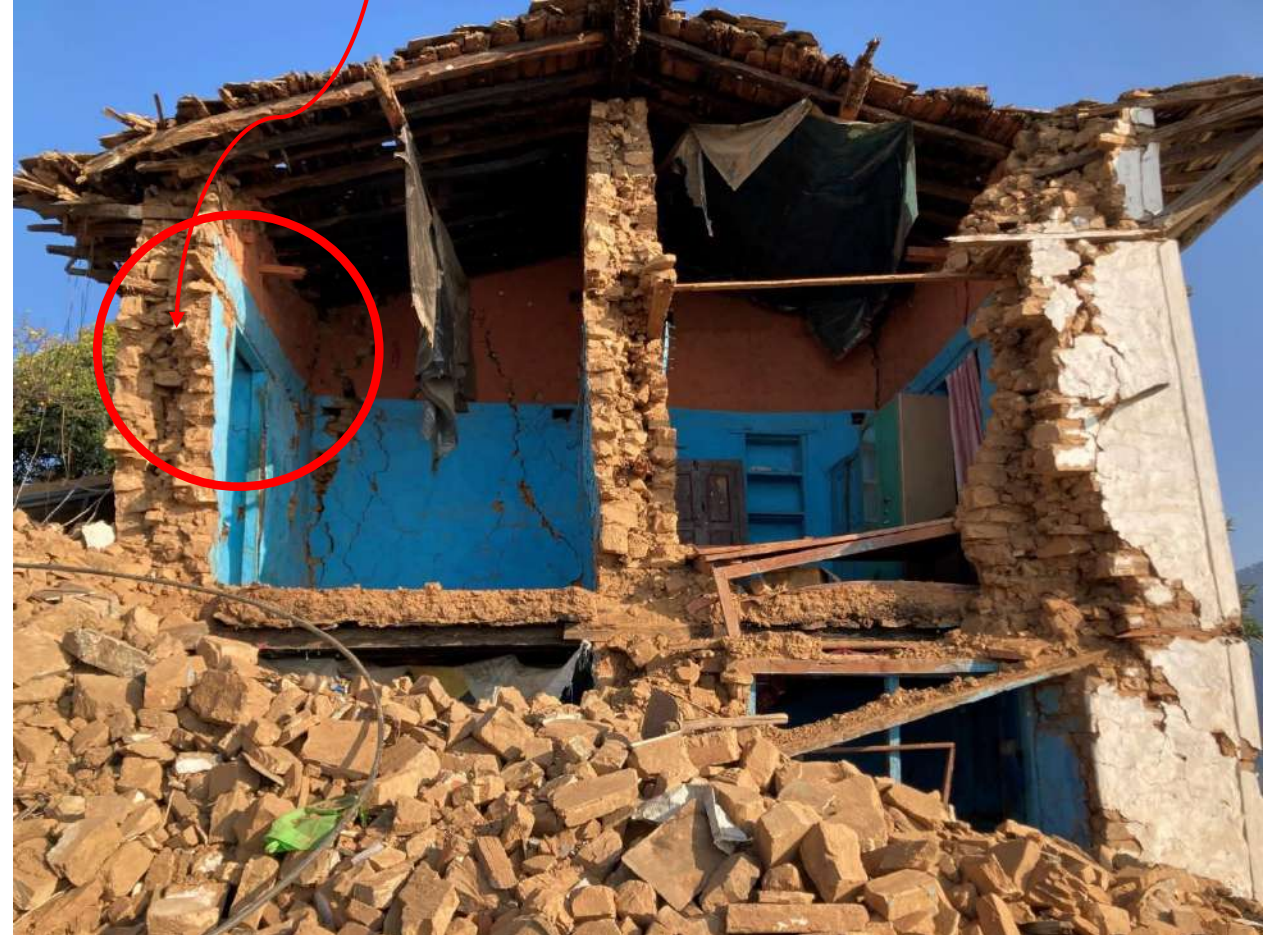
Out-of-plane failure of URM walls

Weak diaphragms, their poor connection with the masonry wall and lack of connection in shorter wall caused out-of-plane collapse of supporting walls

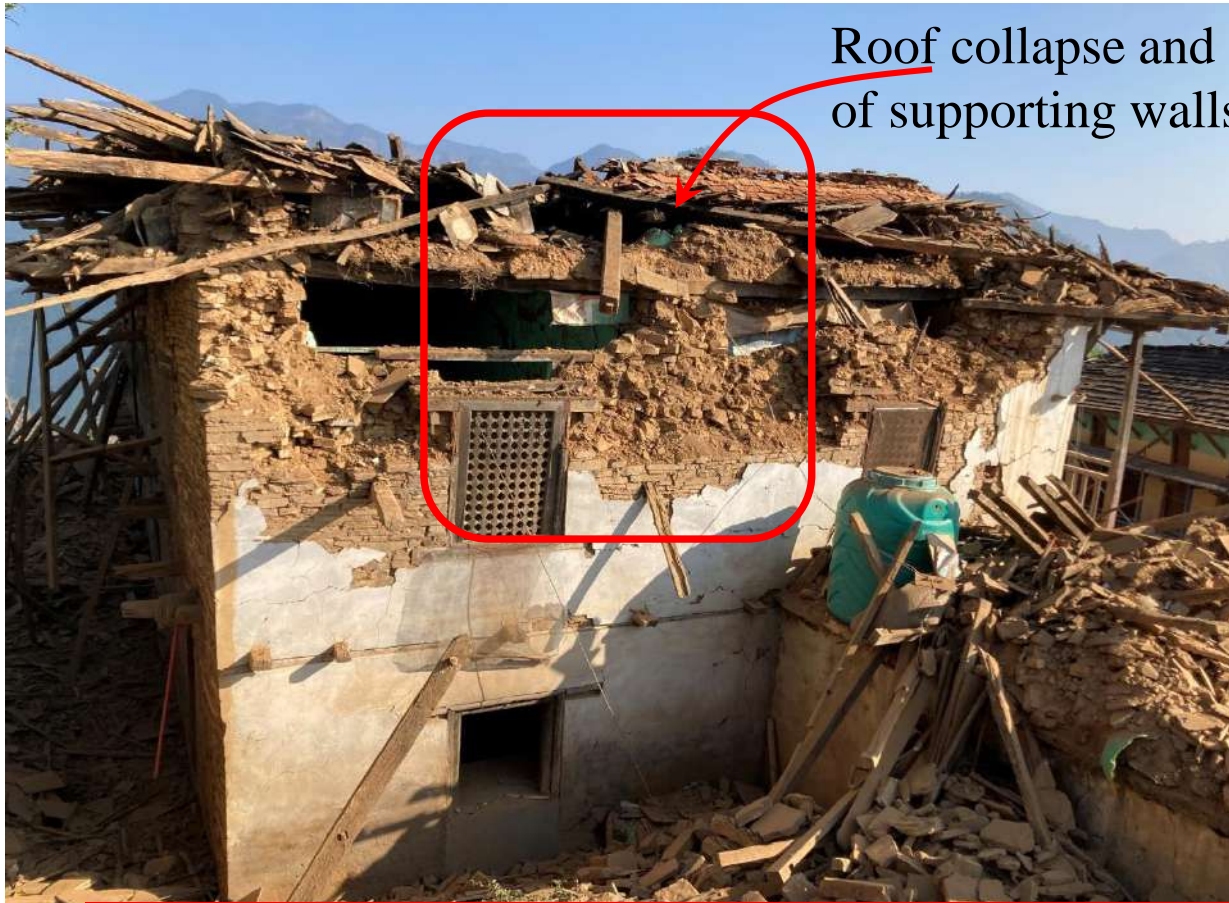
Roof collapse and failure
of supporting walls

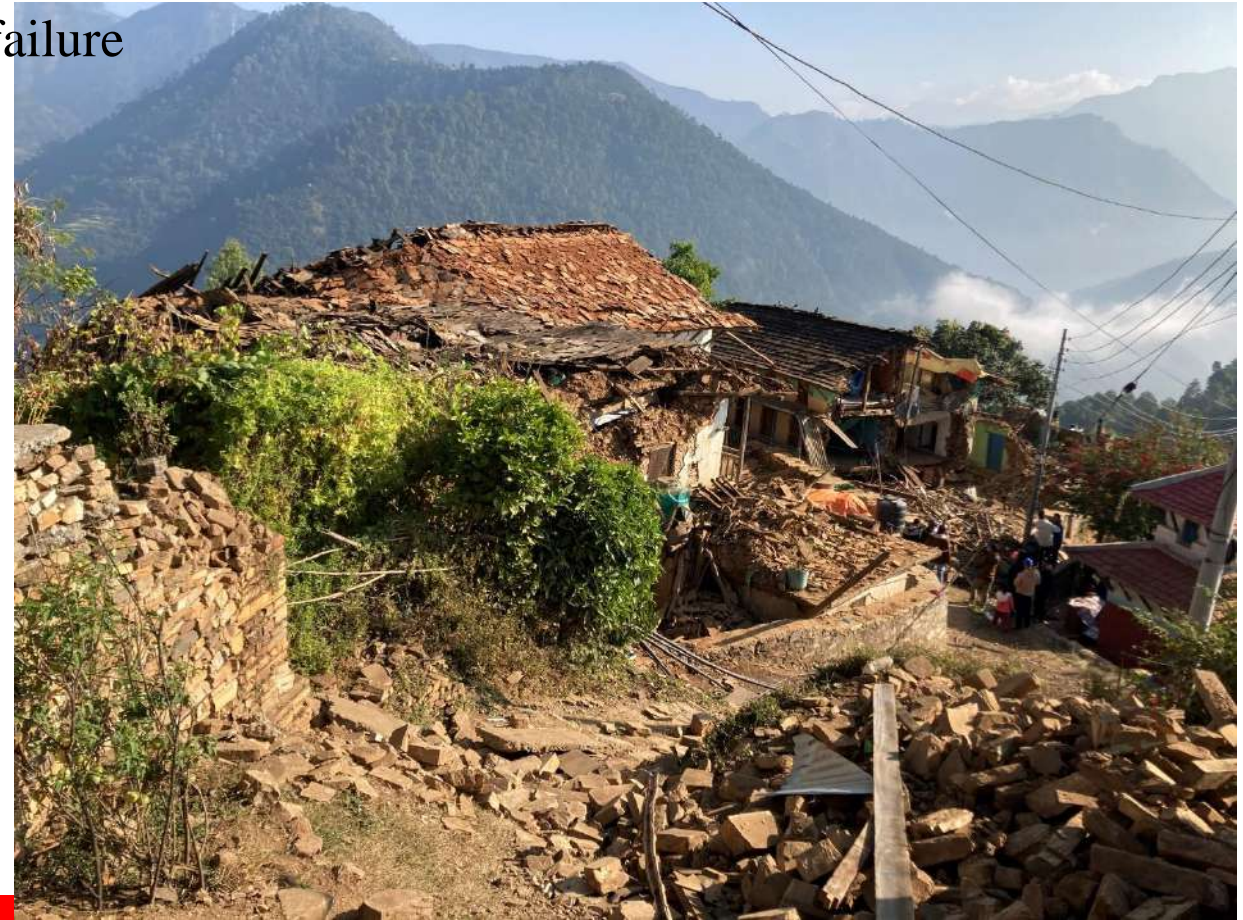
Collapse of the roof and failure of supporting wall

- Collapse of buildings along the ridge

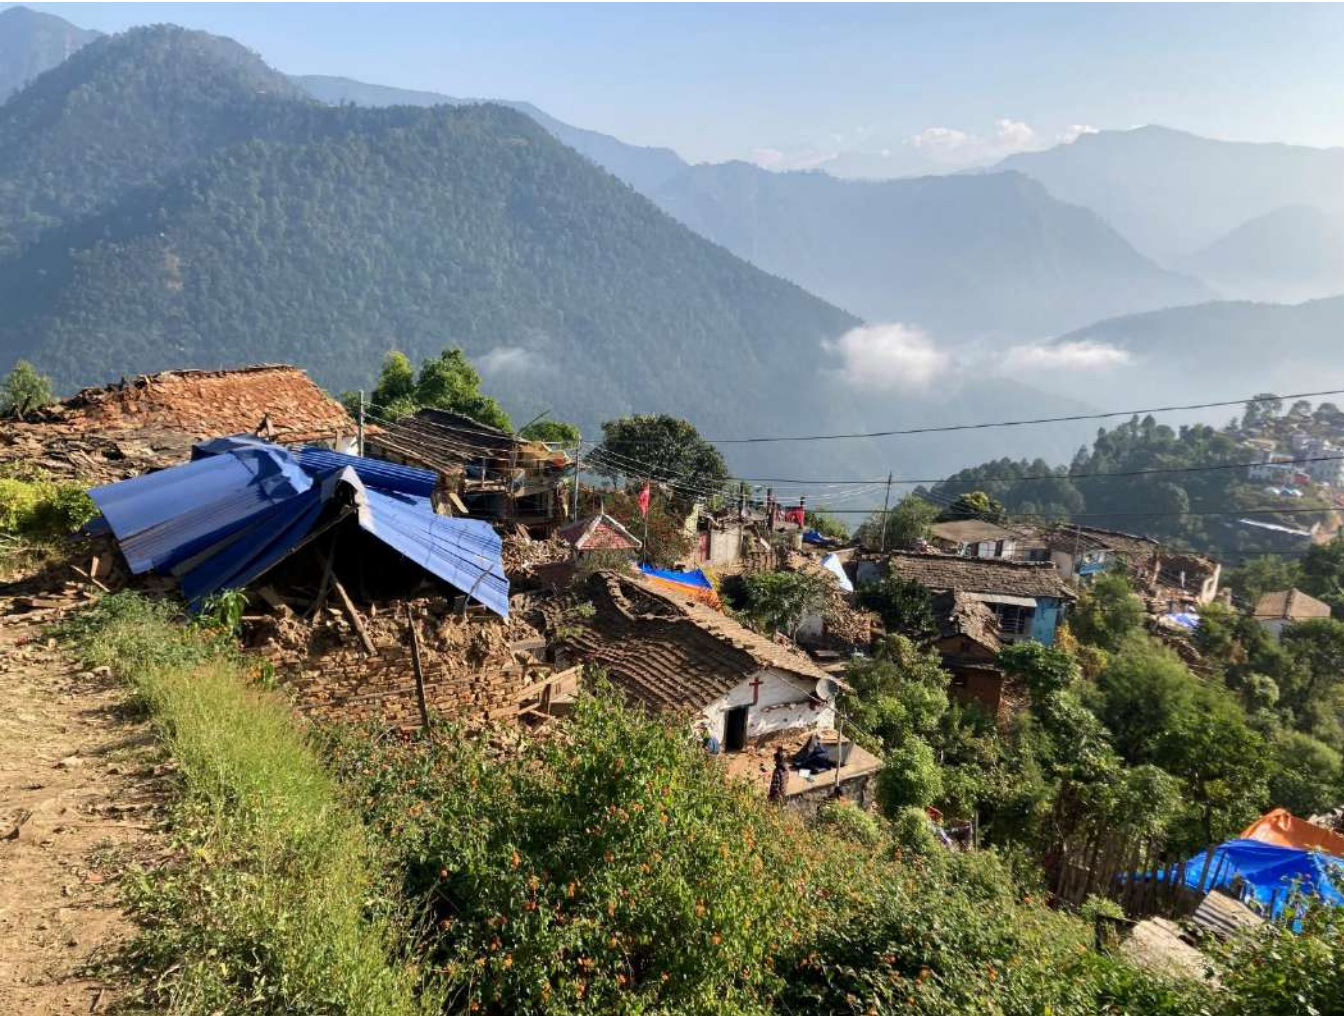
Complete collapse

- Building damage along the ridge line

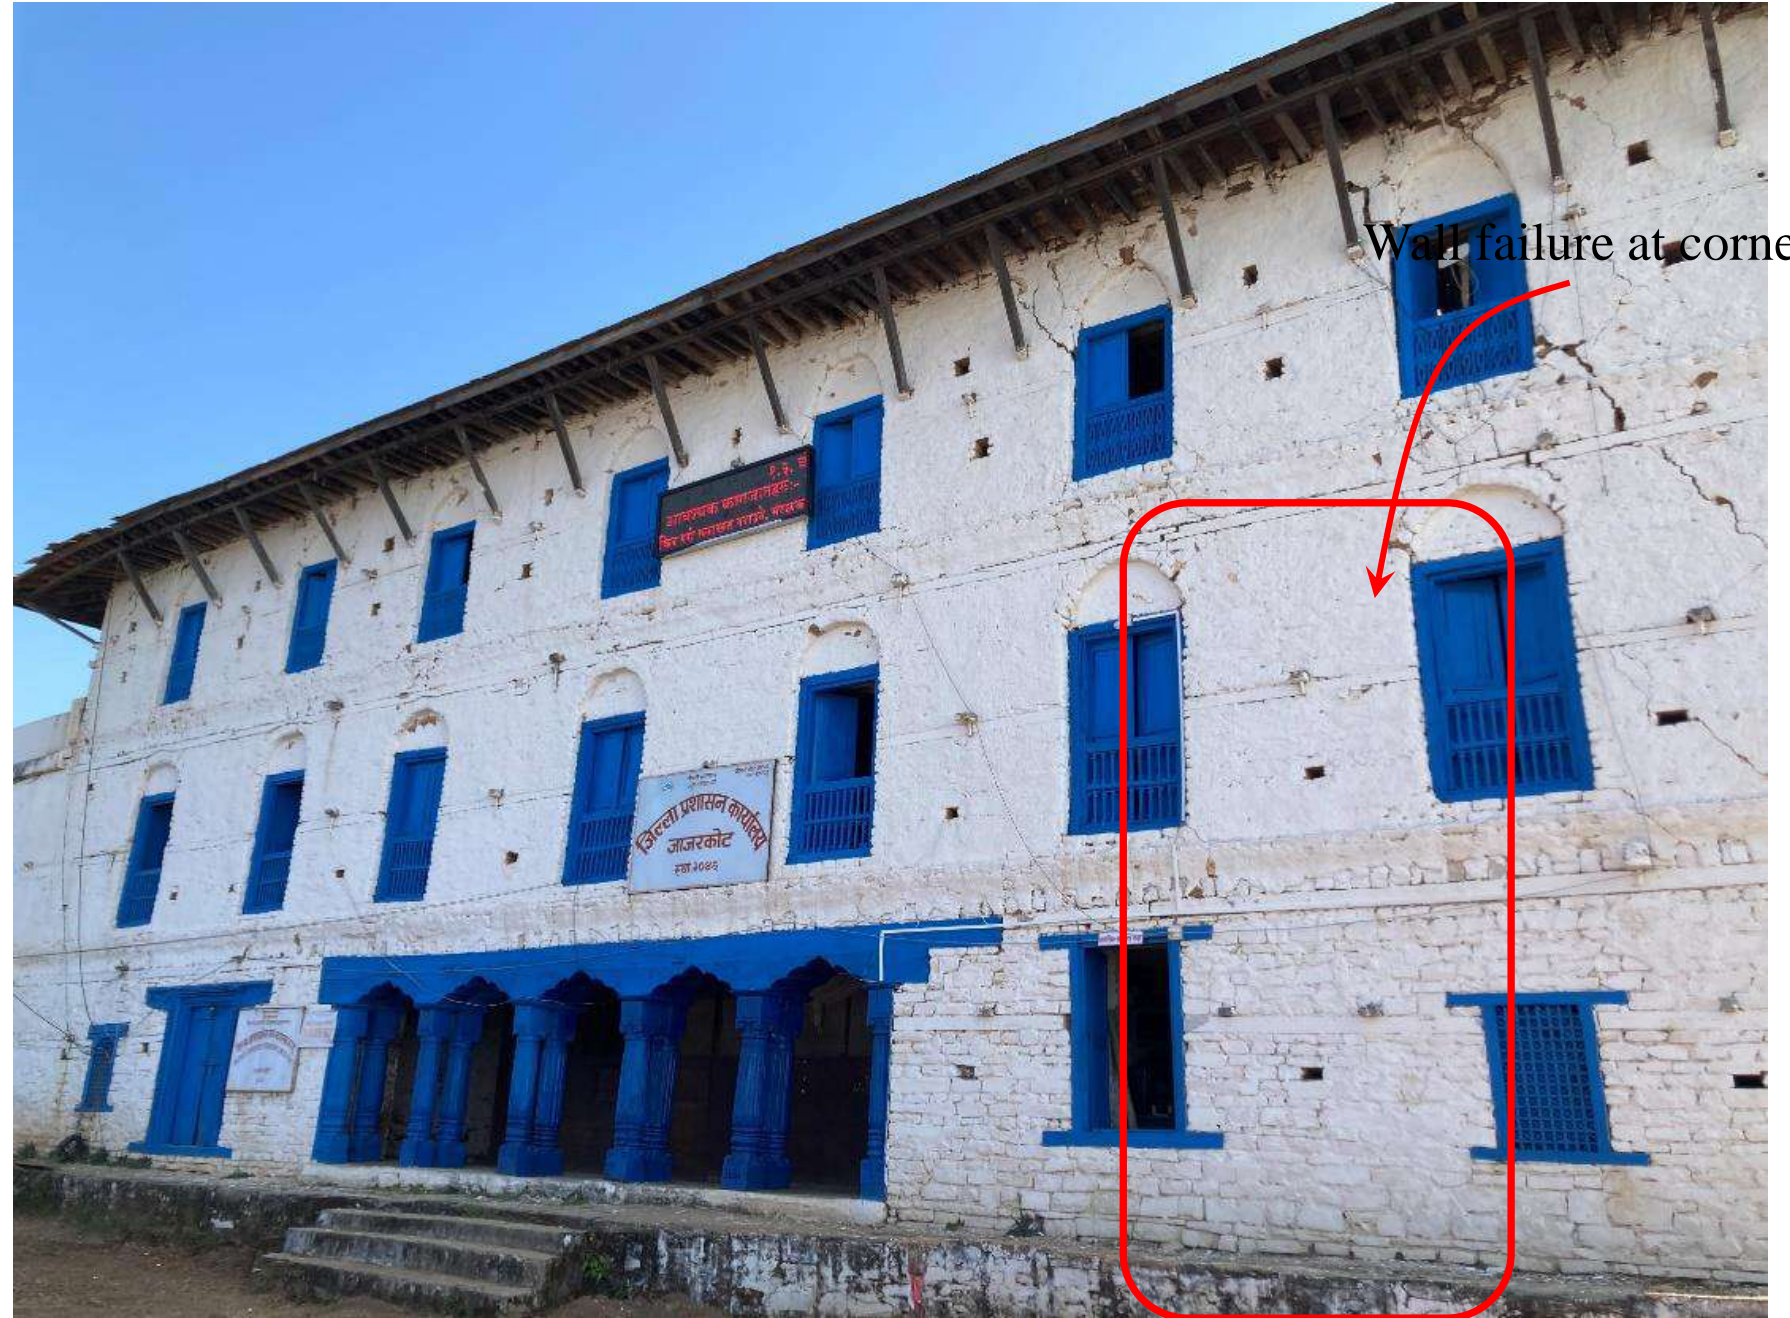
- The then King Gajendra Narayan Shah build the Durbar in 1400BC.
- Rebuilt by the King of Jajarkot [Hari Shah](#) in 1825 BC using burnt bricks.
- The palace was originally seven storeys
- Reduced to four storeys by the 1934 [Earthquake](#).
- The [25th April 2015 Nepal Earthquake](#) further damaged the building.
- Timber band at lintels and roof saved the building

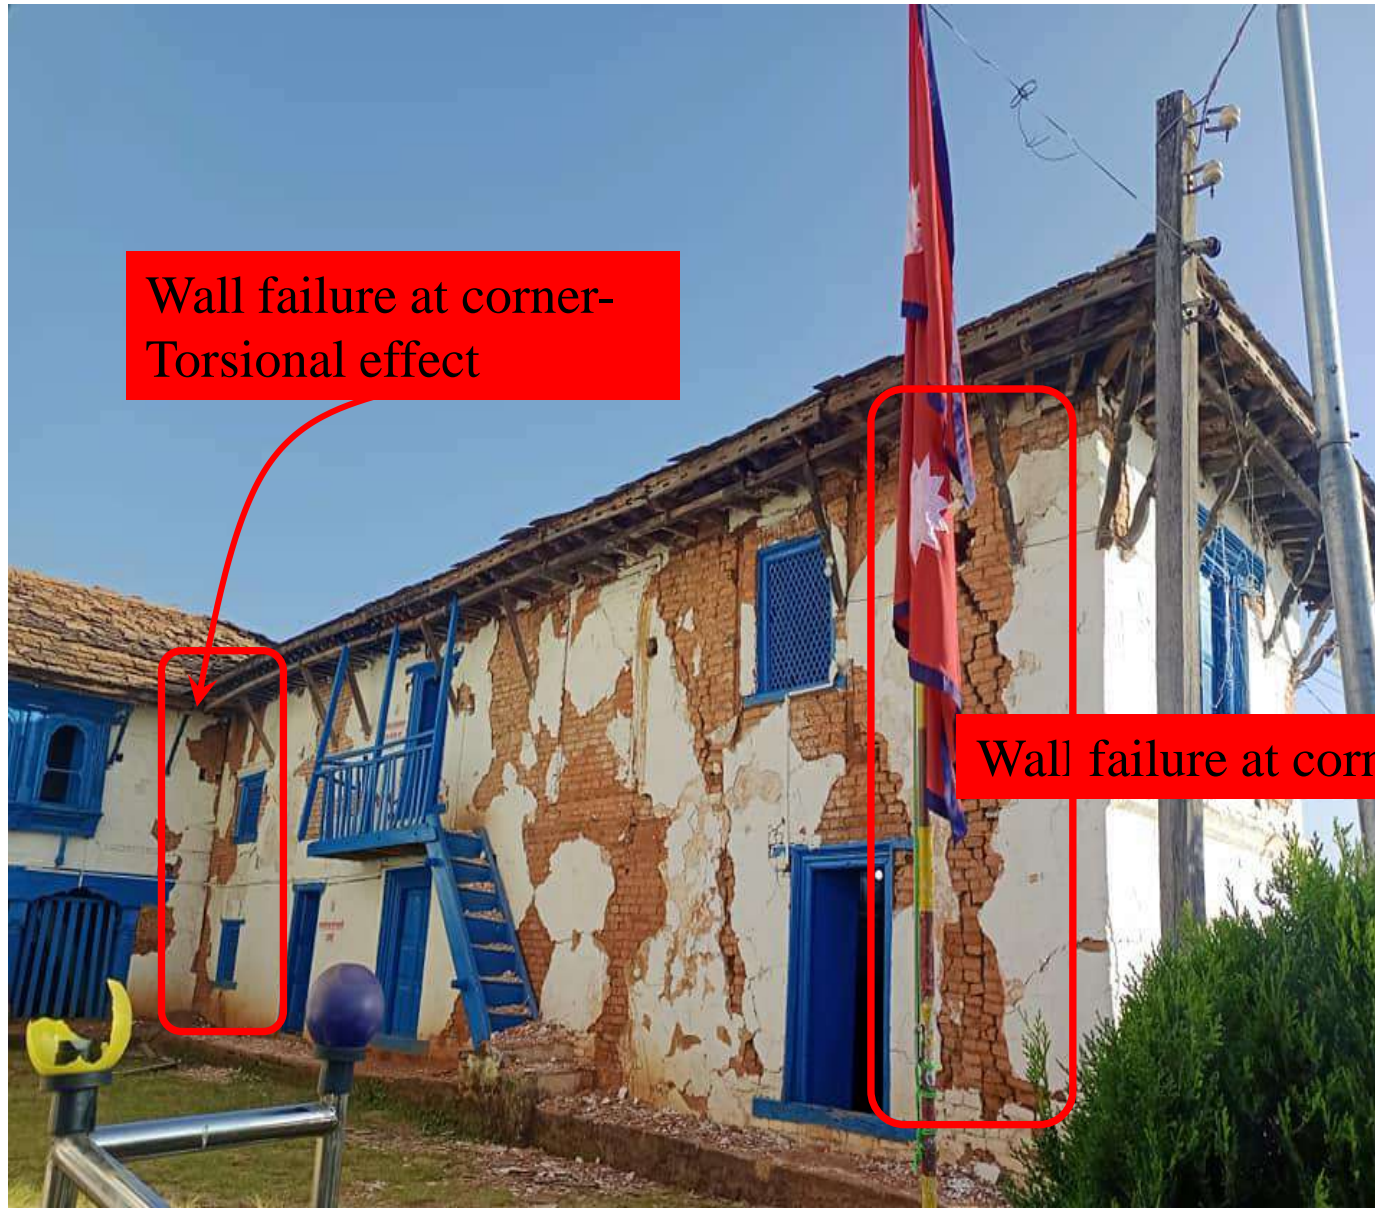
Wall failure at corner-
Torsional effect

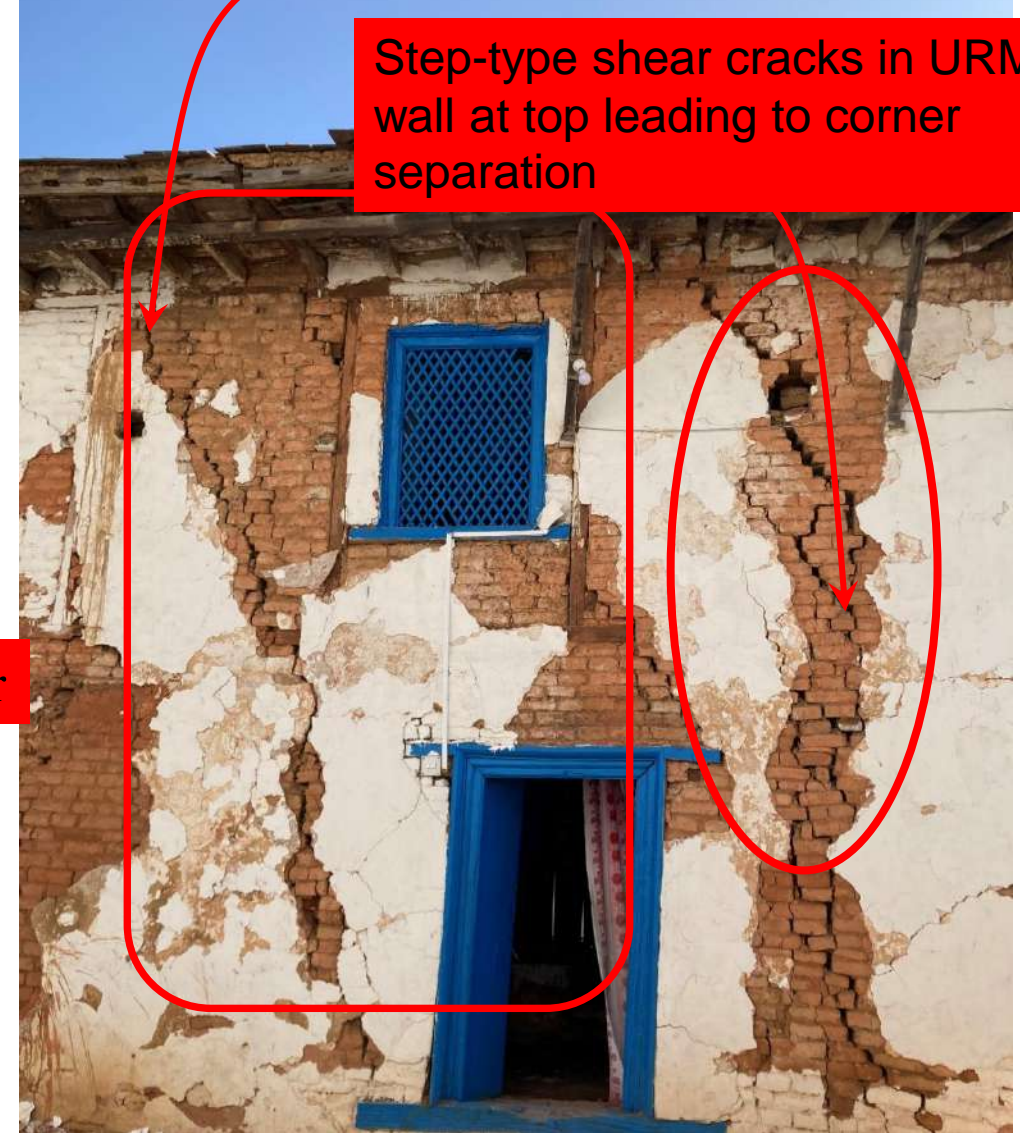
Step-type shear cracks in URM
wall at top leading to corner
separation

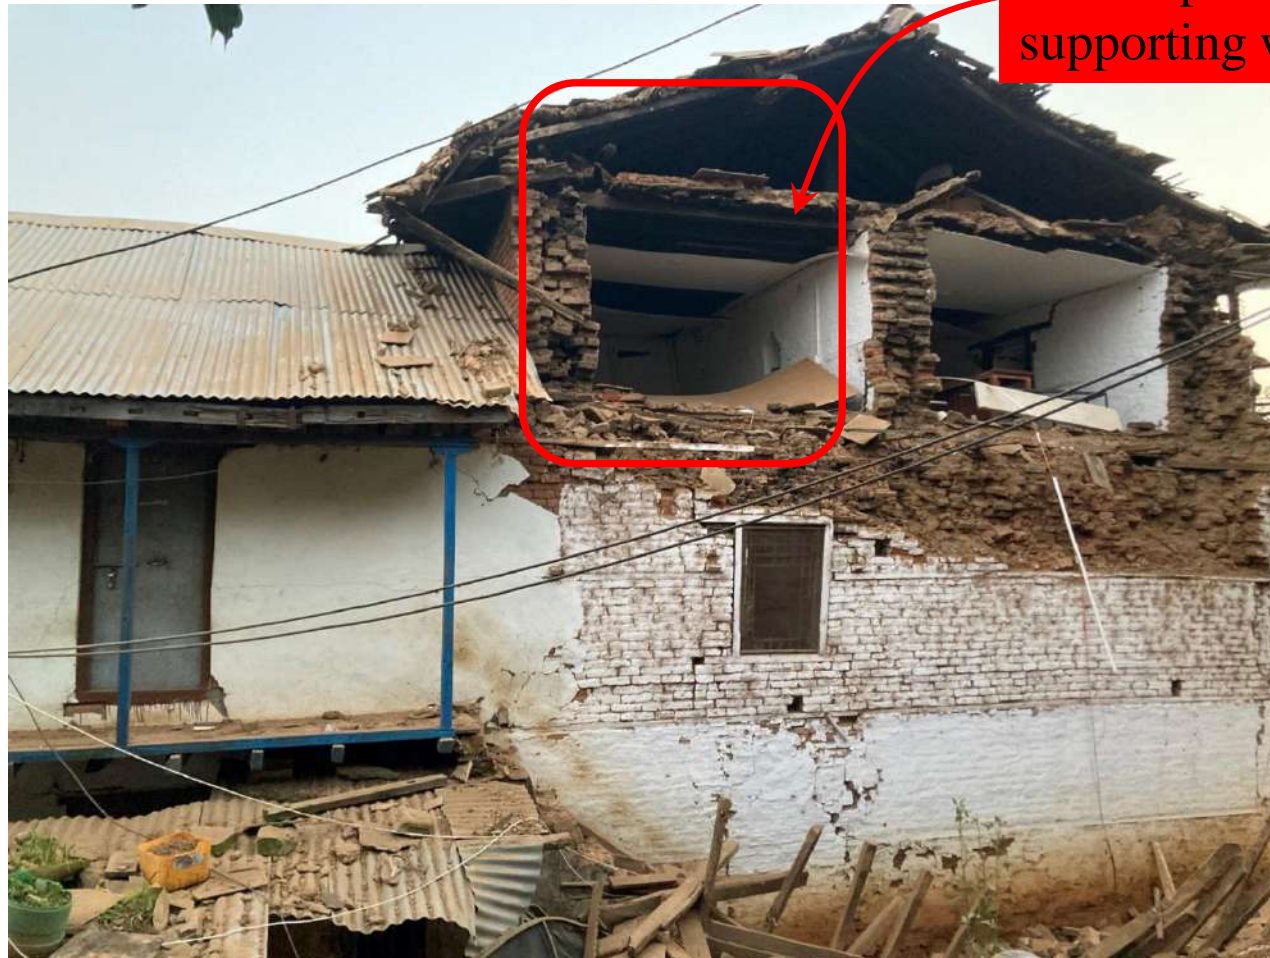
Out-of-plane failure of gable and supporting walls

- Unsupported gable wall failure in the absence of band at gable
- Flexible floor is not supported on the short wall

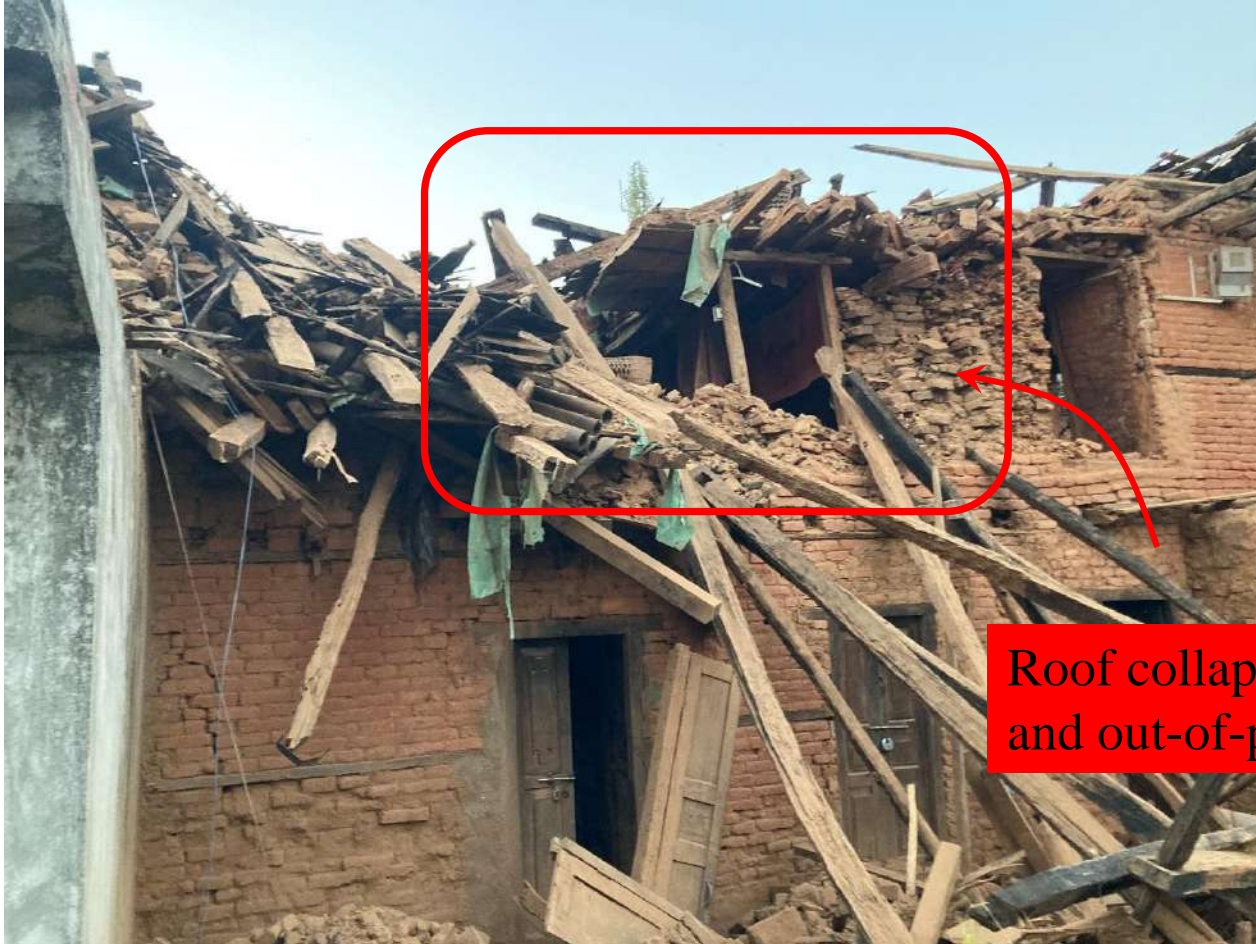
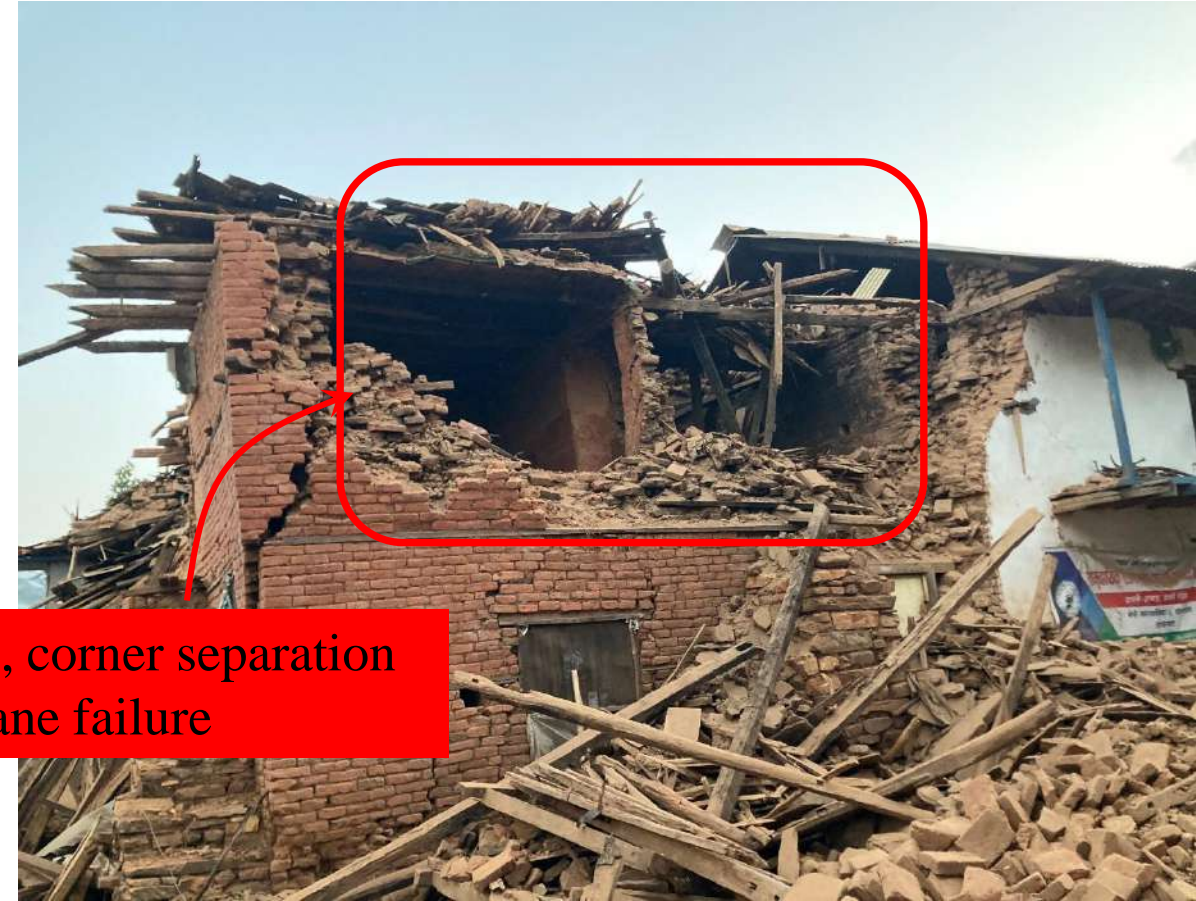
Roof collapse, corner separation
and out-of-plane failure
