Jajarkot Earthquake: Impacts and Future Directions for Earthquake Resilient Reconstruction

Gokarna Bahadur Motra, PhD

11 Nov. 2023 (2080/08/08)

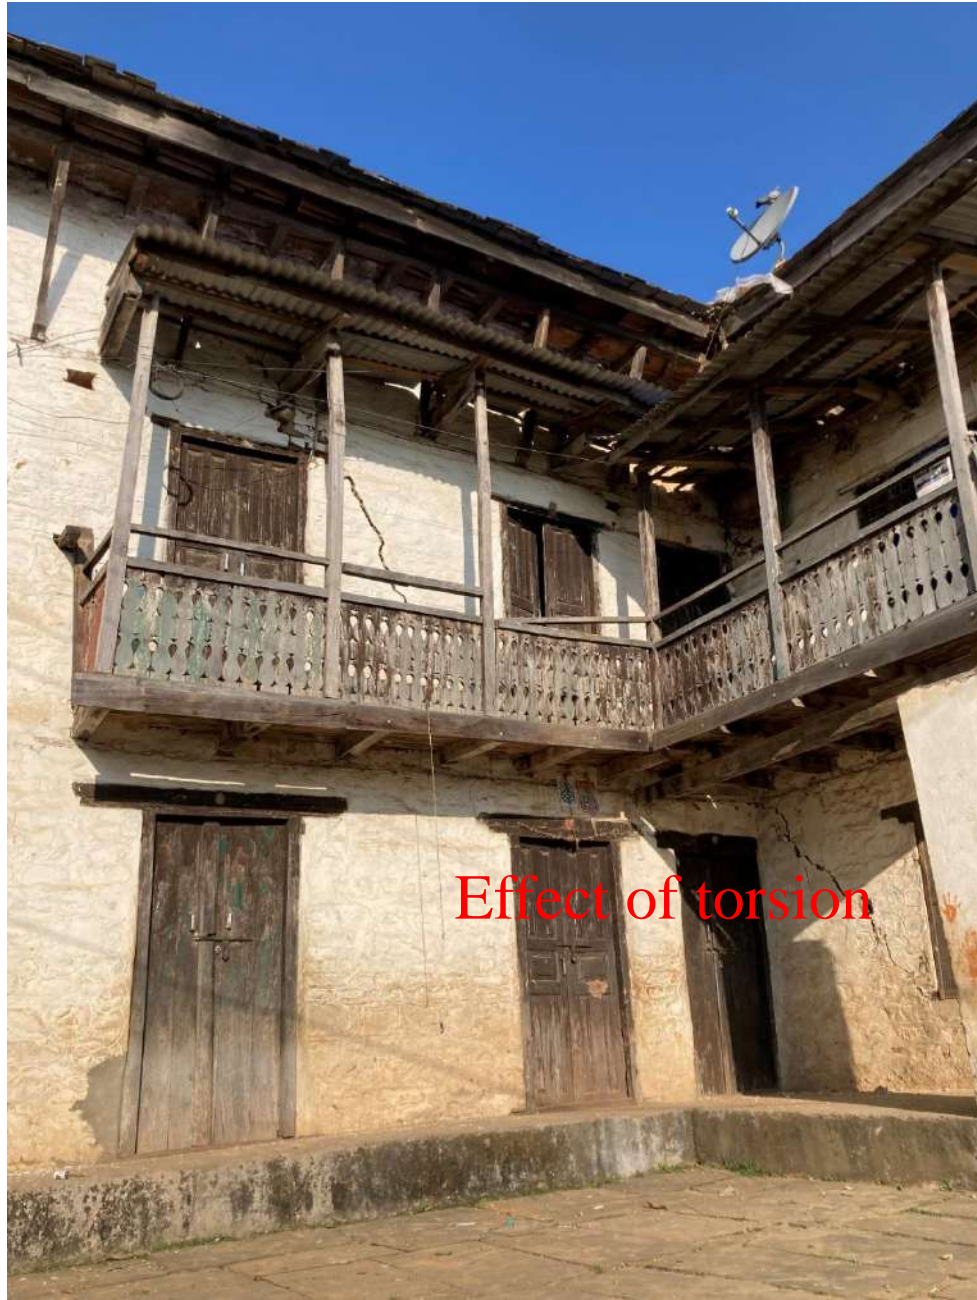
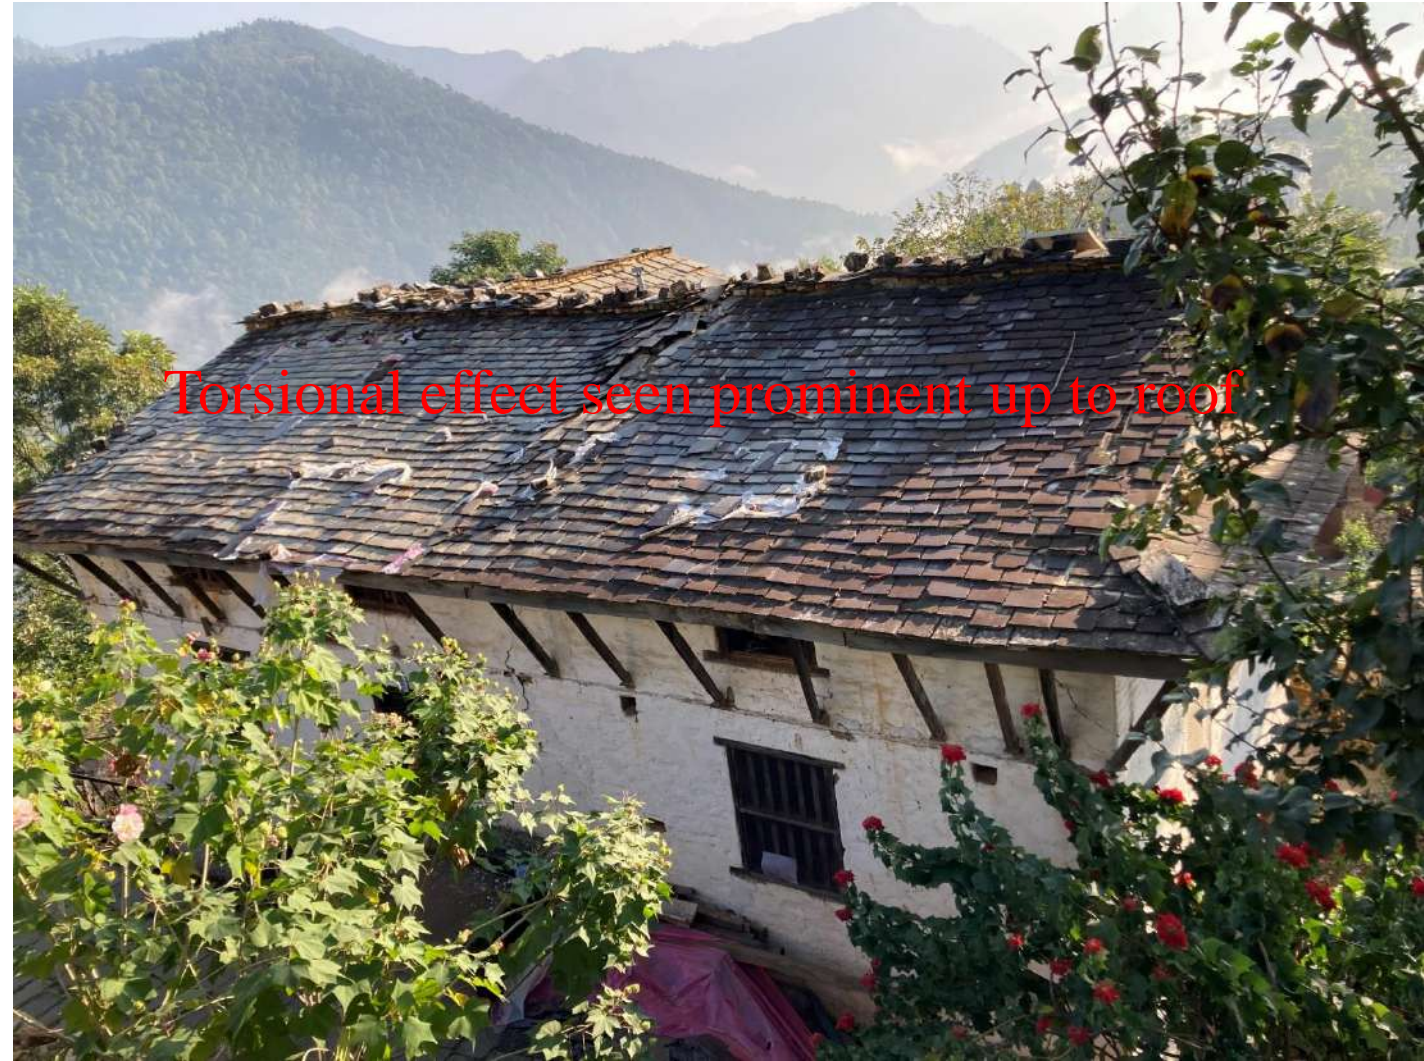
Torsional effect is prominent in L-, T-shape buildings, leading to cracks at the junction

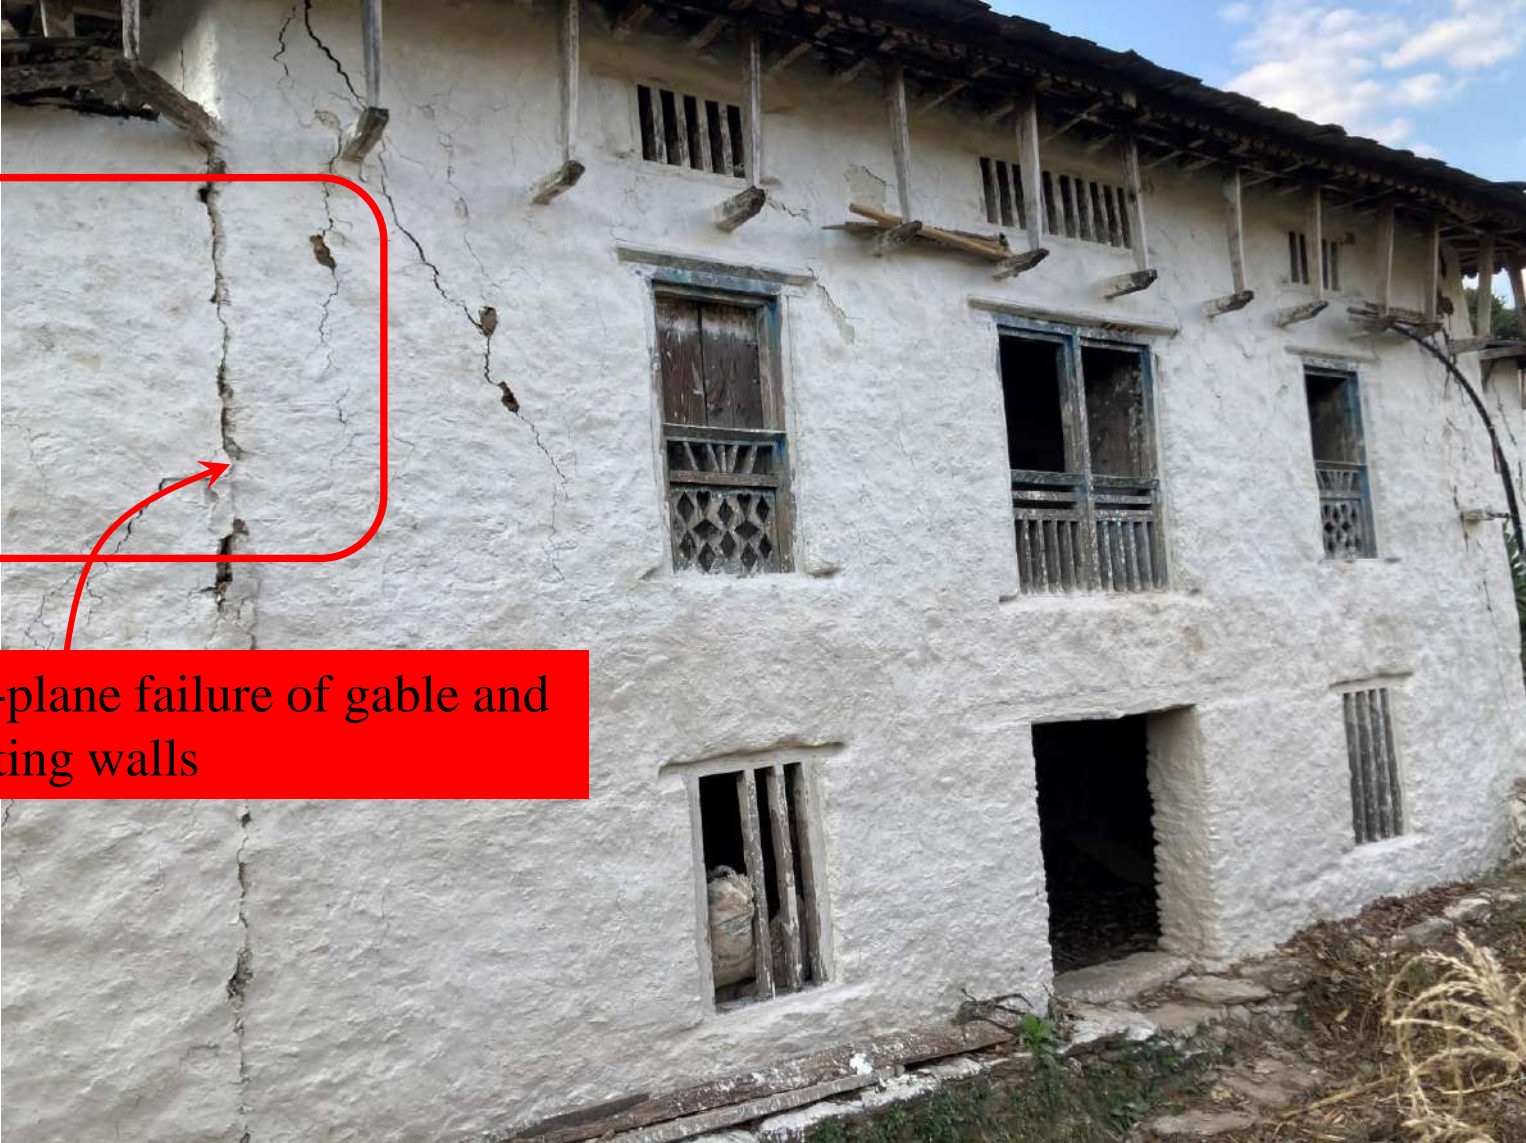
Out-of-plane failure of gable and supporting walls

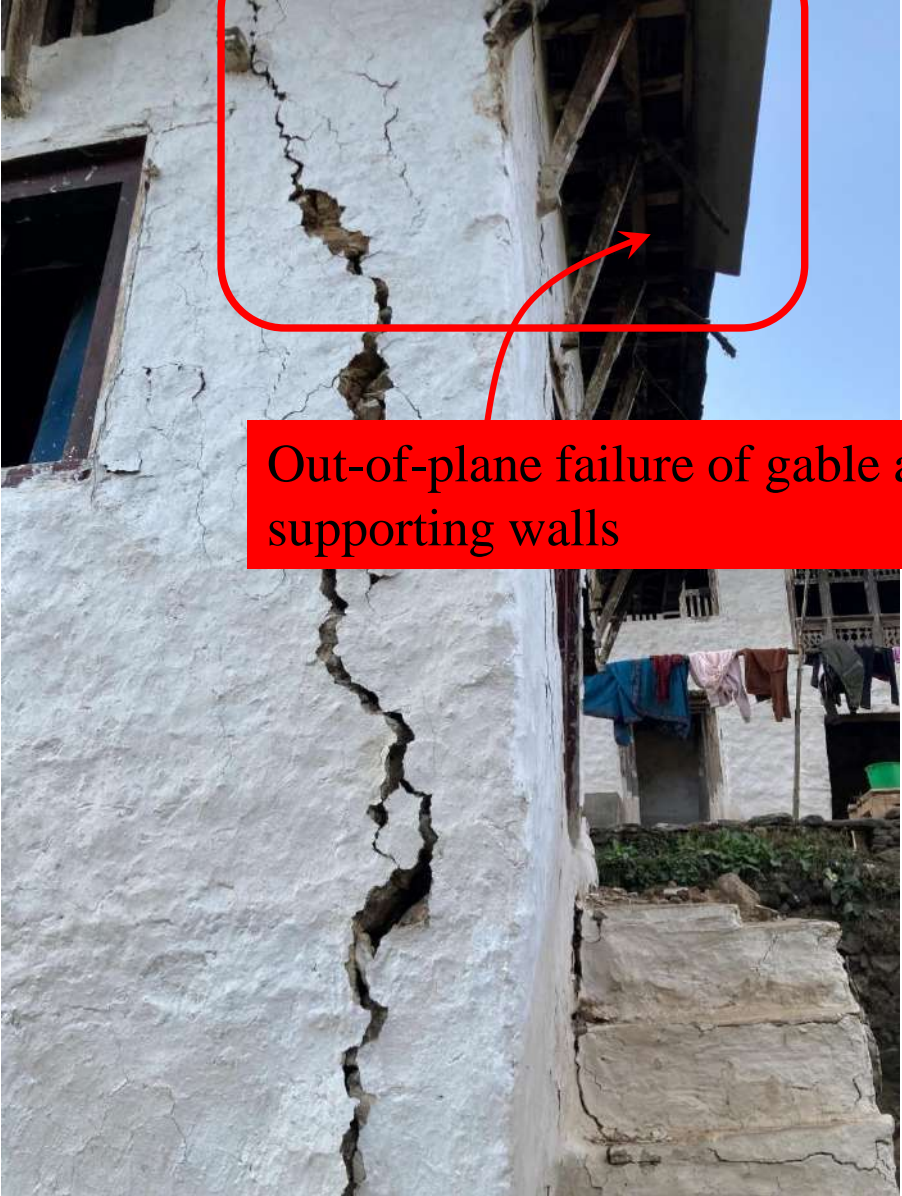
Out-of-plane failure of gable and supporting walls

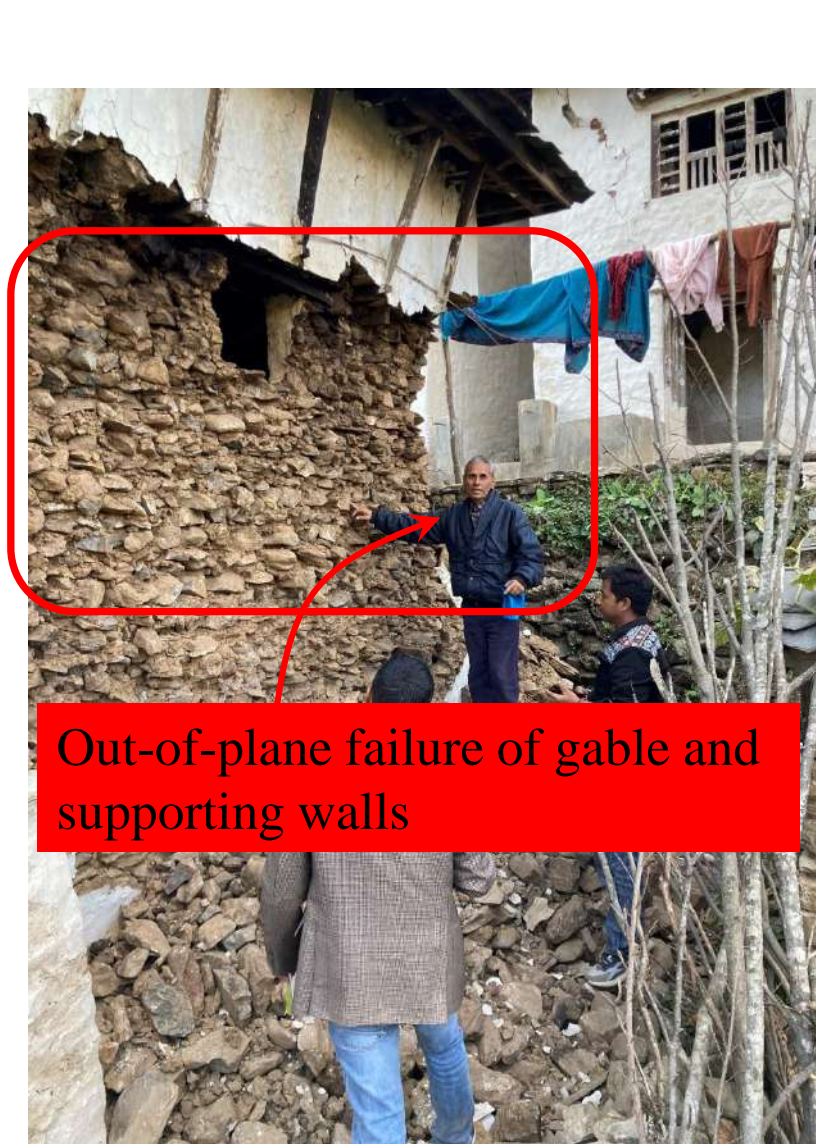
Out-of-plane failure of gable and supporting walls

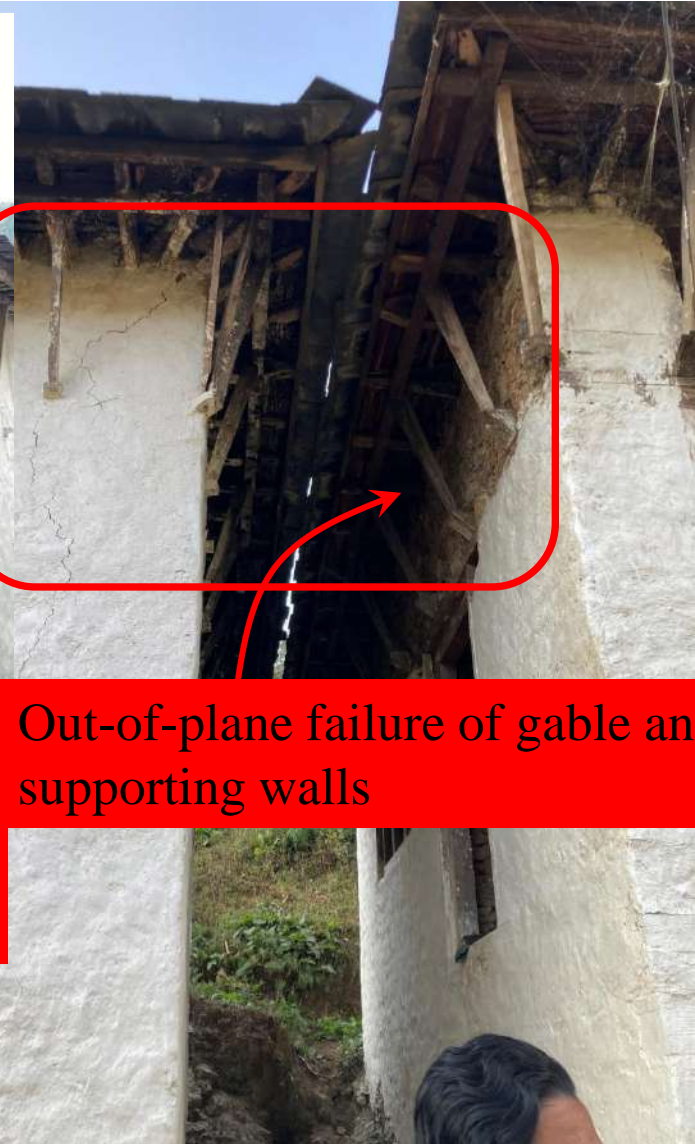
Out-of-plane failure of gable and supporting walls

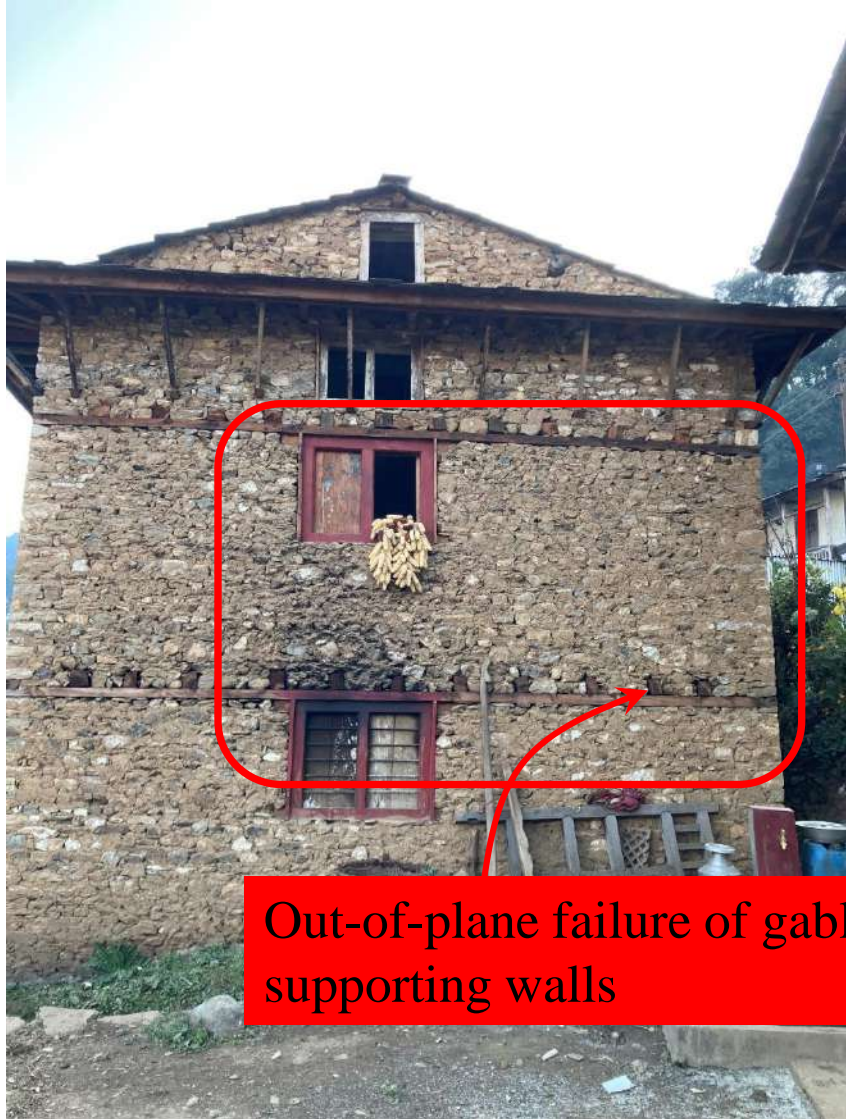
Out-of-plane failure of gable and supporting walls

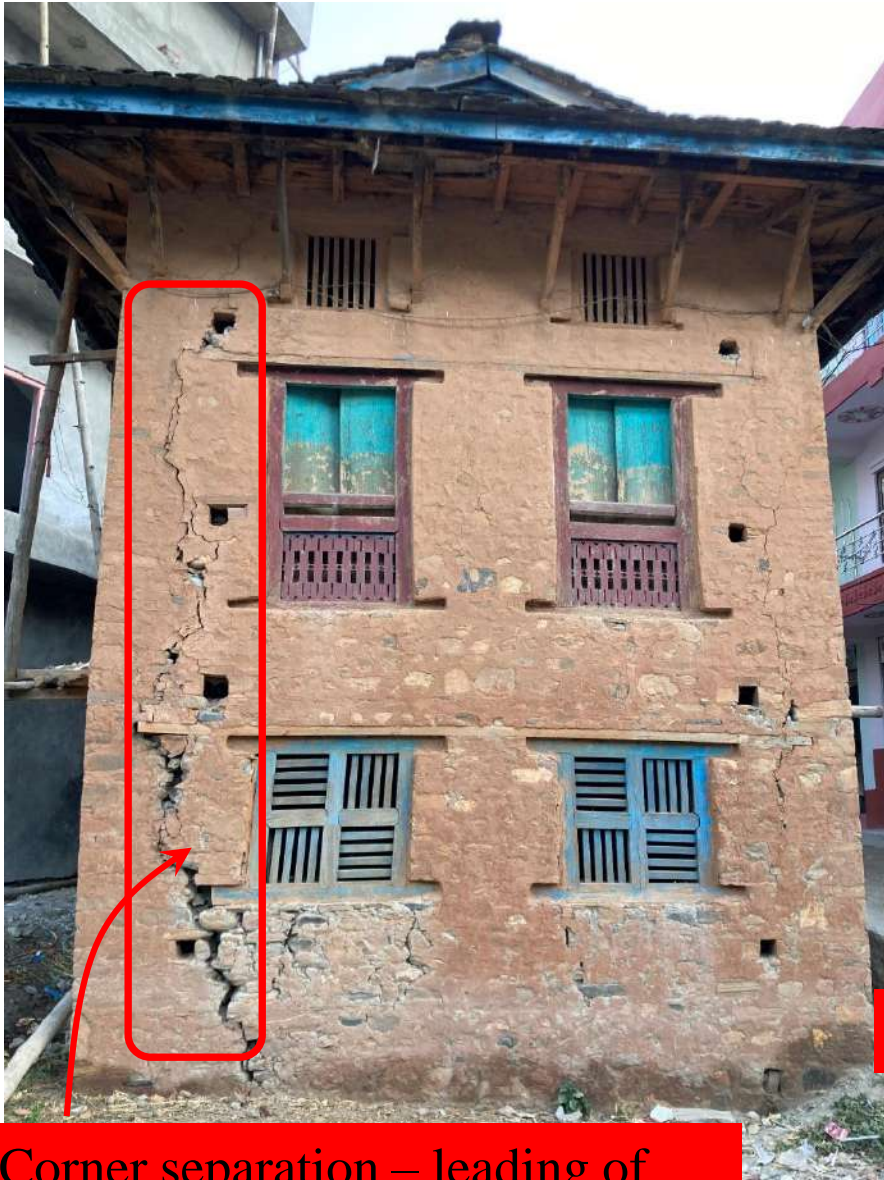
Corner separation – leading of out-of-plane failure

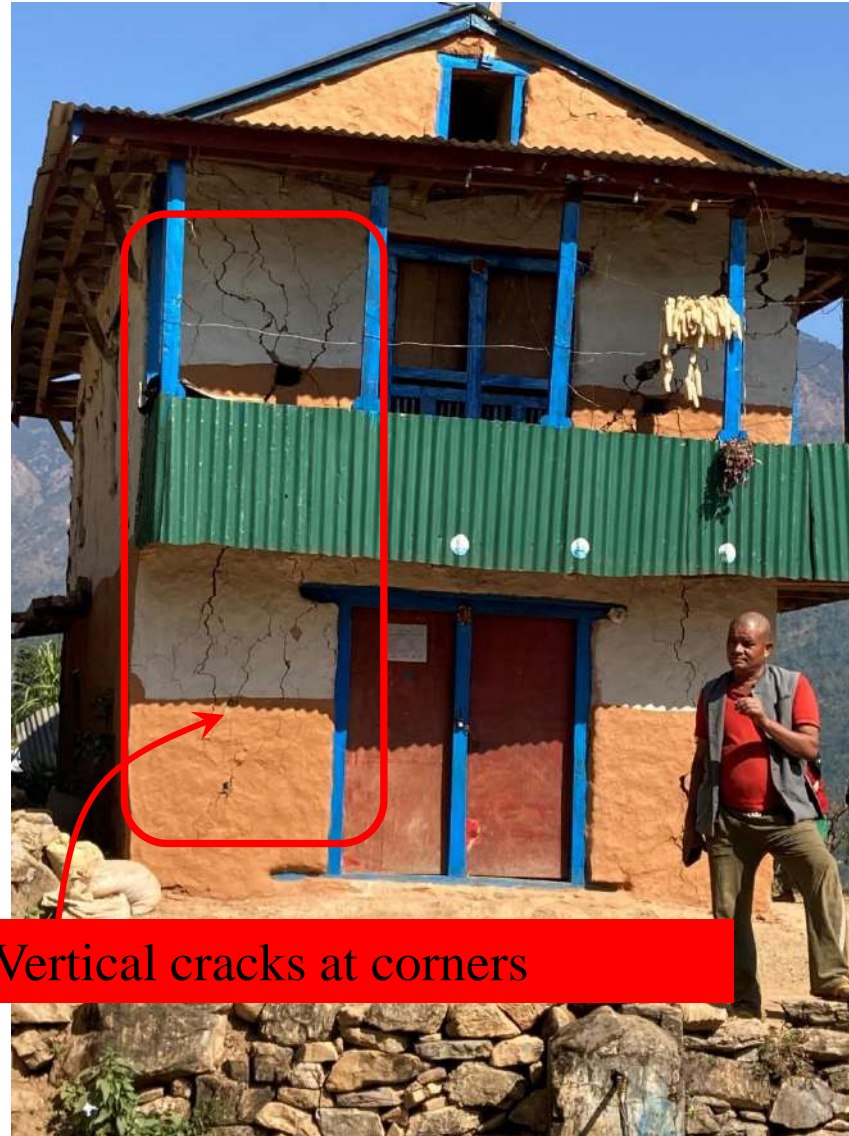
Vertical cracks at corners

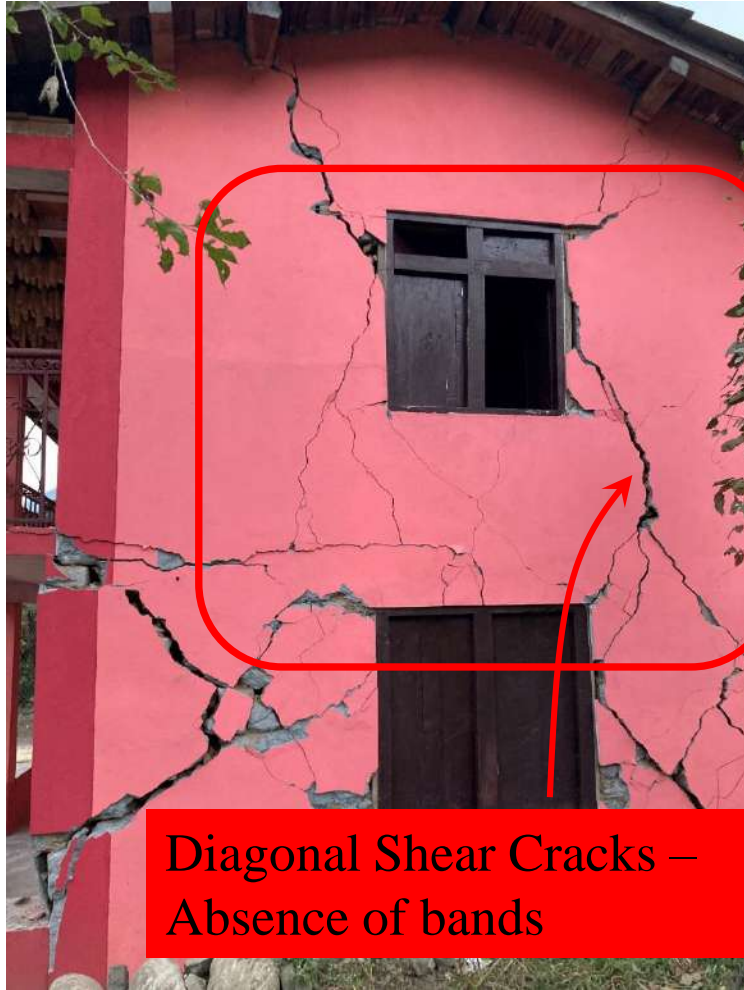
Diagonal Shear Cracks –
Absence of bands

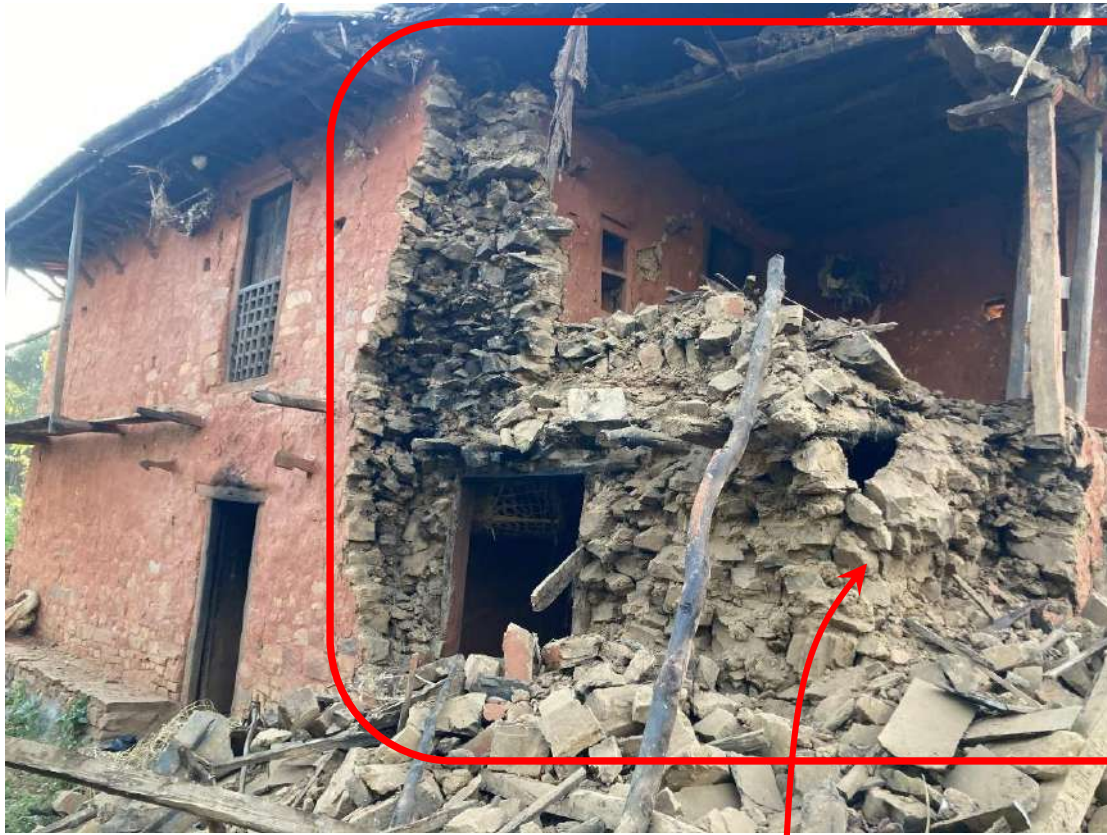
Salyan- Darma Rural Municipality-3

Out-of-plane failure – Free standing walls and absence of bands

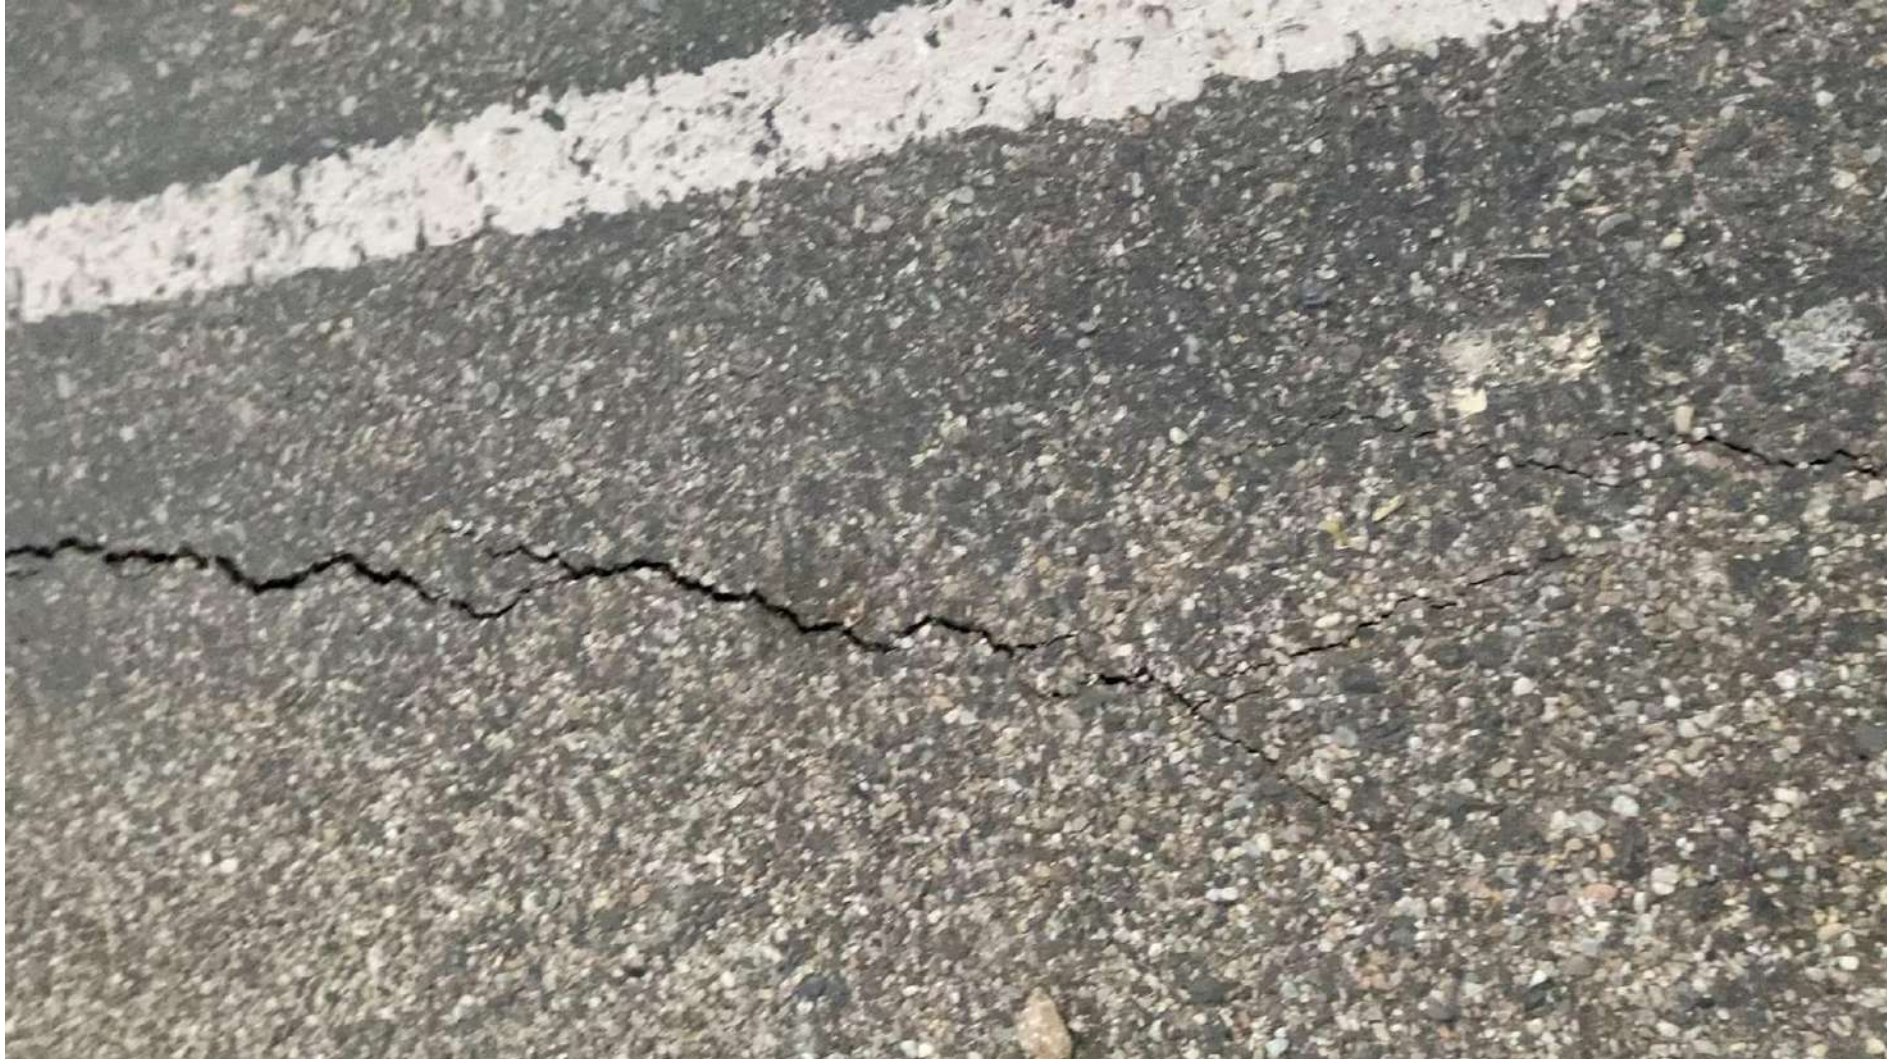
- Damage in Mid-Mountain Highway- Musikot to Cahurjhari Rukum (West)

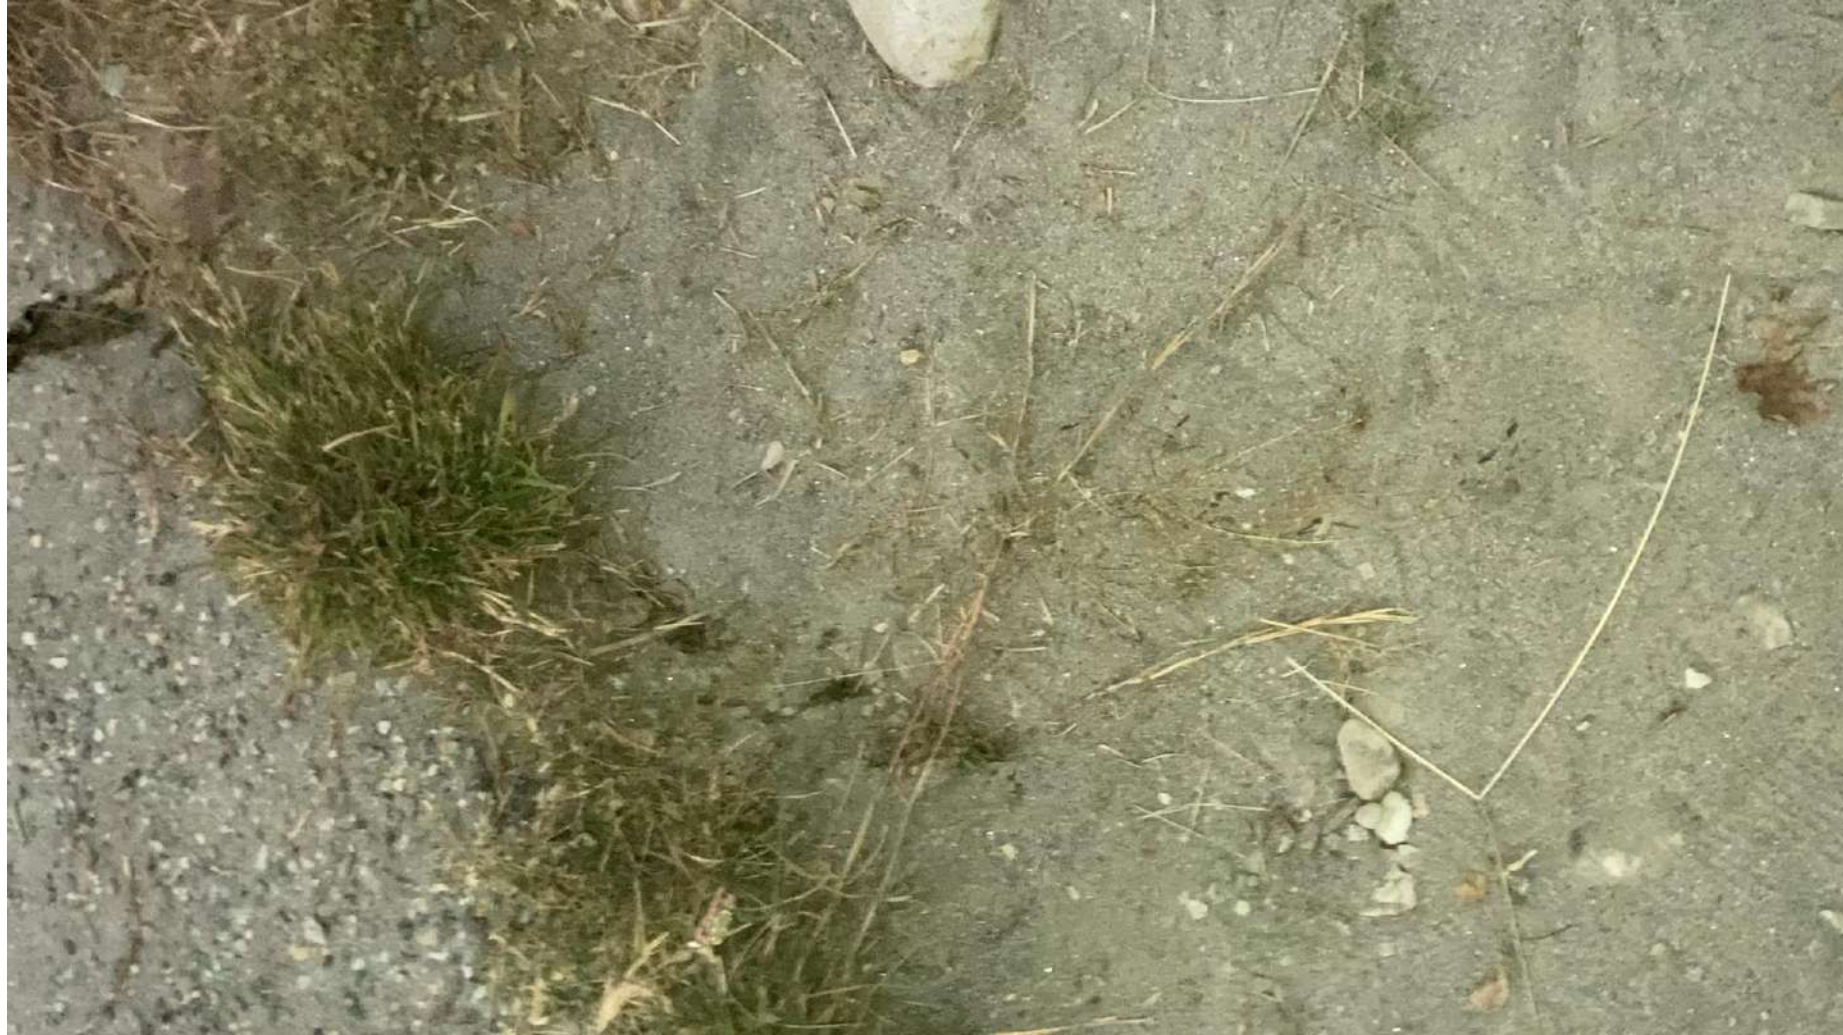
- Damage in Madhya Pahadi Rajmarg- near China Bazar way to Cahurjhari Rukum (West)
- Land slides
- Minor damage in bridge
