Jajarkot Earthquake: Impacts and Future Directions for Earthquake Resilient Reconstruction

Gokarna Bahadur Motra, PhD

11 Nov. 2023 (2080/08/08)

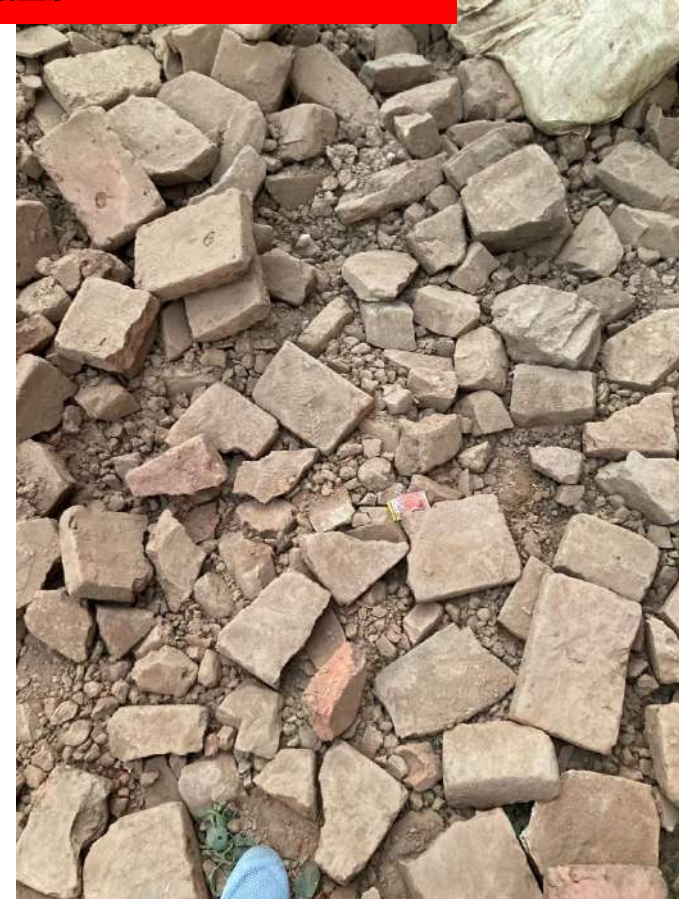
Out-of-plane failure of gable and supporting walls

Flat bricks on flexible floor base

- Unsupported gable wall failure in the absence of band at gable
- Flexible floor is not supported on the short wall

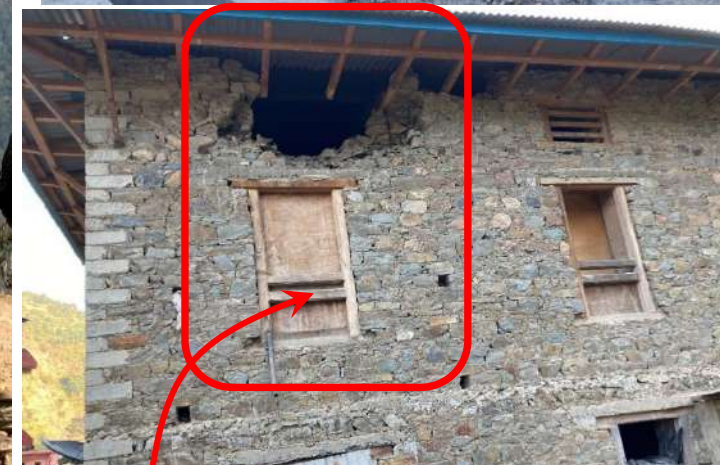
Vertical cracks at corners
