Jajarkot Earthquake: Impacts and Future Directions for Earthquake Resilient Reconstruction

Gokarna Bahadur Motra, PhD

11 Nov. 2023 (2080/08/08)

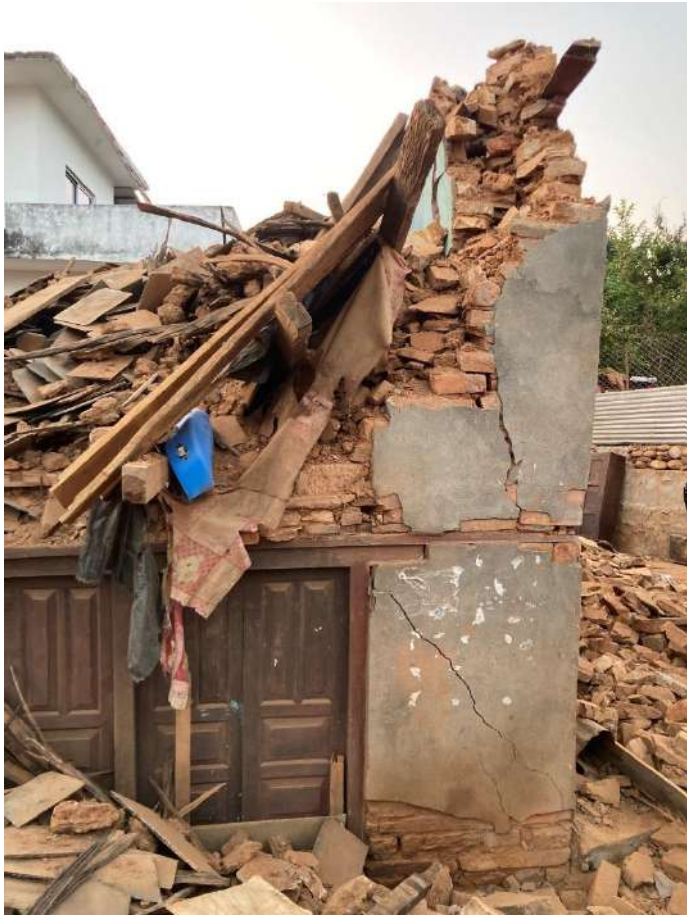
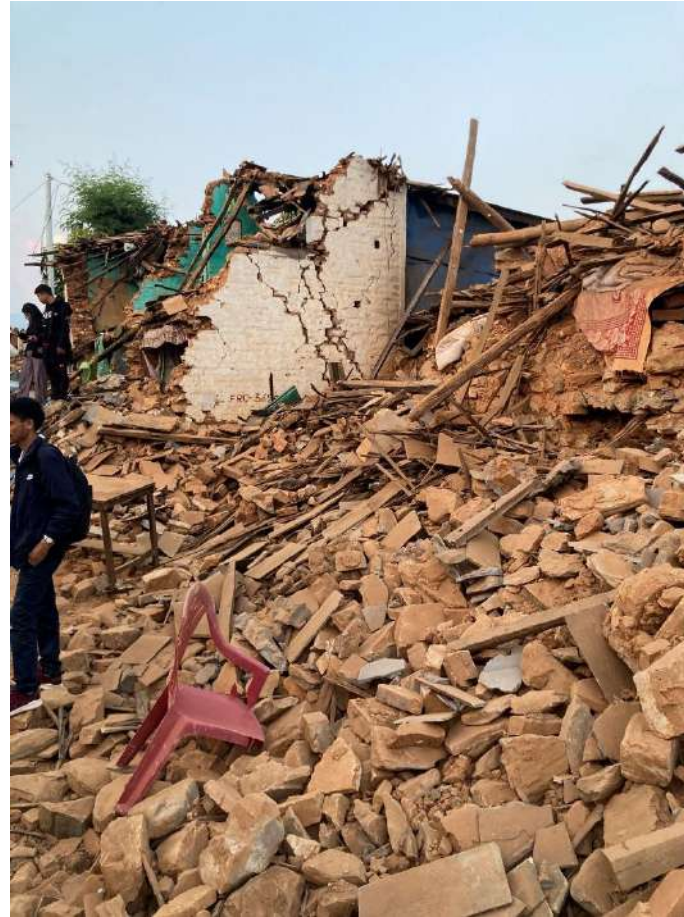
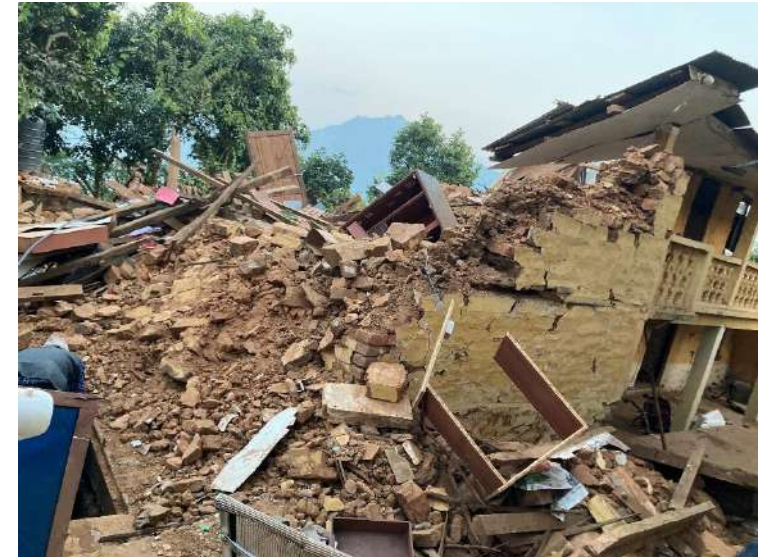
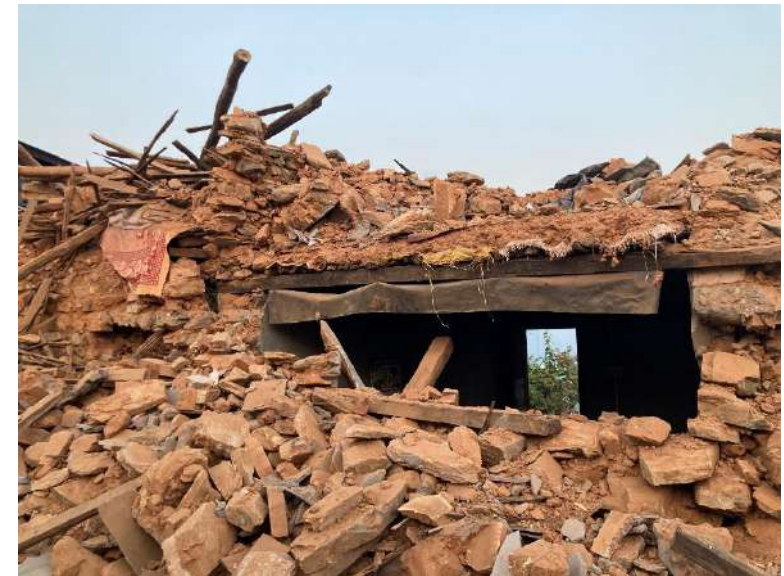
Complete collapse of Stone Masonry Building in Mud Mortar at Khalanga, Jajarkot

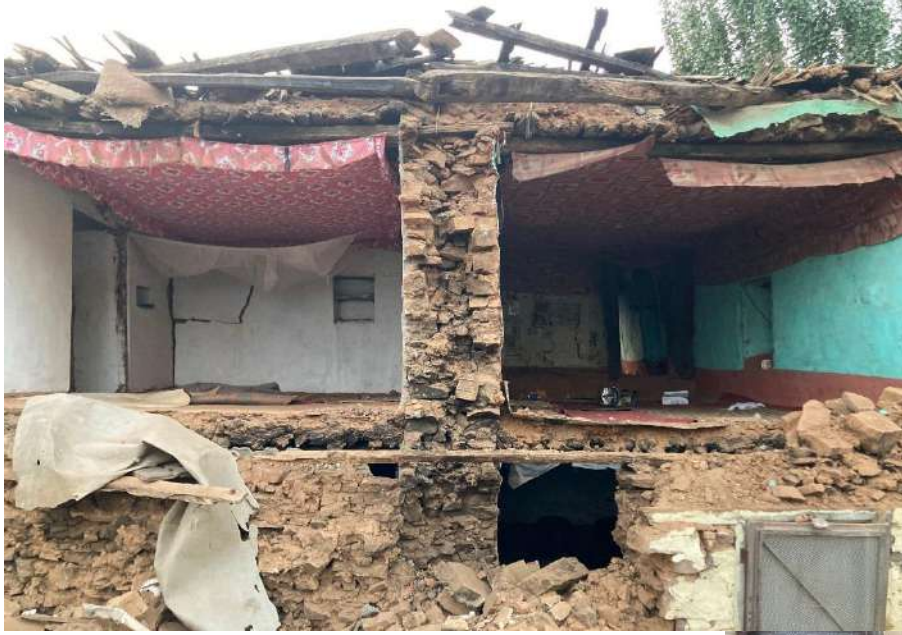
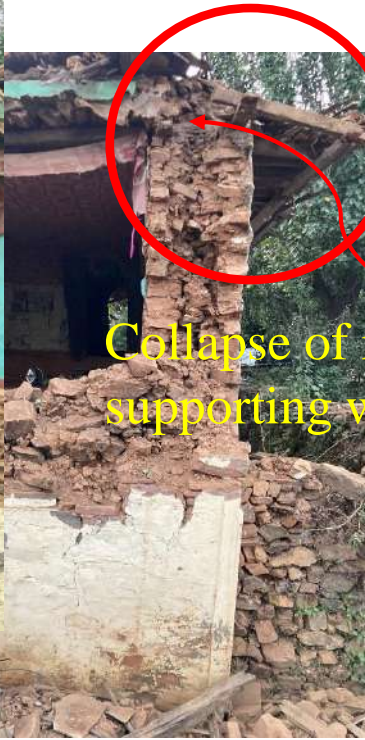
Collapse of roof and failure of supporting walls

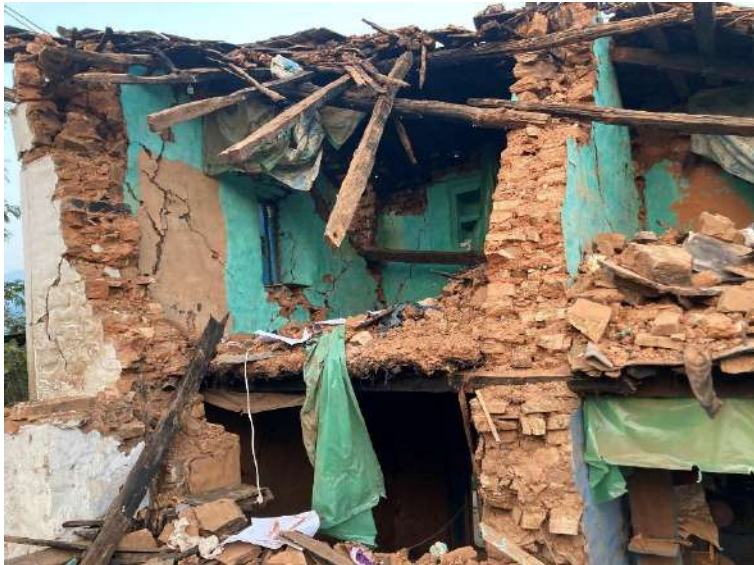
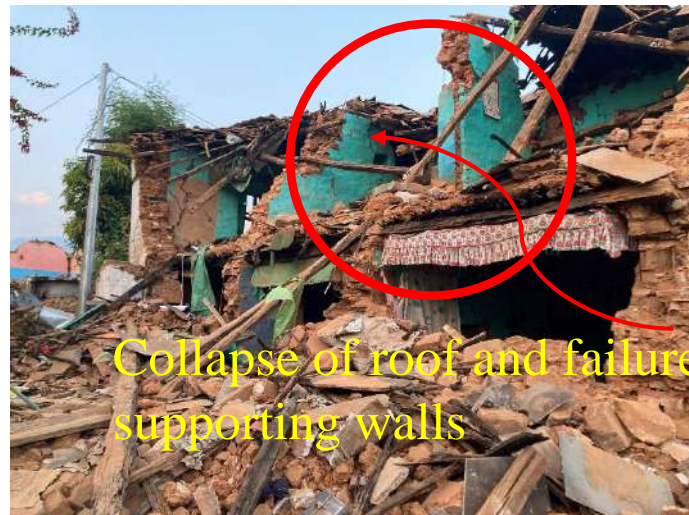
Collapse of roof and failure of supporting walls

- Heavy roof collapse and out of plane failure of supporting walls
- Typical out-of-plane failure of URM walls

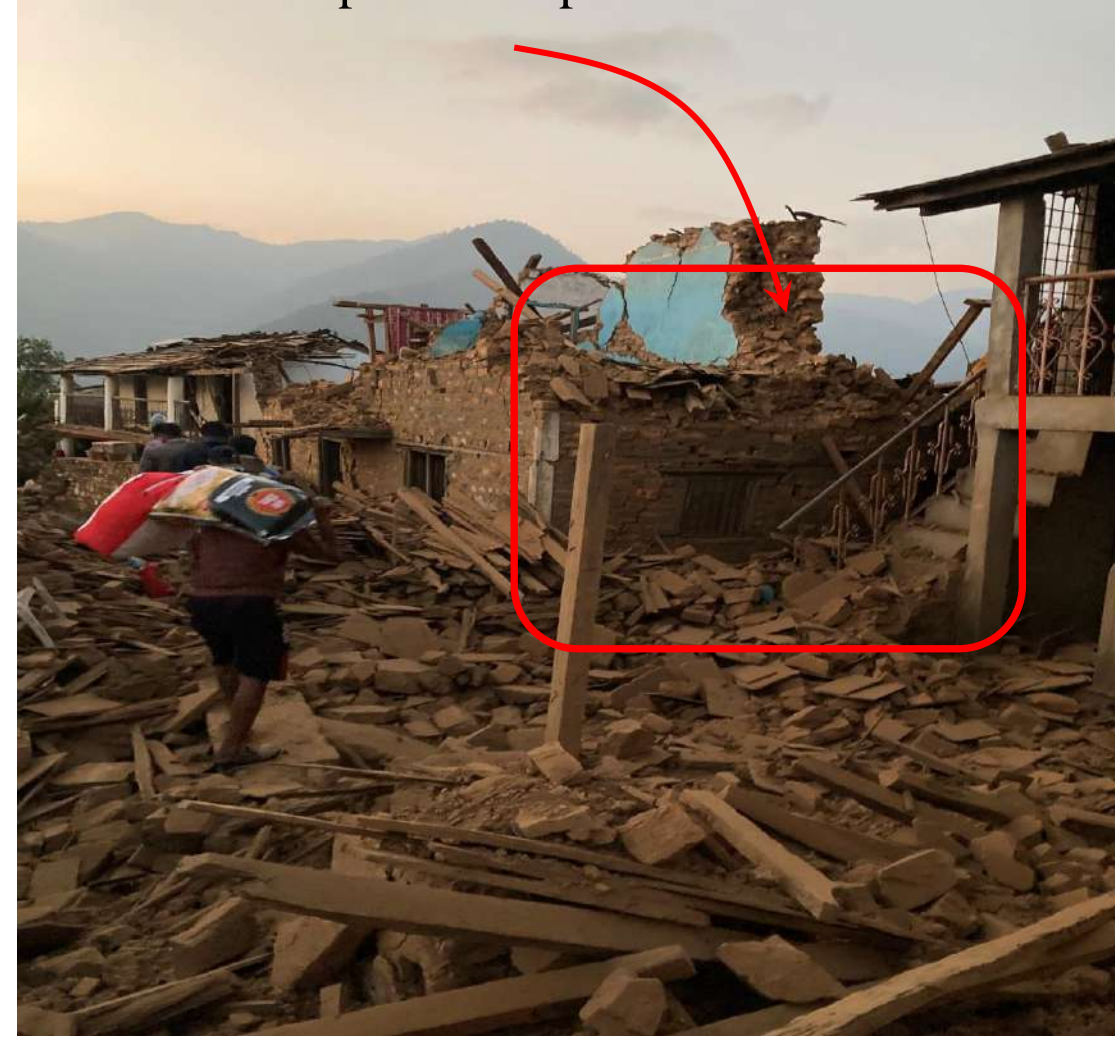
Complete collapse

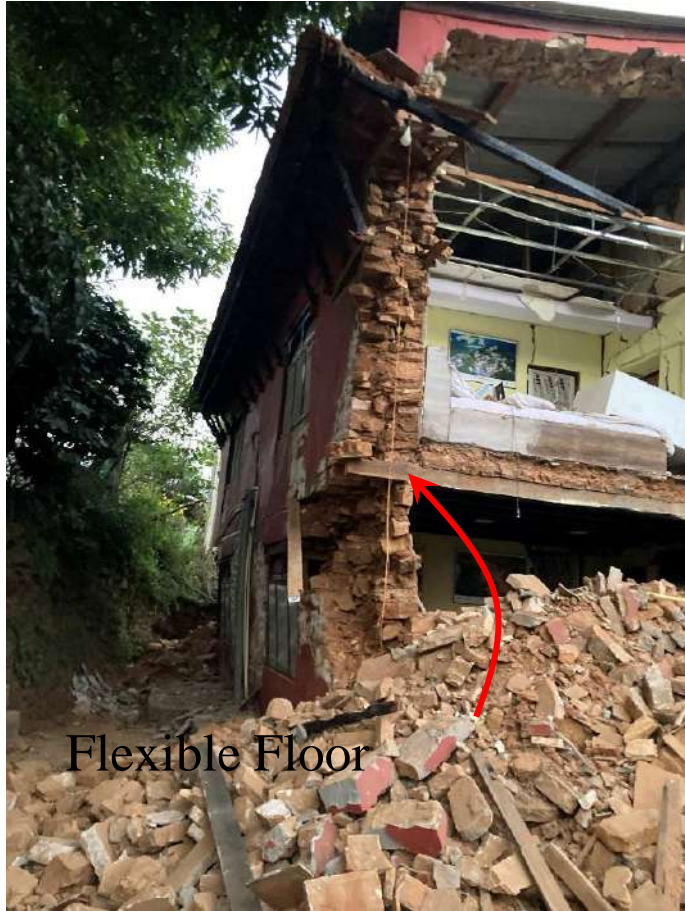
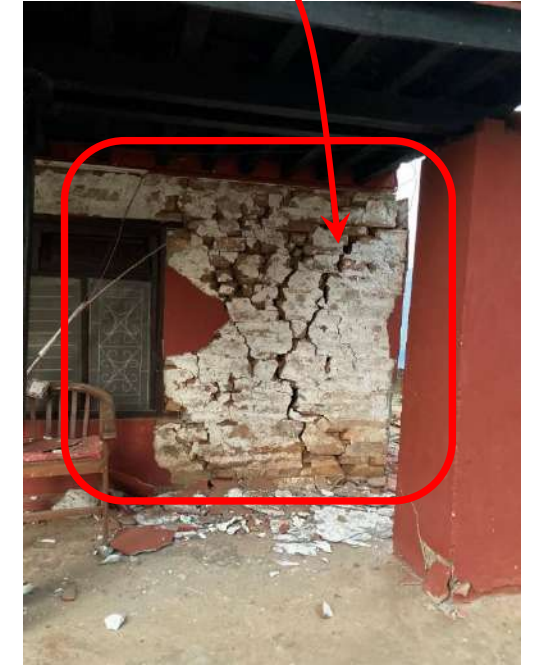
Wall pier diagonal cracking

- Flexible floor- holding one direction walls only
- Formation of vertical cracks at the corners of the building reduce the out-of-plane stability of the walls drastically that leads to strength loss significantly.

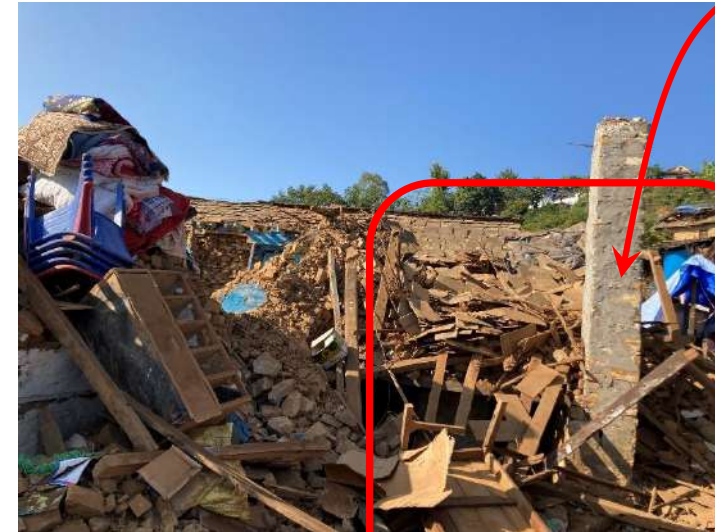
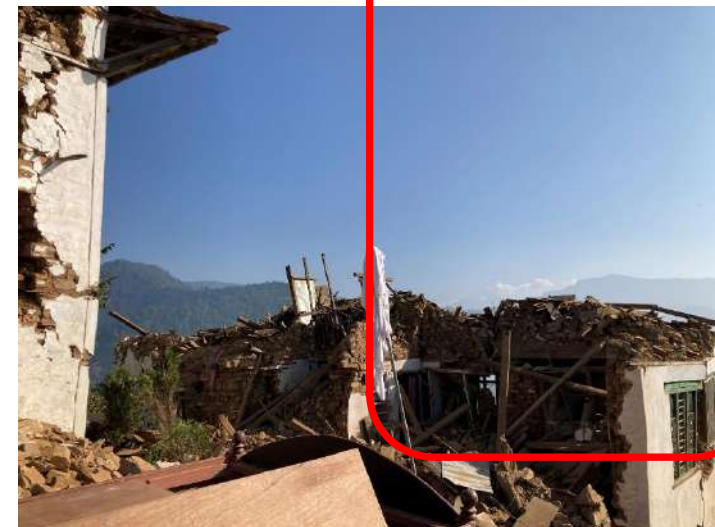
Complete collapse

- Building damage along the ridge line

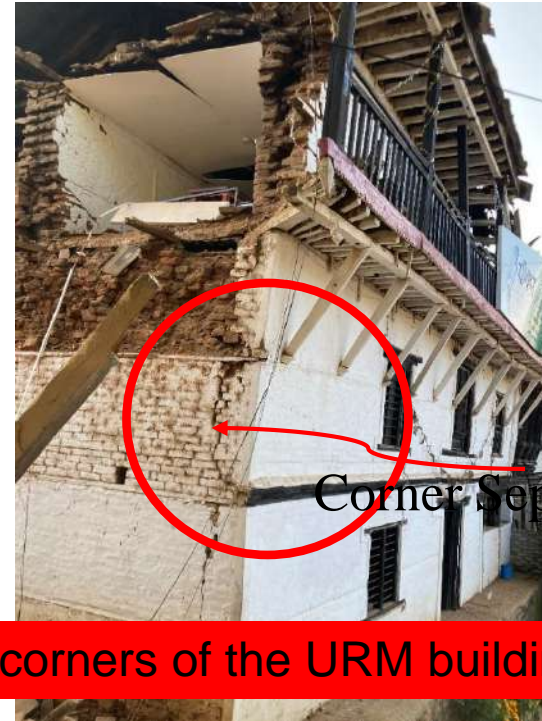
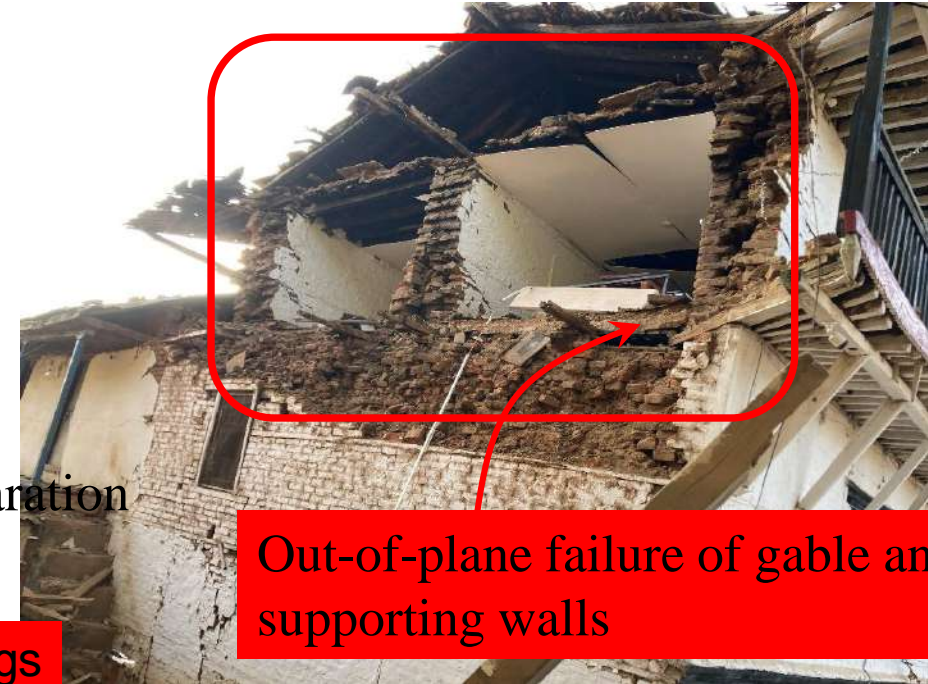
- Poor connection with the diaphragm and cross walls led to the out-of-plane collapse of old load bearing masonry walls at Khalanga, Jajarkot.

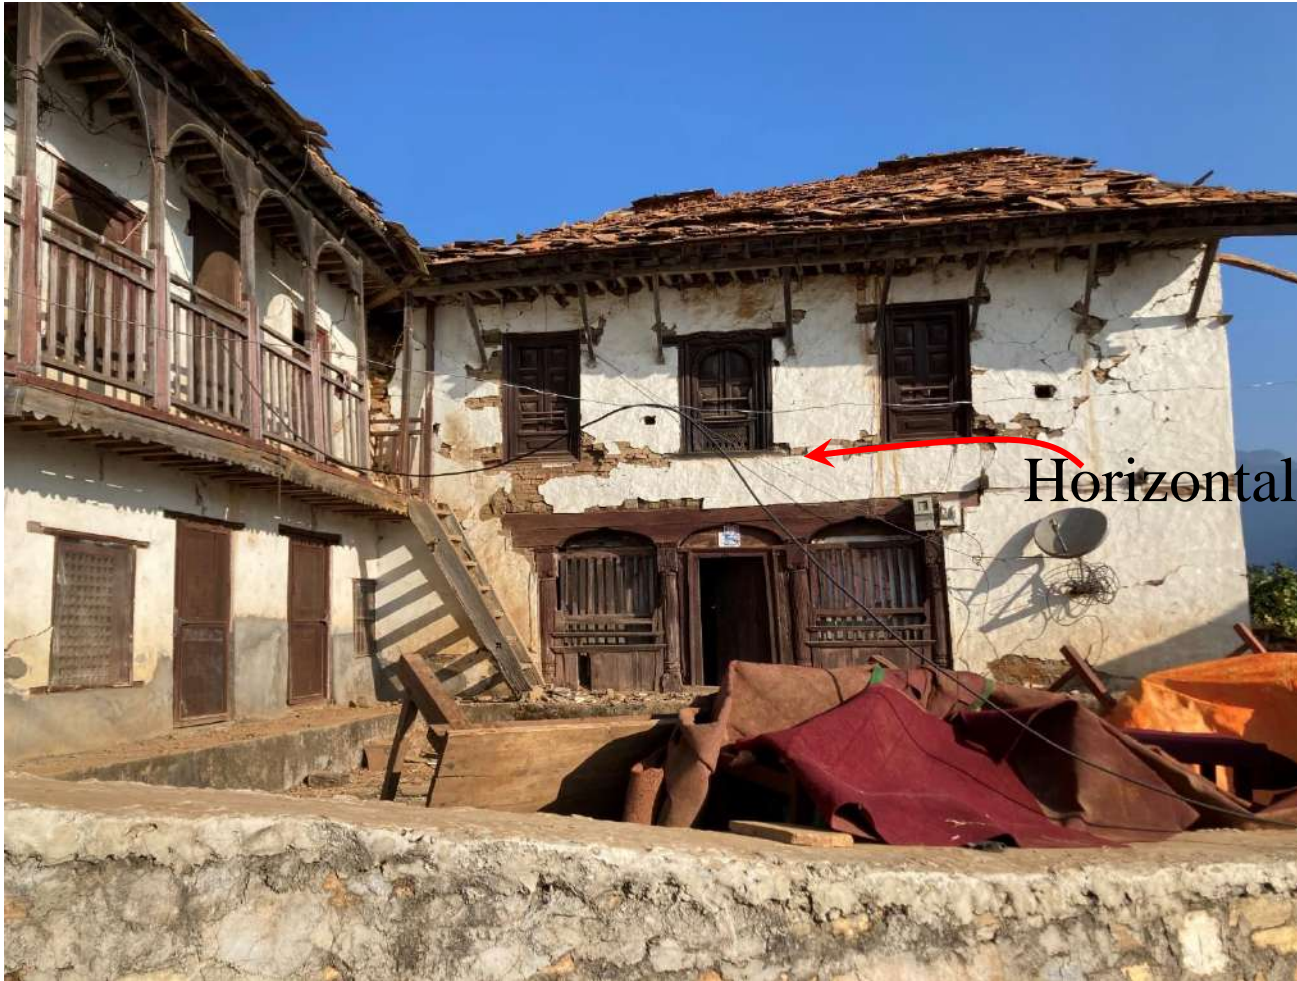
Horizontal shear sliding

Torsional effect is prominent in L-, T-shape buildings, leading to cracks at the junction

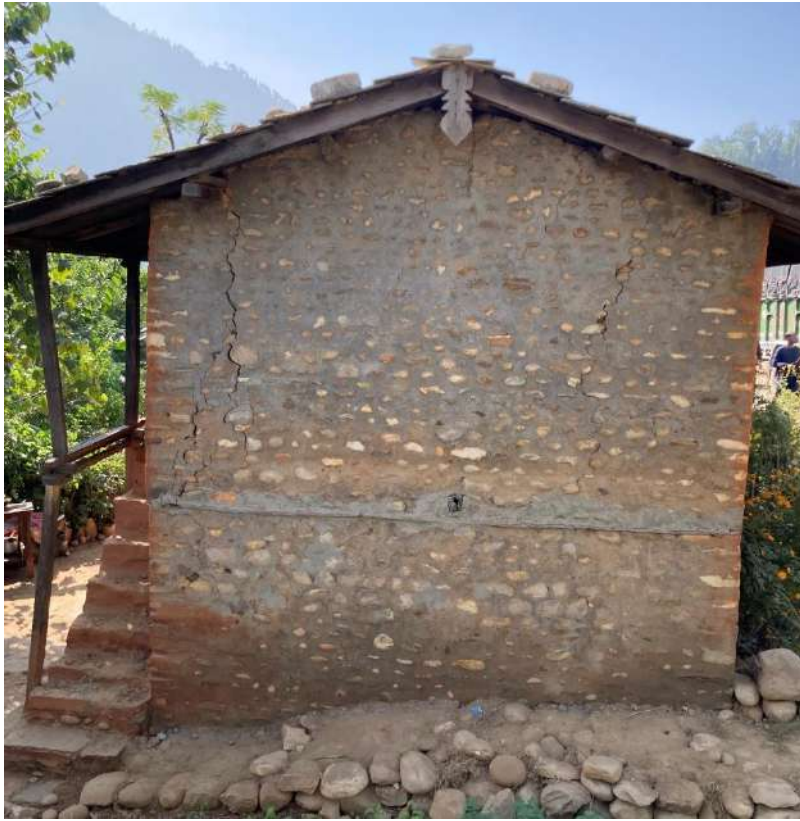
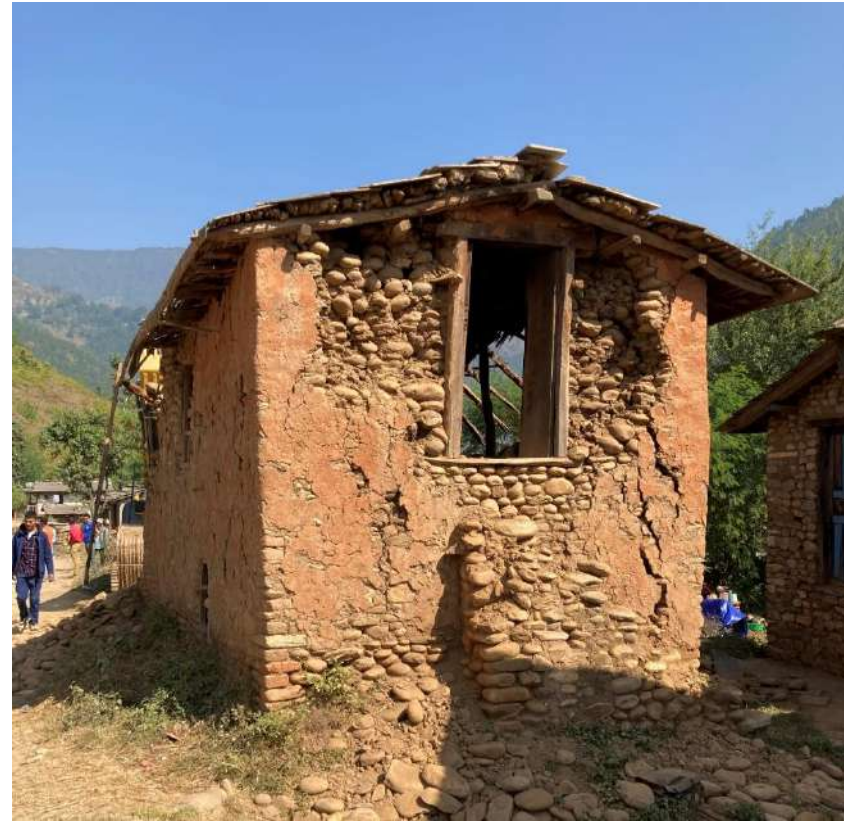
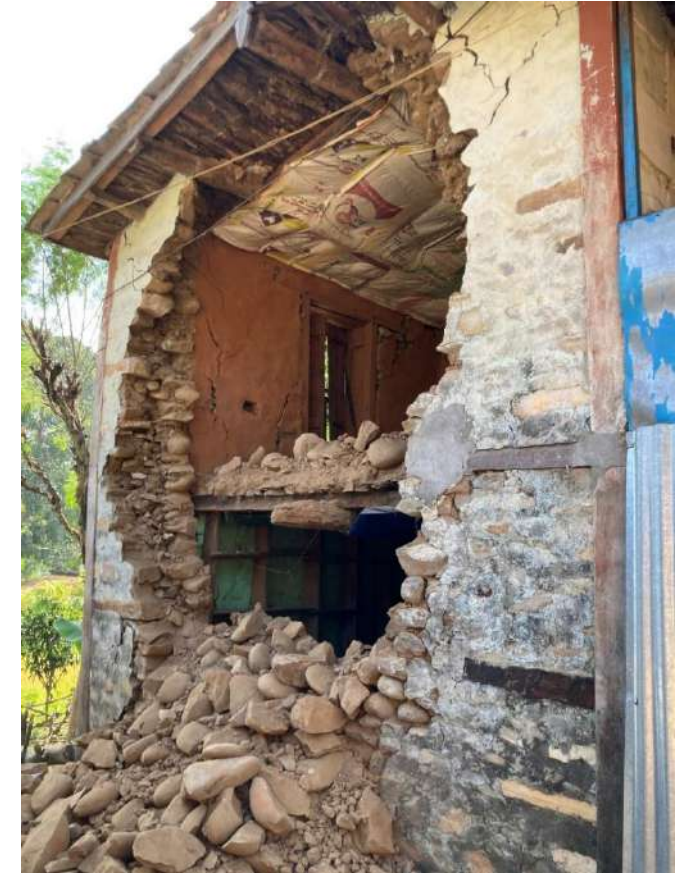
Buildings along Veri River

River picked boulders are unstable units. Absence of bands in the walls and heavy roof load during shaking need to transfer from in-plane wall action to out-of-plane wall. Absence of bands cause initiation of vertical cracks at the corners reducing the out-of-plane stability of the walls drastically leading to out-of-plane failure of the walls.

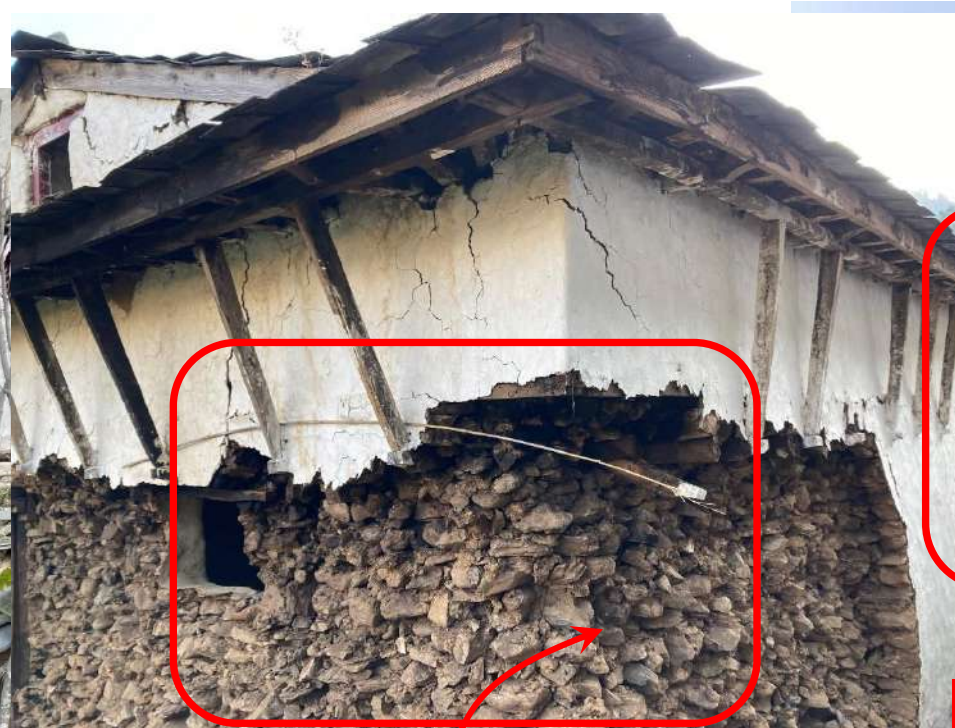
Out-of-plane failure of gable and supporting walls

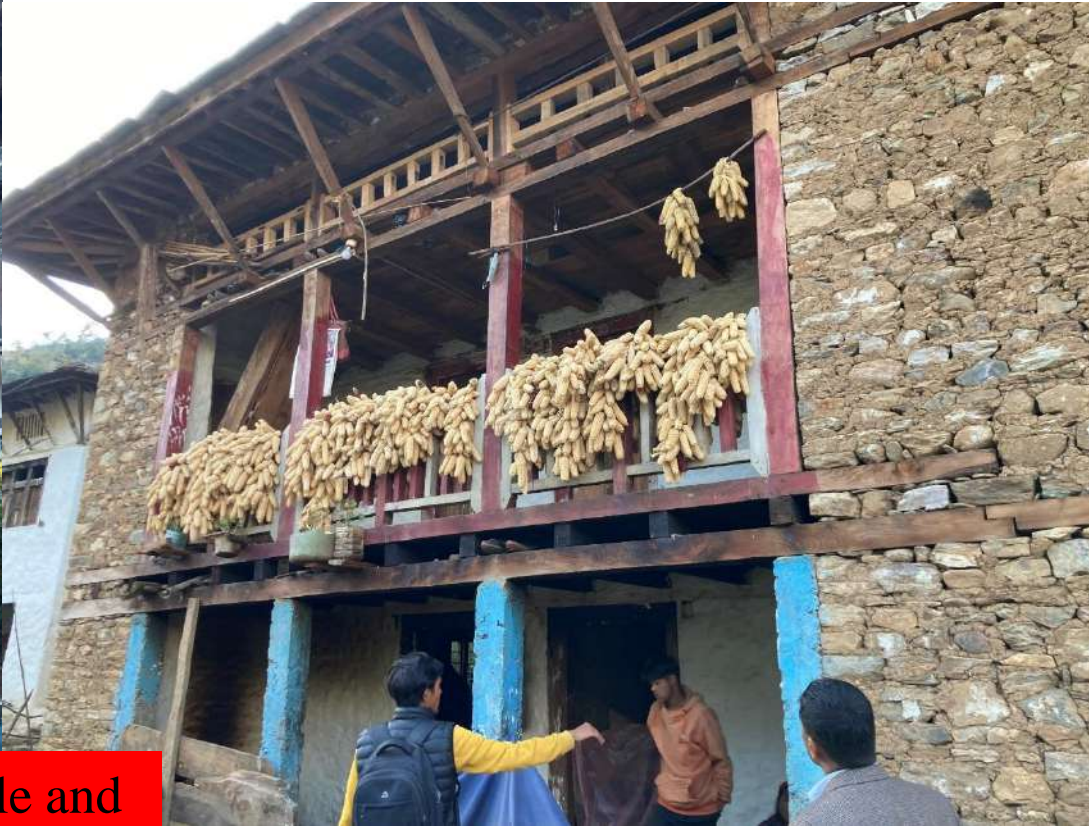
Out-of-plane failure of gable and supporting walls

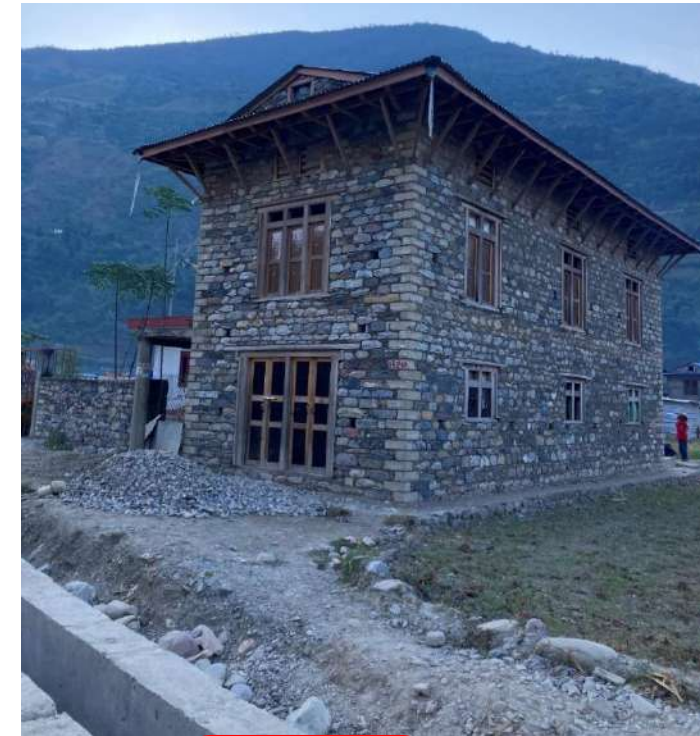
Vertical cracks at corners

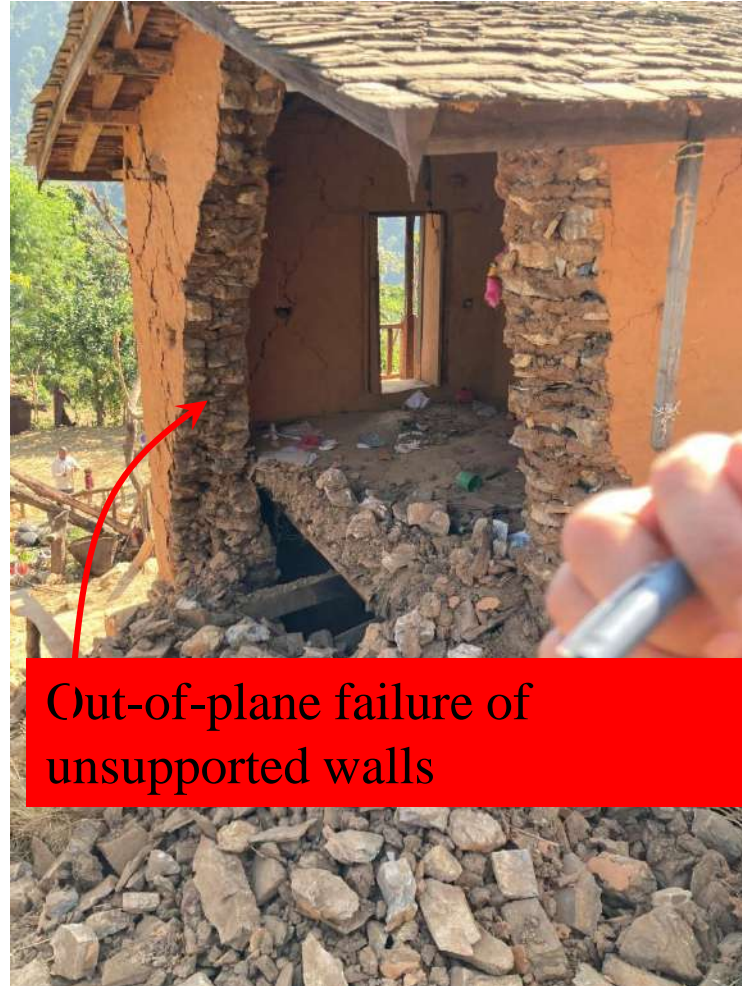
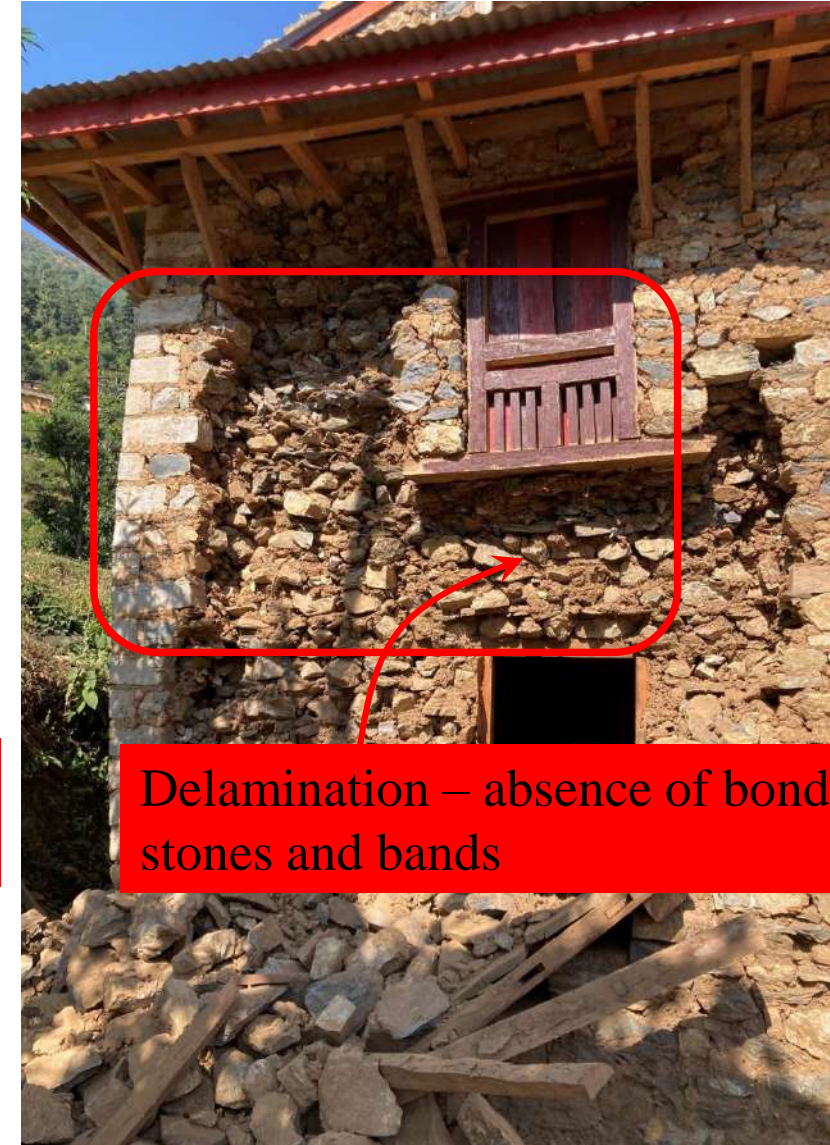
Nalgad Rural Municipality, Chiyaure

Out-of-plane failure of SMM wall- absence of roof band

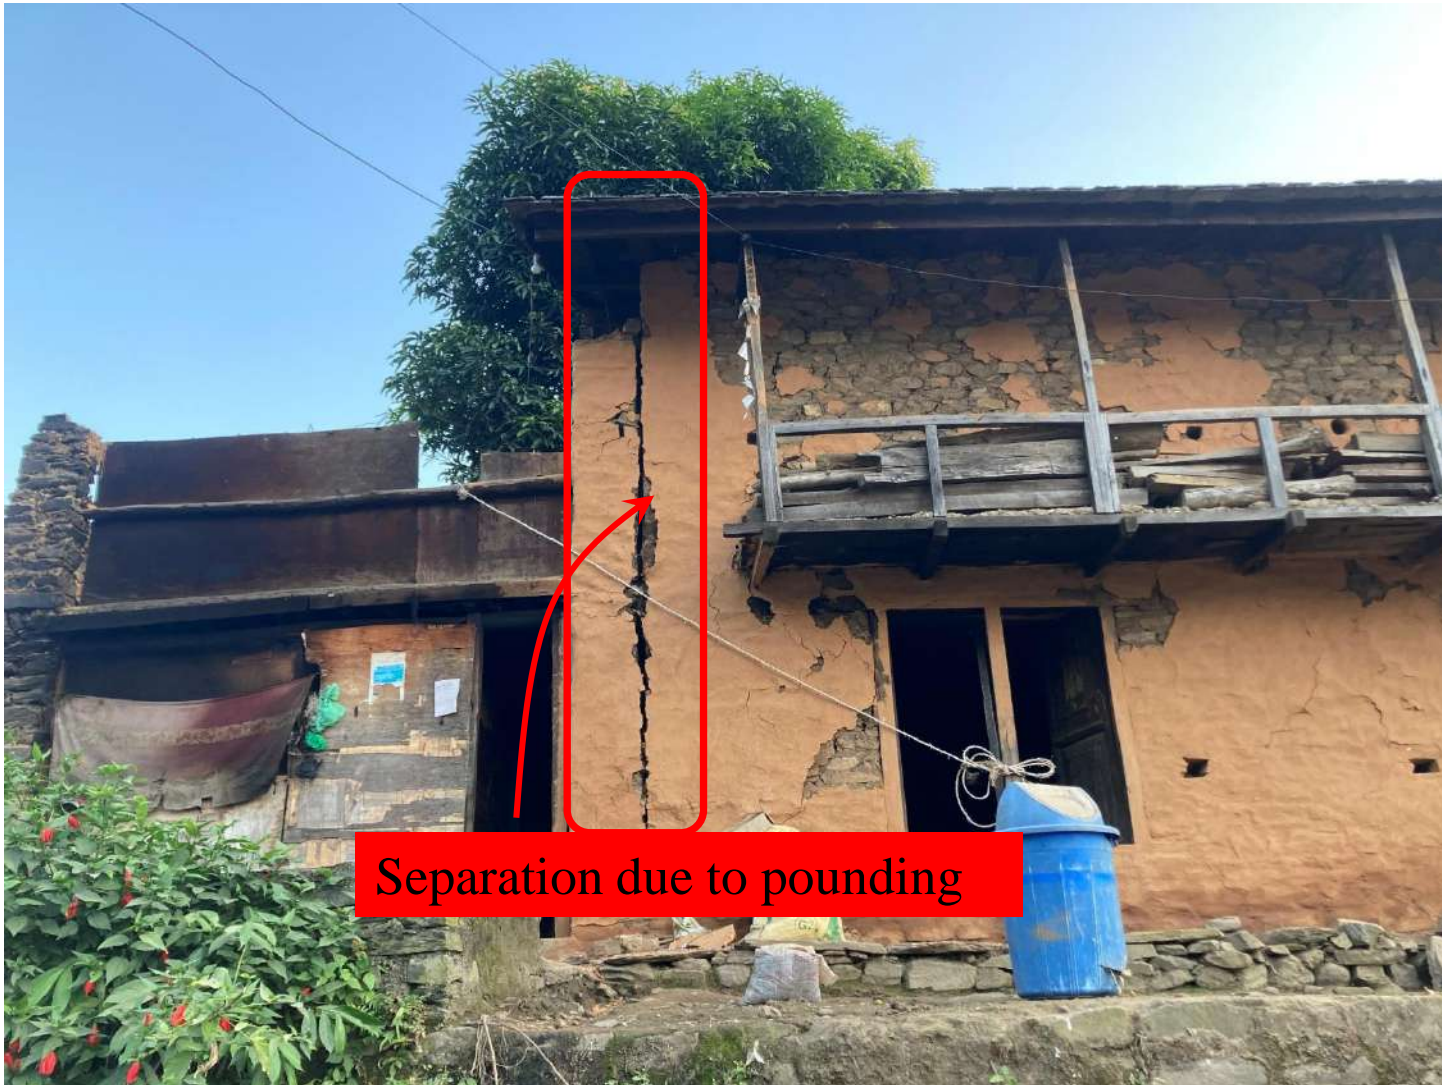
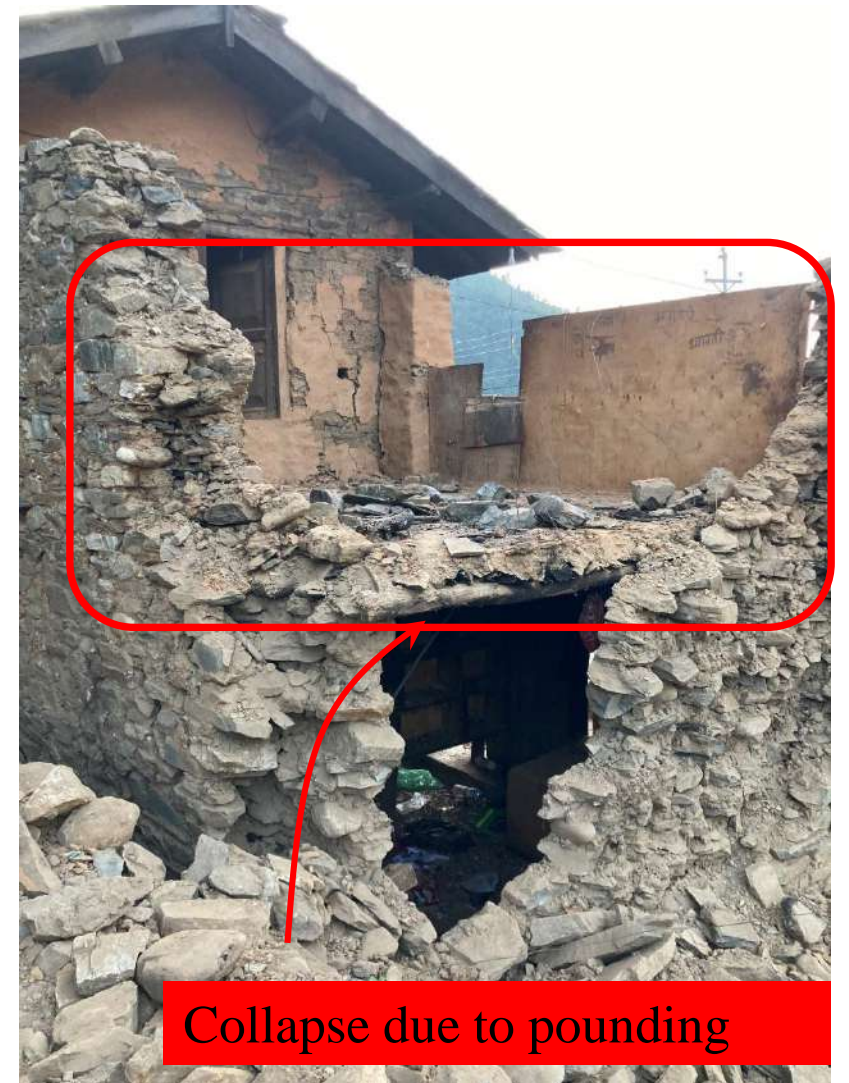
Pounding Effect

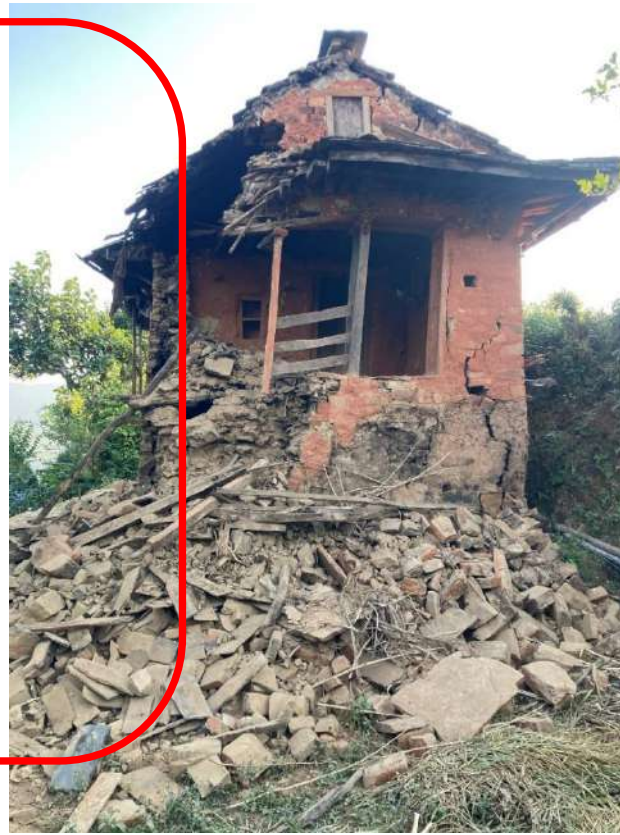
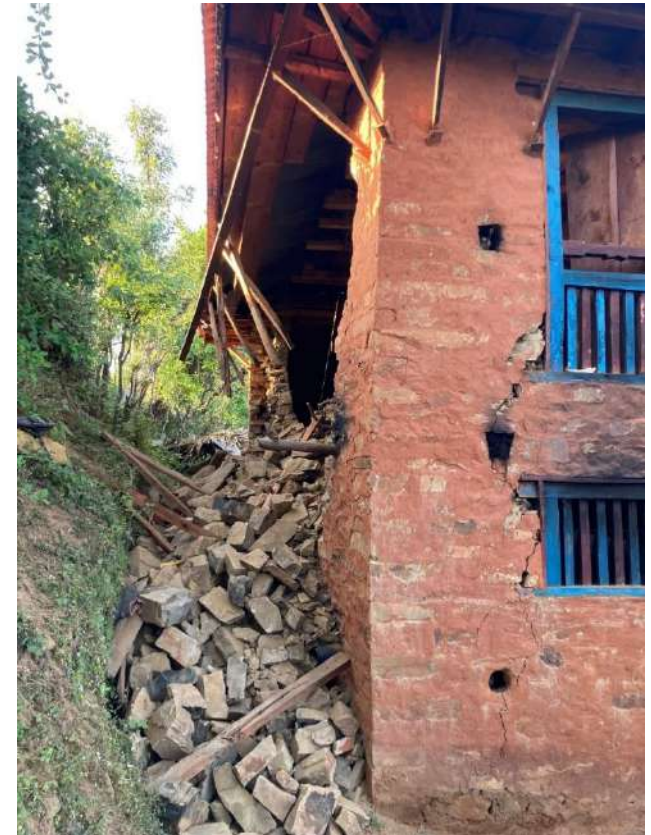
Salyan- Darma Rural Municipality-3

Diagonal Shear Cracks –
Absence of bands

Out-of-plane failure – Free standing walls and absence of bands

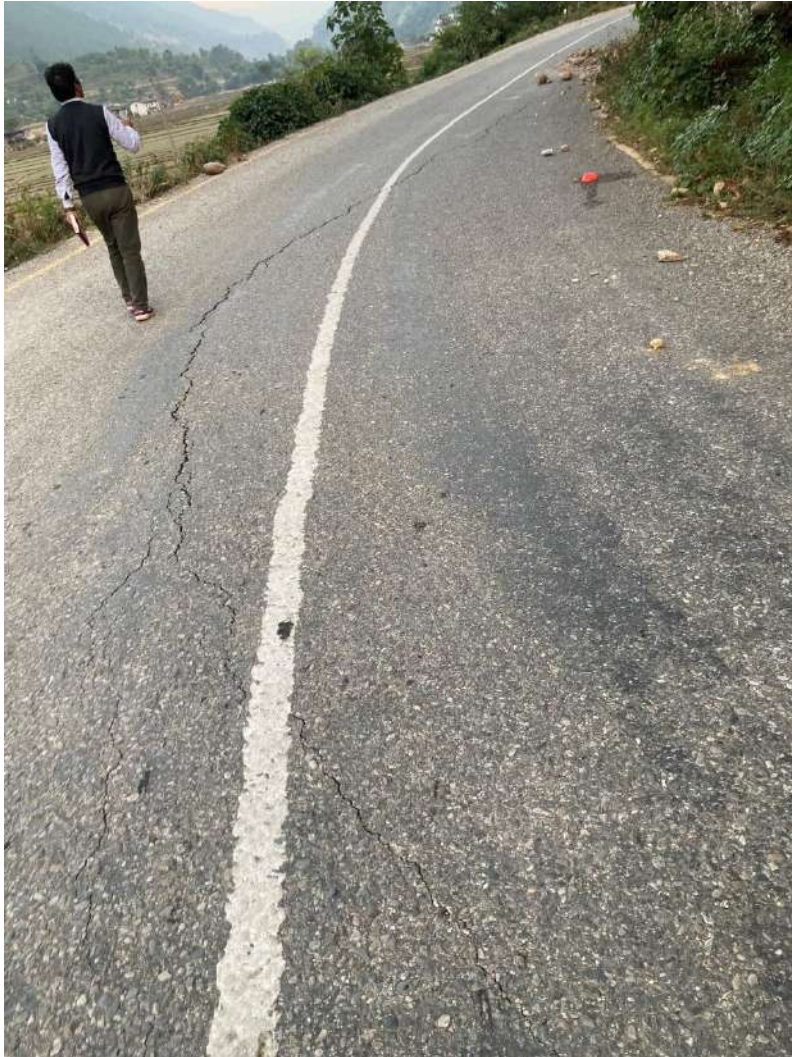
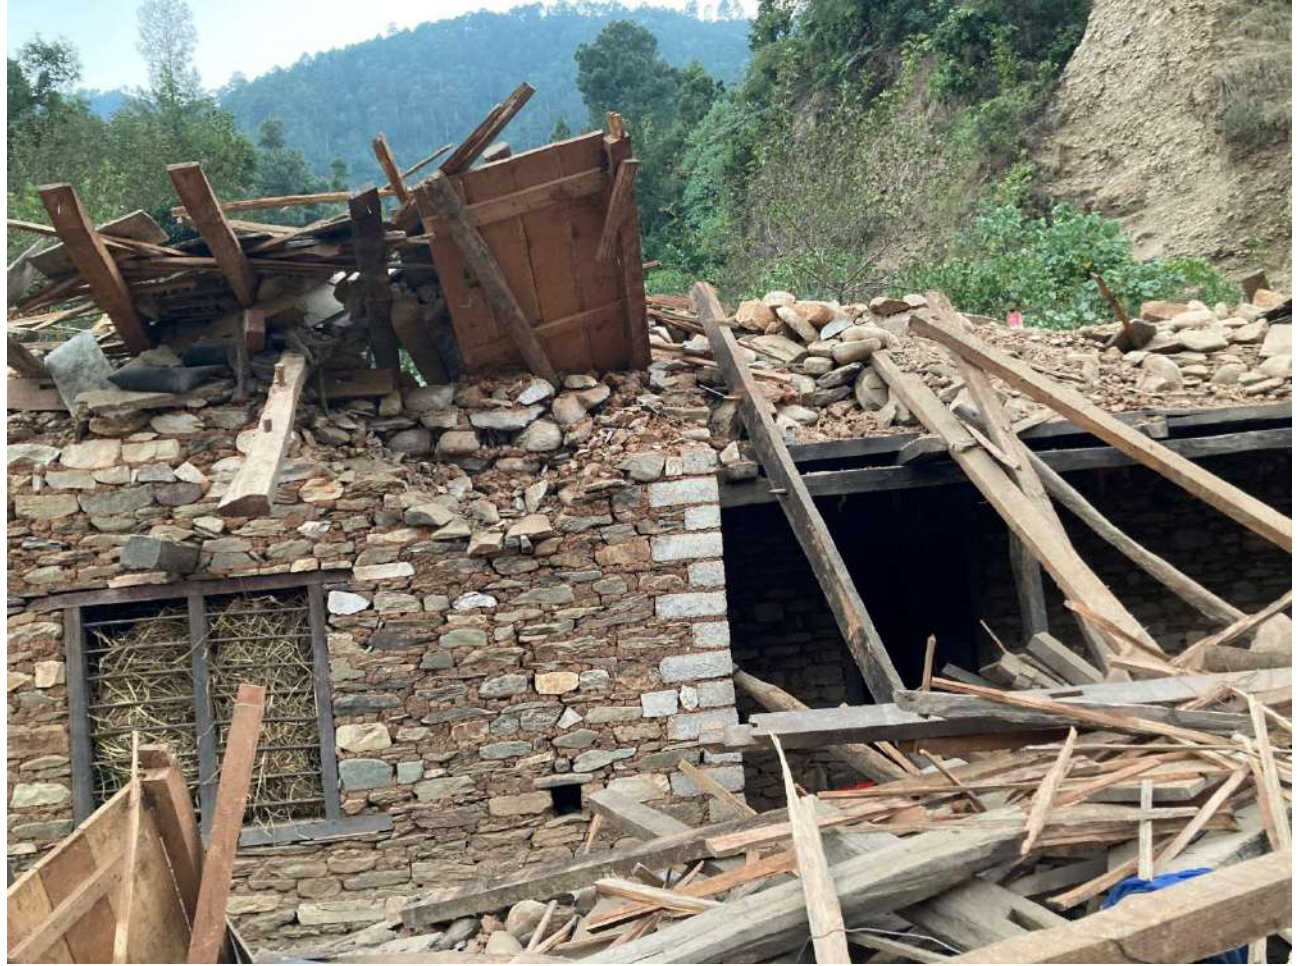
Geotechnical Failures

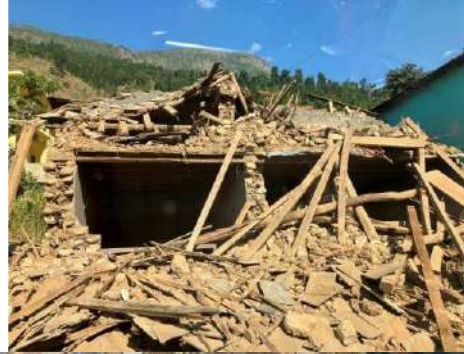
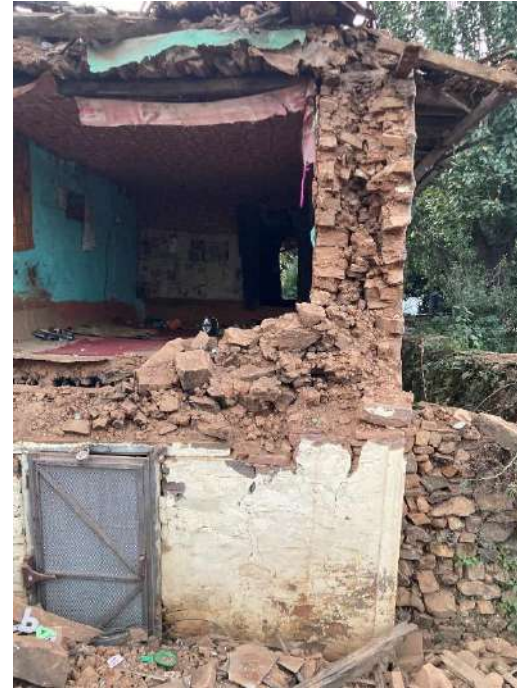
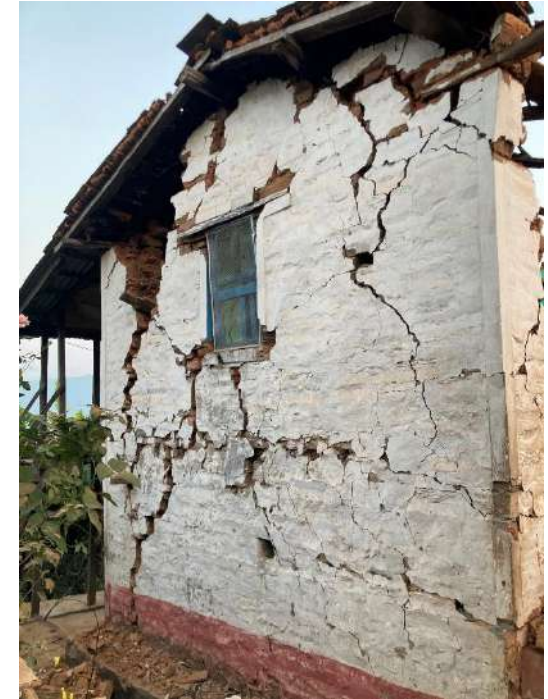
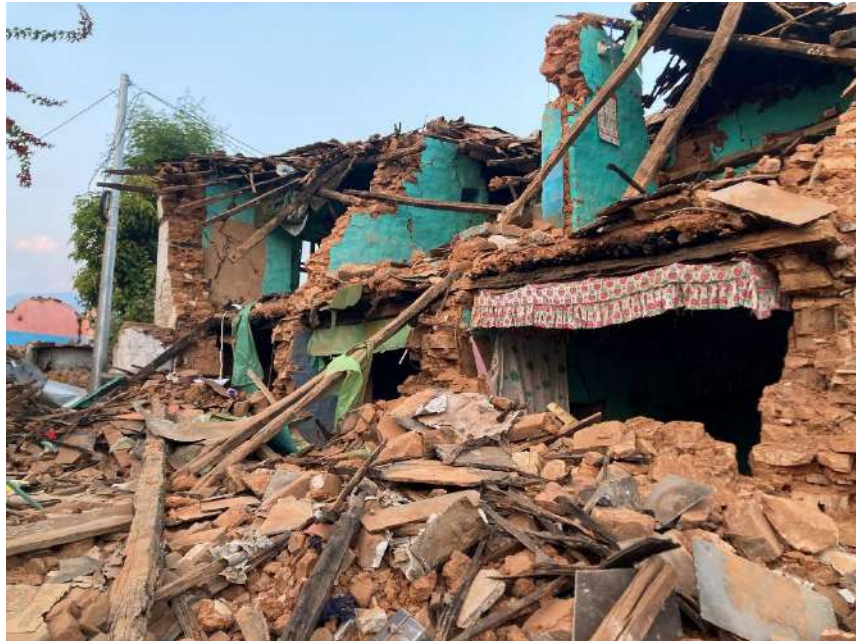
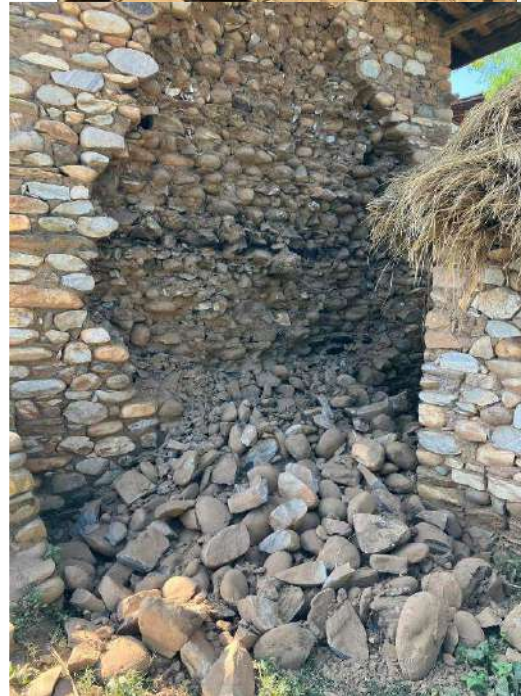
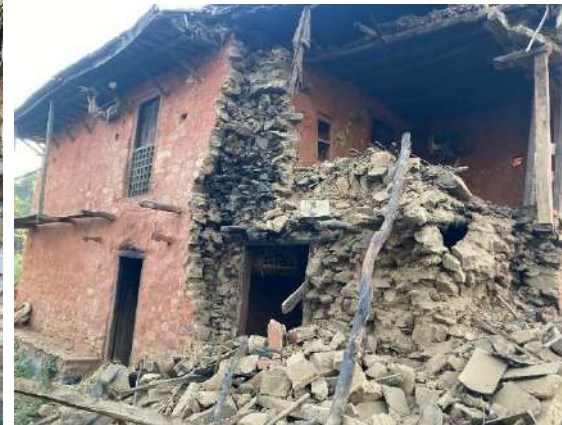
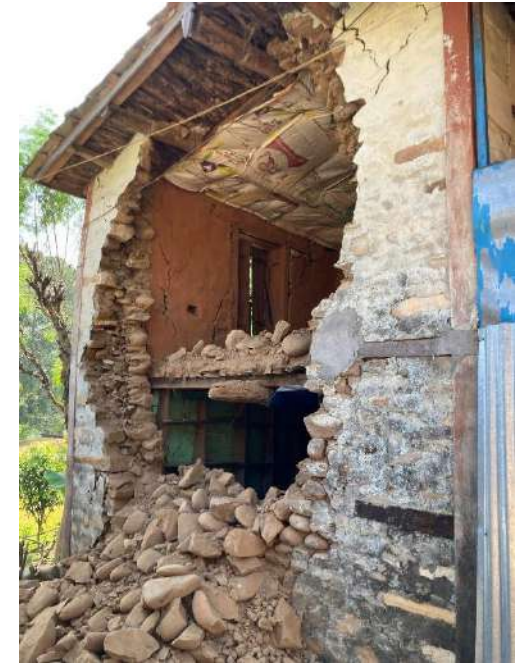
- Lack of bracing-walls, floors, roofs
- Construction and structural deficiencies
- Issues in materials

- Absence of key stones, through stones, bands
 - Absence of EQ force resistive elements
 - Absence of the provisions mentioned in masonry guidelines, NBC and ...
-
- Office buildings of all Municipalities are of RCC Frame Structures
 - Even poor RCC buildings survived the EQ shaking
 - **Distractions and misconceptions to masonry buildings among users**
 - Technical manpower at municipalities need trainings to implement NBC
